Navajo Abandoned Uranium Mine Site Screen Report

Nanabah Vandever AUM Site

Navajo AUM Eastern Region

May 2009

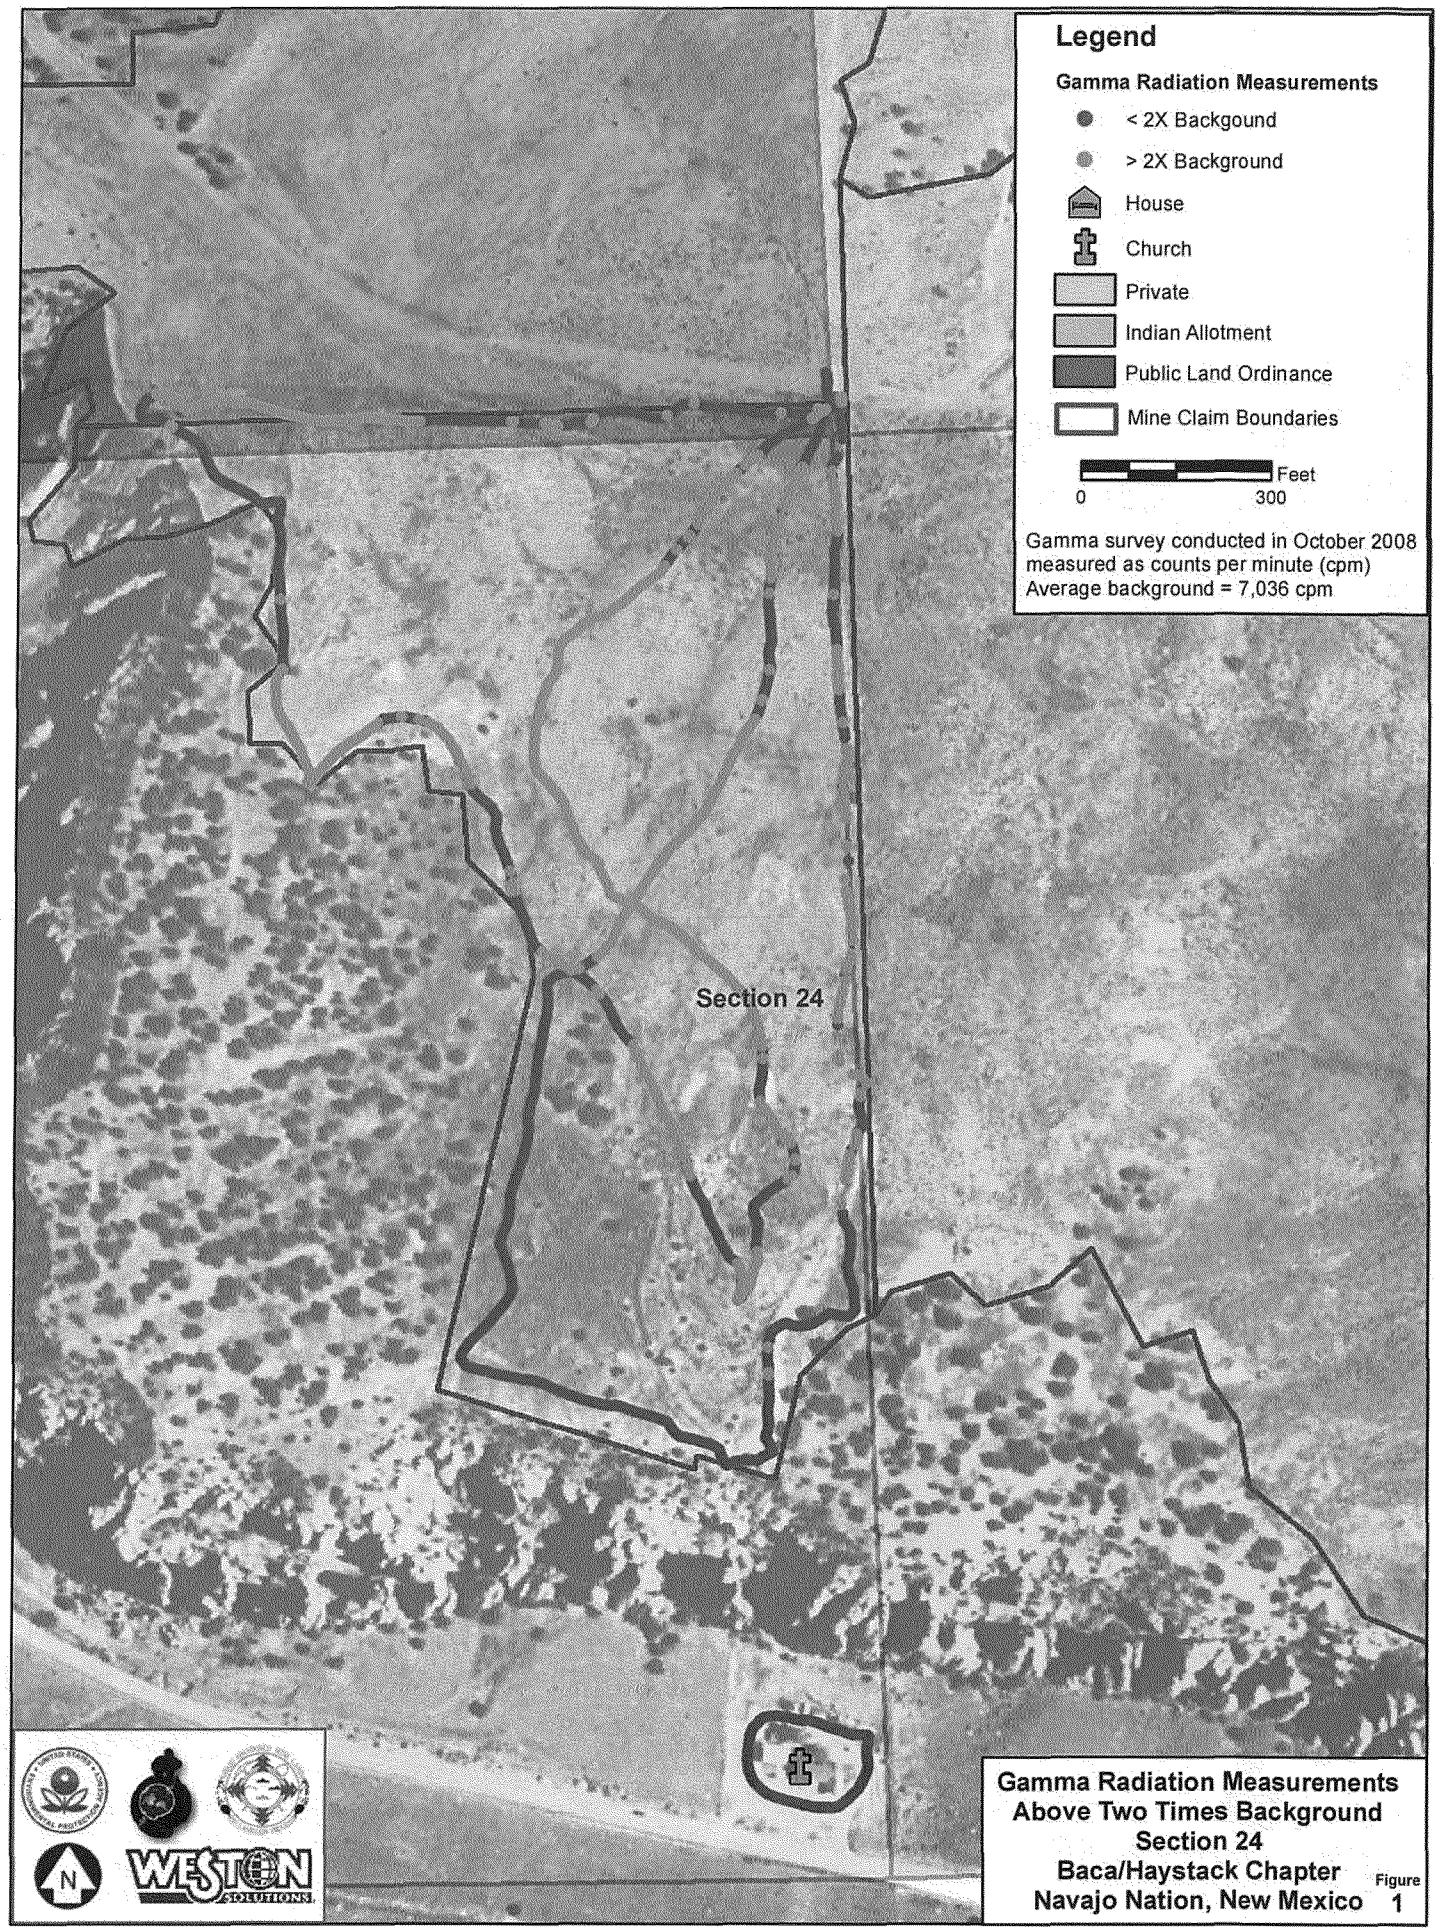
Figure 1

A total of 3,024 gamma radiation measurements were collected from mine sites, ranging from 4,569 cpm to 594,083 cpm. The measurements are represented in Figures 1 and 2.

Gamma Radiation Measurements Above Two Times Background
Section 24
Baca/Haystack Chapter
Navajo Nation, New Mexico

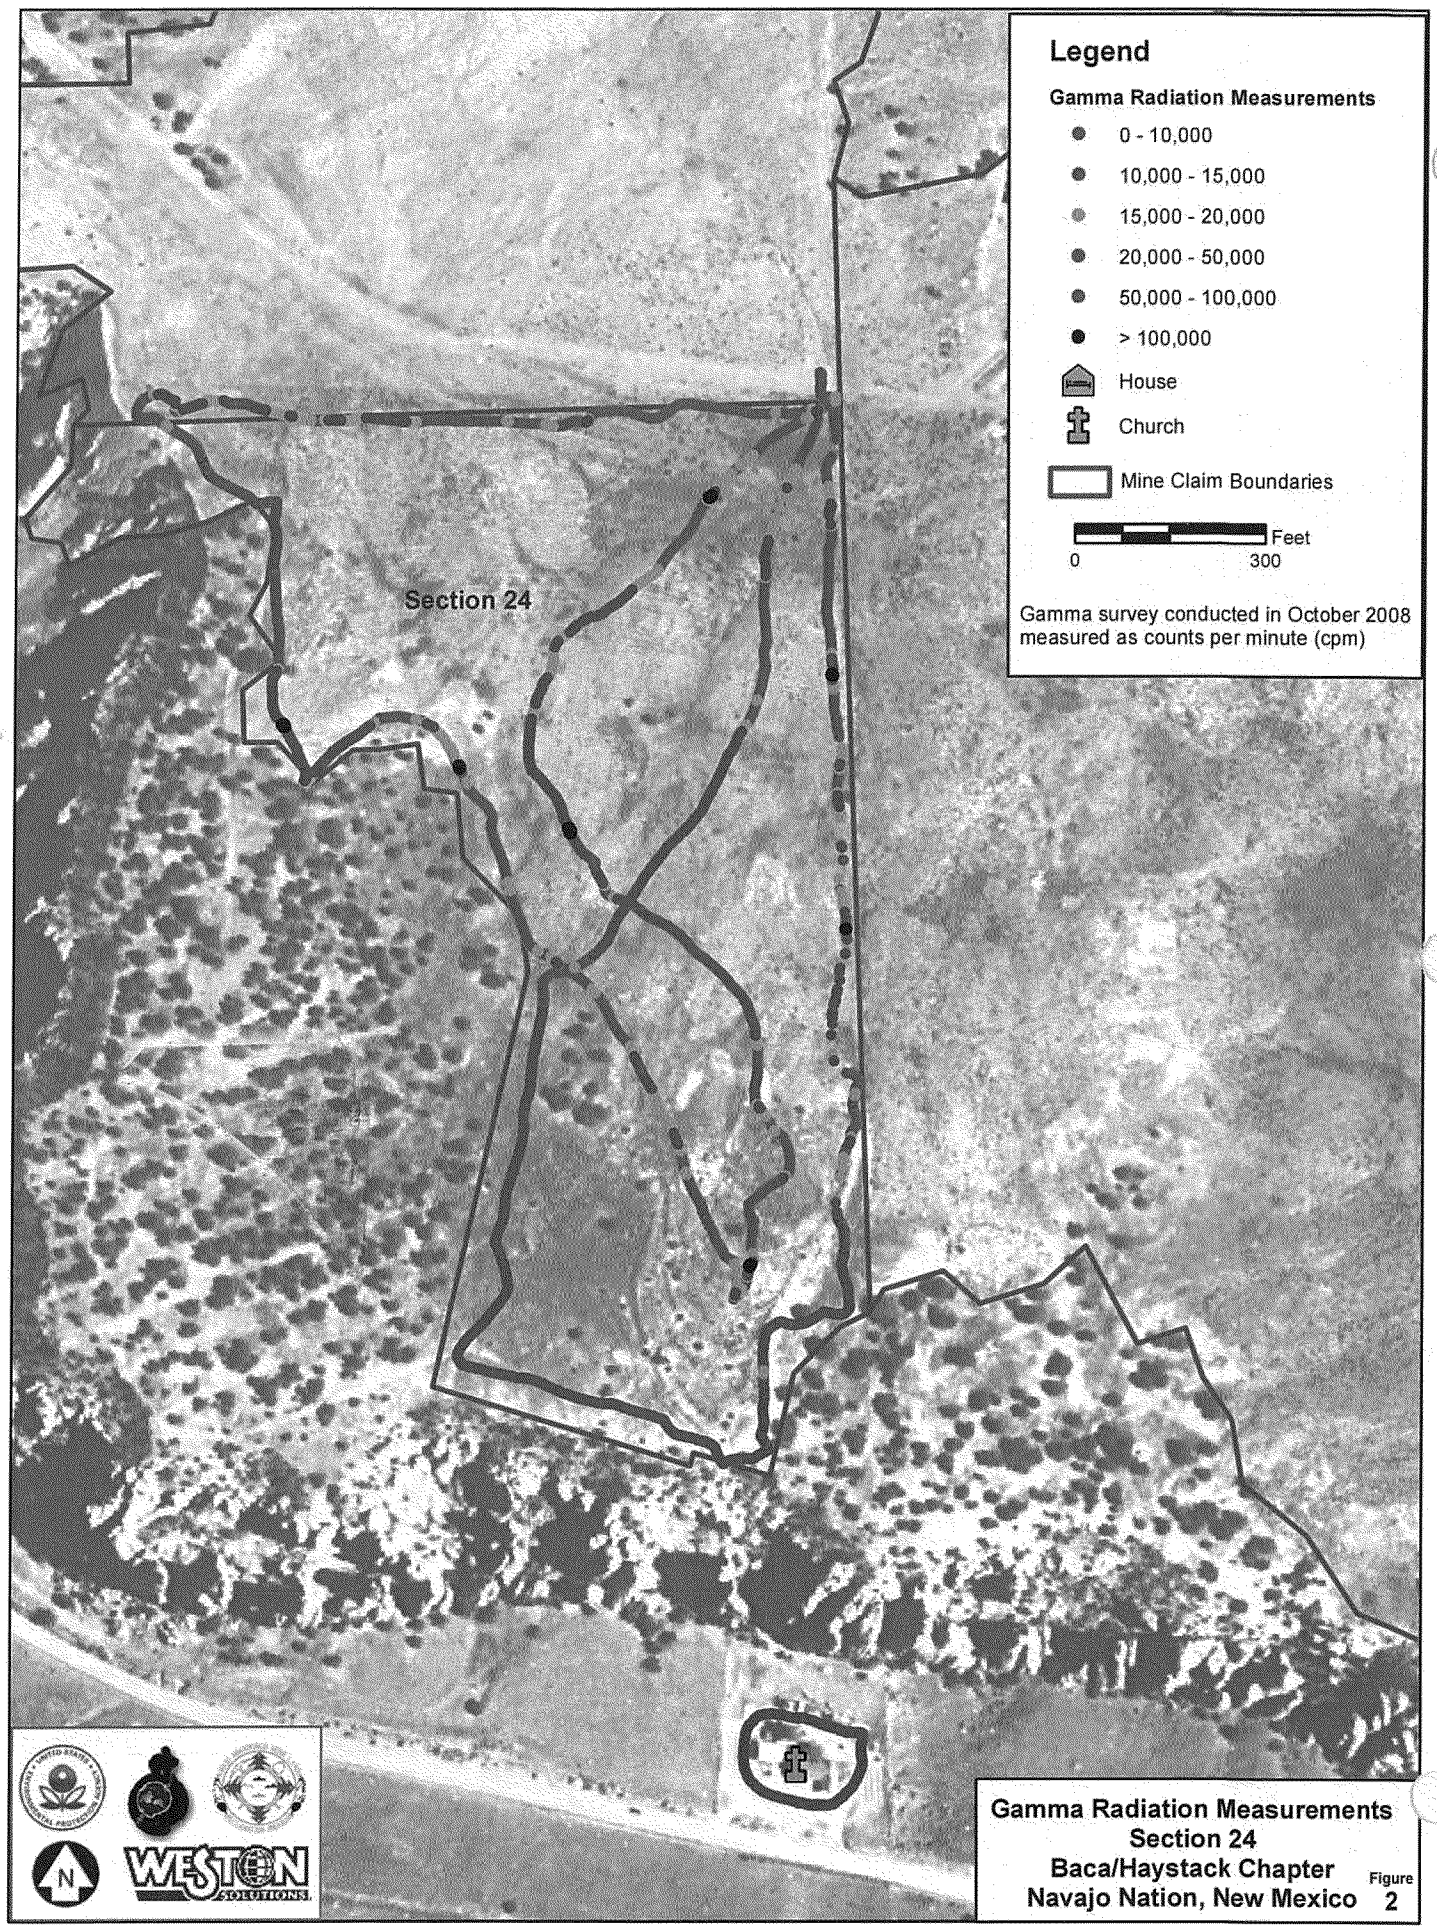
Figure **2**

Gamma Radiation Measurements
Section 24
Baca/Haystack Chapter
Navajo Nation, New Mexico
