Navajo Abandoned Uranium Mine Site Screen Report

Haystack No. 1 AUM Site

Navajo AUM Eastern Region

May 2009

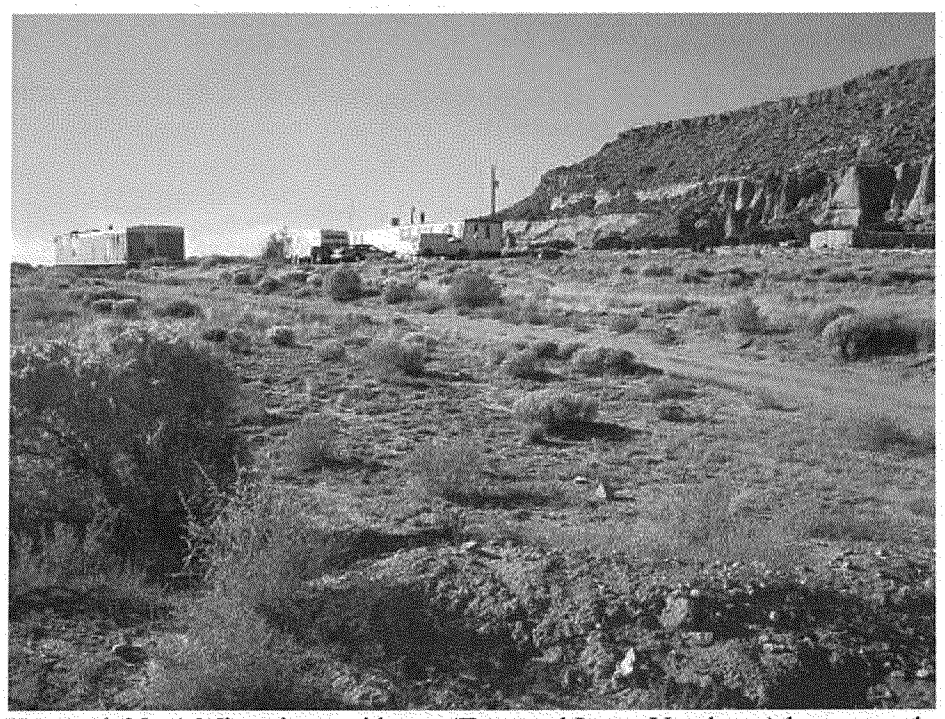
Photo 3. Haystack No 1 Mine site, residence (Tom and LeneaVandever) locate on the mine site

Photo 4. Haystack No 1 Mine site, open hole or vent near residence

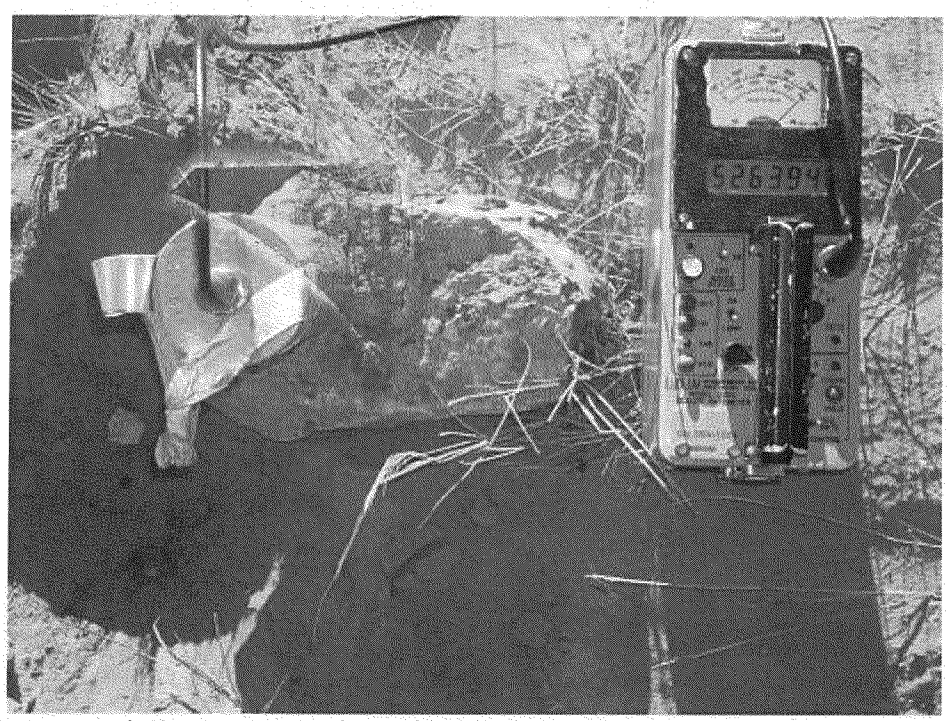
Photo 6. Haystack No 1 Mine site, gamma radiation emitting 500,000 cpm from waste rock located near residence
