Navajo Abandoned Uranium Mine Site Screen Report

Bibo Trespass AUM Site

Navajo AUM Eastern Region

Weston Solutions, Inc.

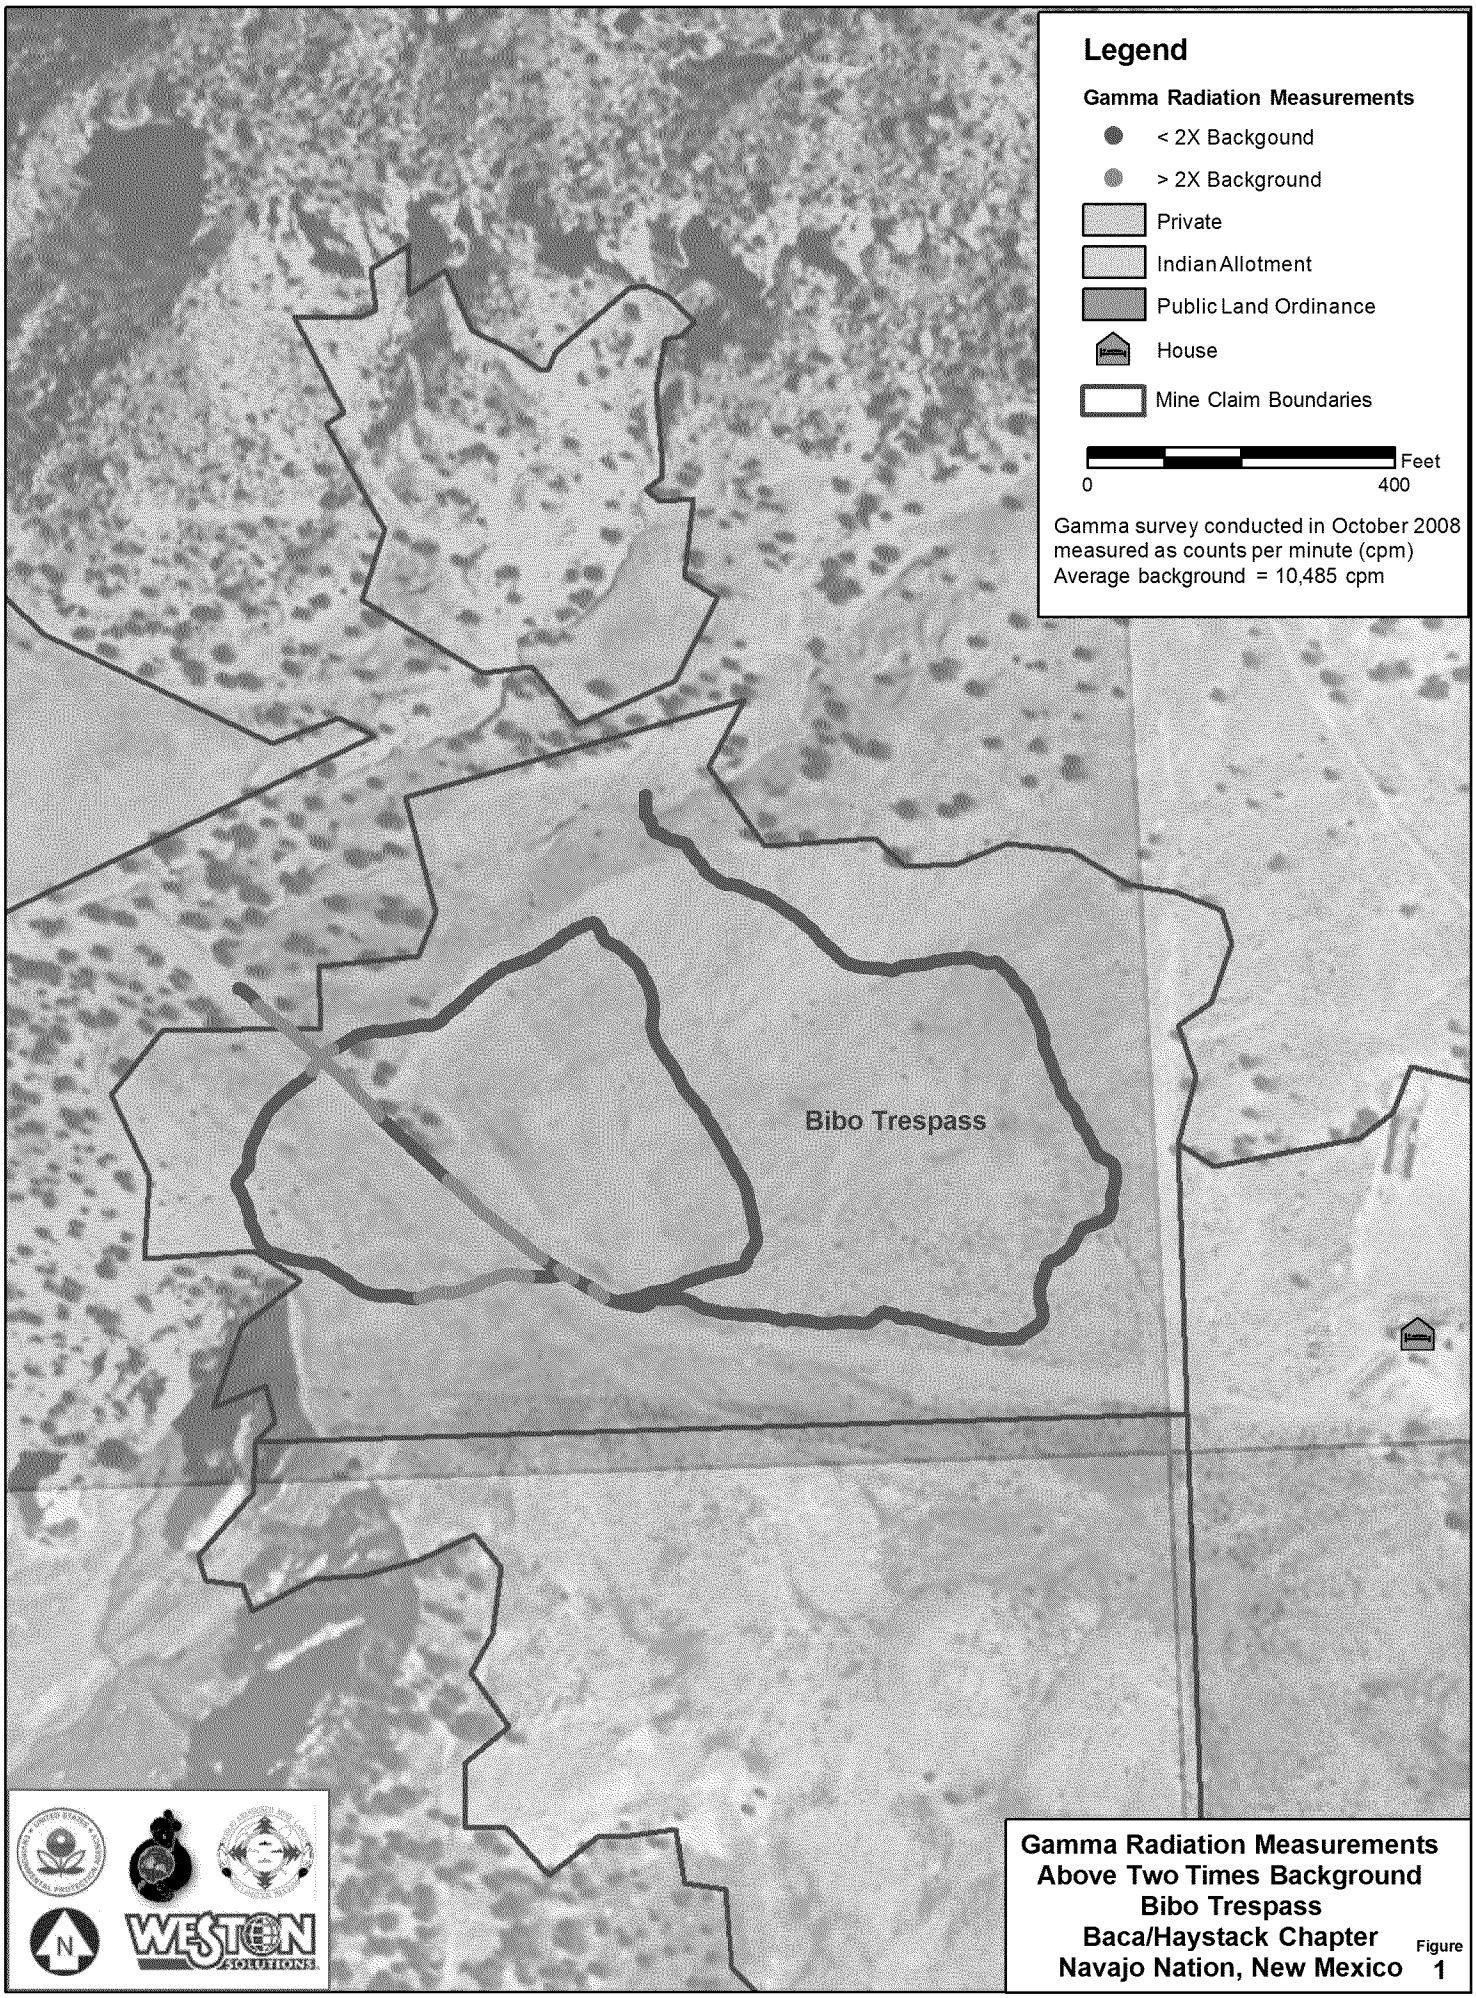
Figure 1

Describe any other radiological measurements:
1,095 gamma radiation measurements were collected from mine sites, ranging from 6,552 cpm to 89,750 cpm. Measurements were found at their highest along the dirt road transecting the site. The measurements are represented in Figures 1 and 2.

Gamma Radiation Measurements Above Two Times Background Bibo Trespass Baca/Haystack Chapter Navajo Nation, New Mexico

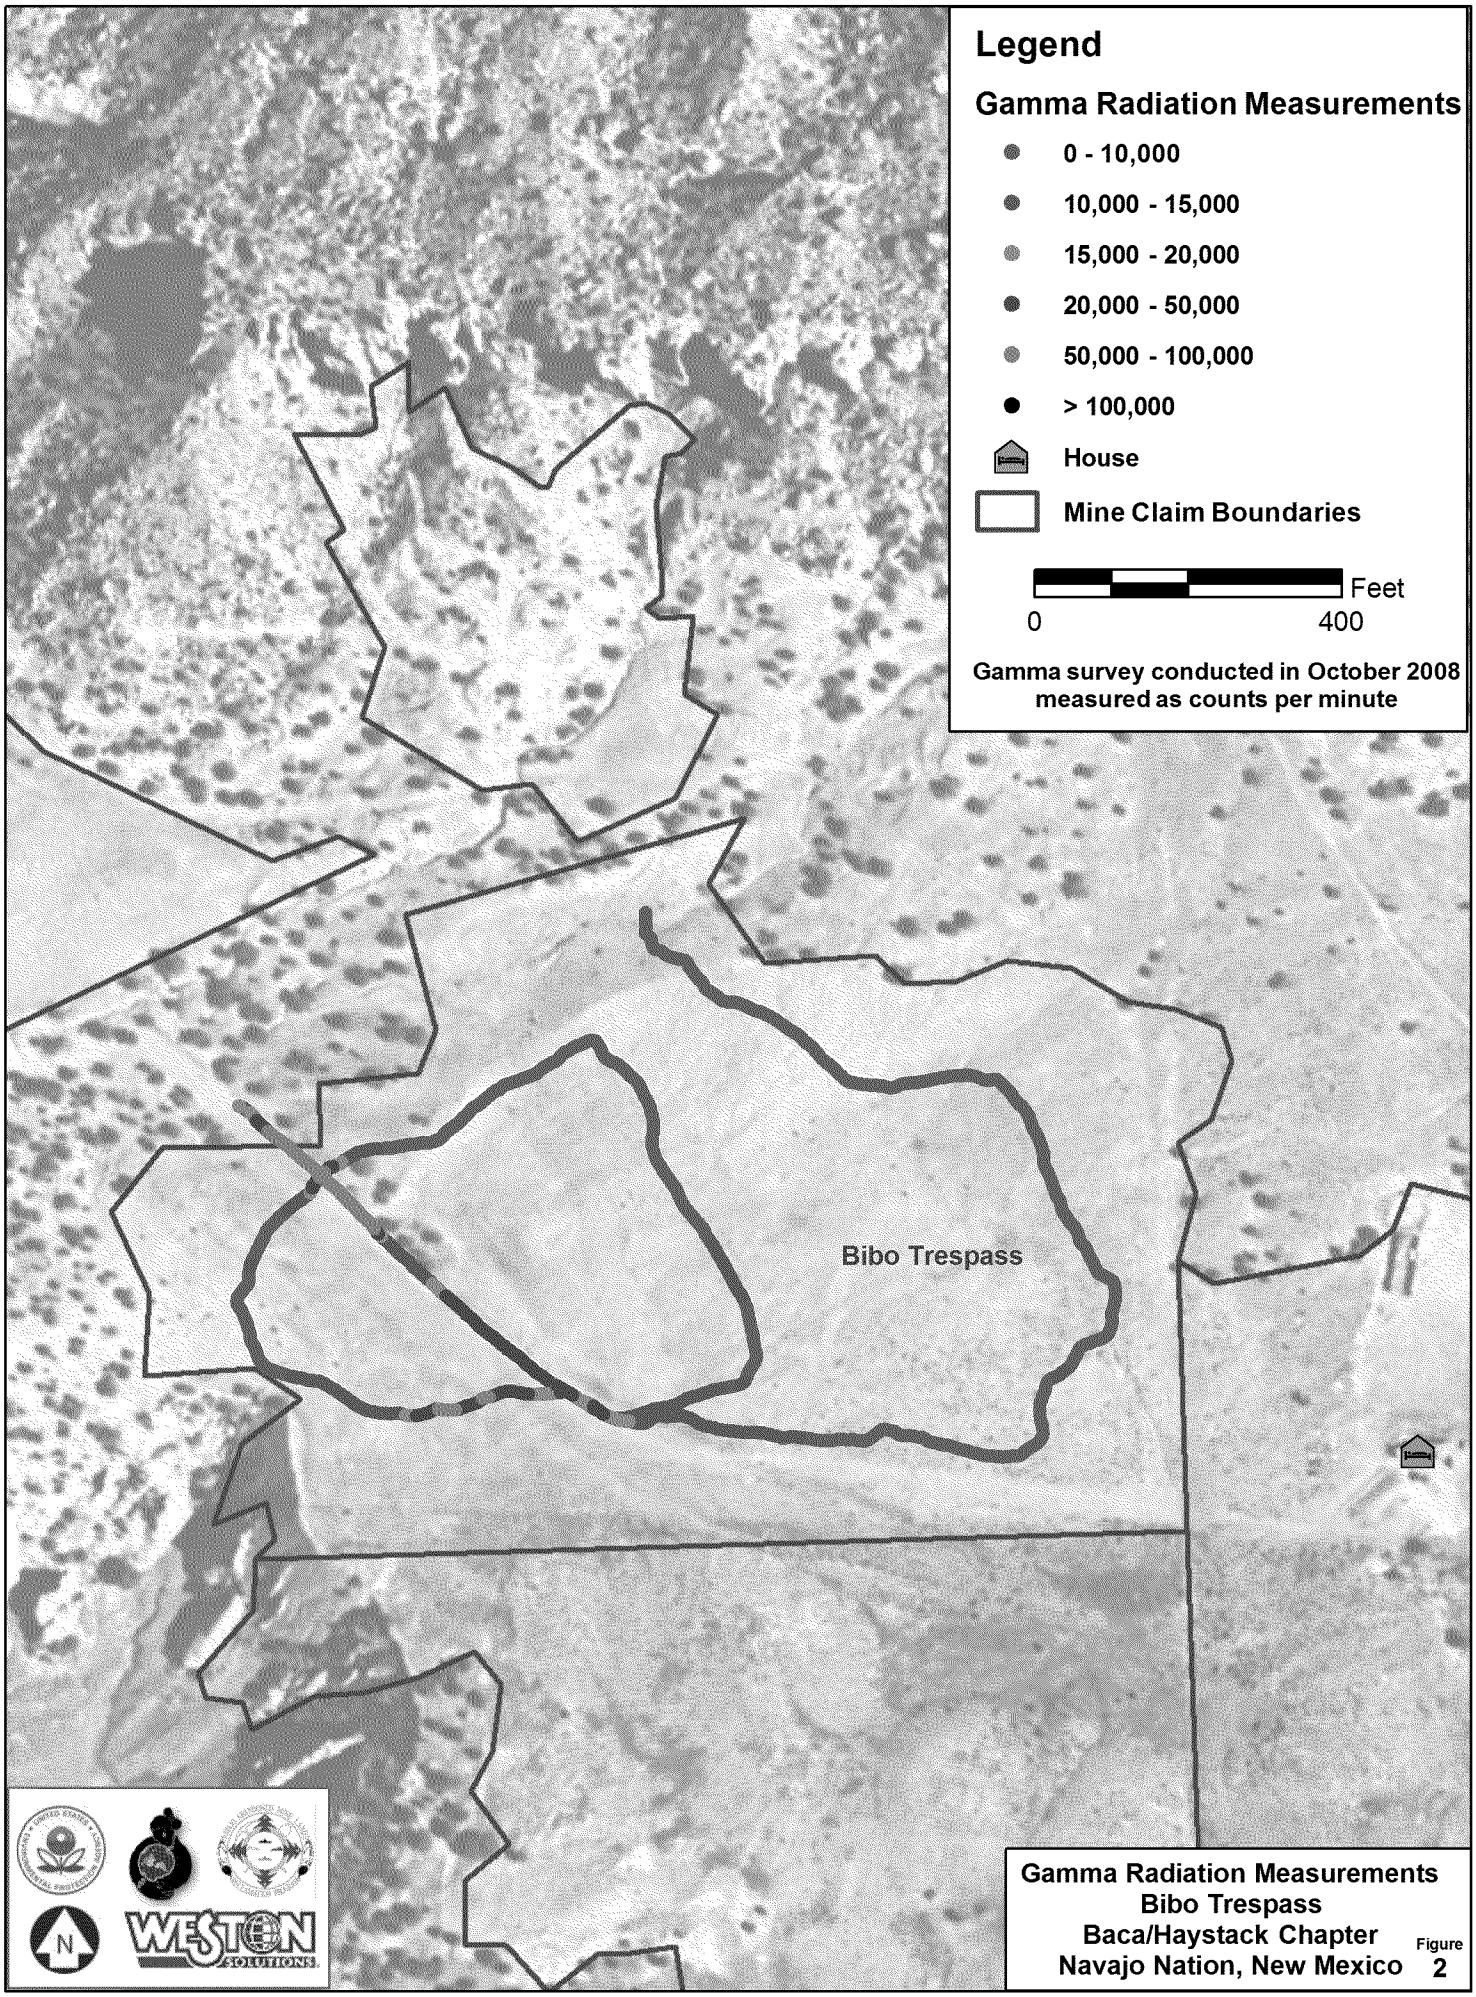
Figure 2

Gamma Radiation Measurements
Bibo Trespass
Baca/Haystack Chapter
Navajo Nation, New Mexico
