Navajo Abandoned Uranium Mine Site Screen Report

Nanabah Vandever AUM Site

Navajo AUM Eastern Region

May 2009

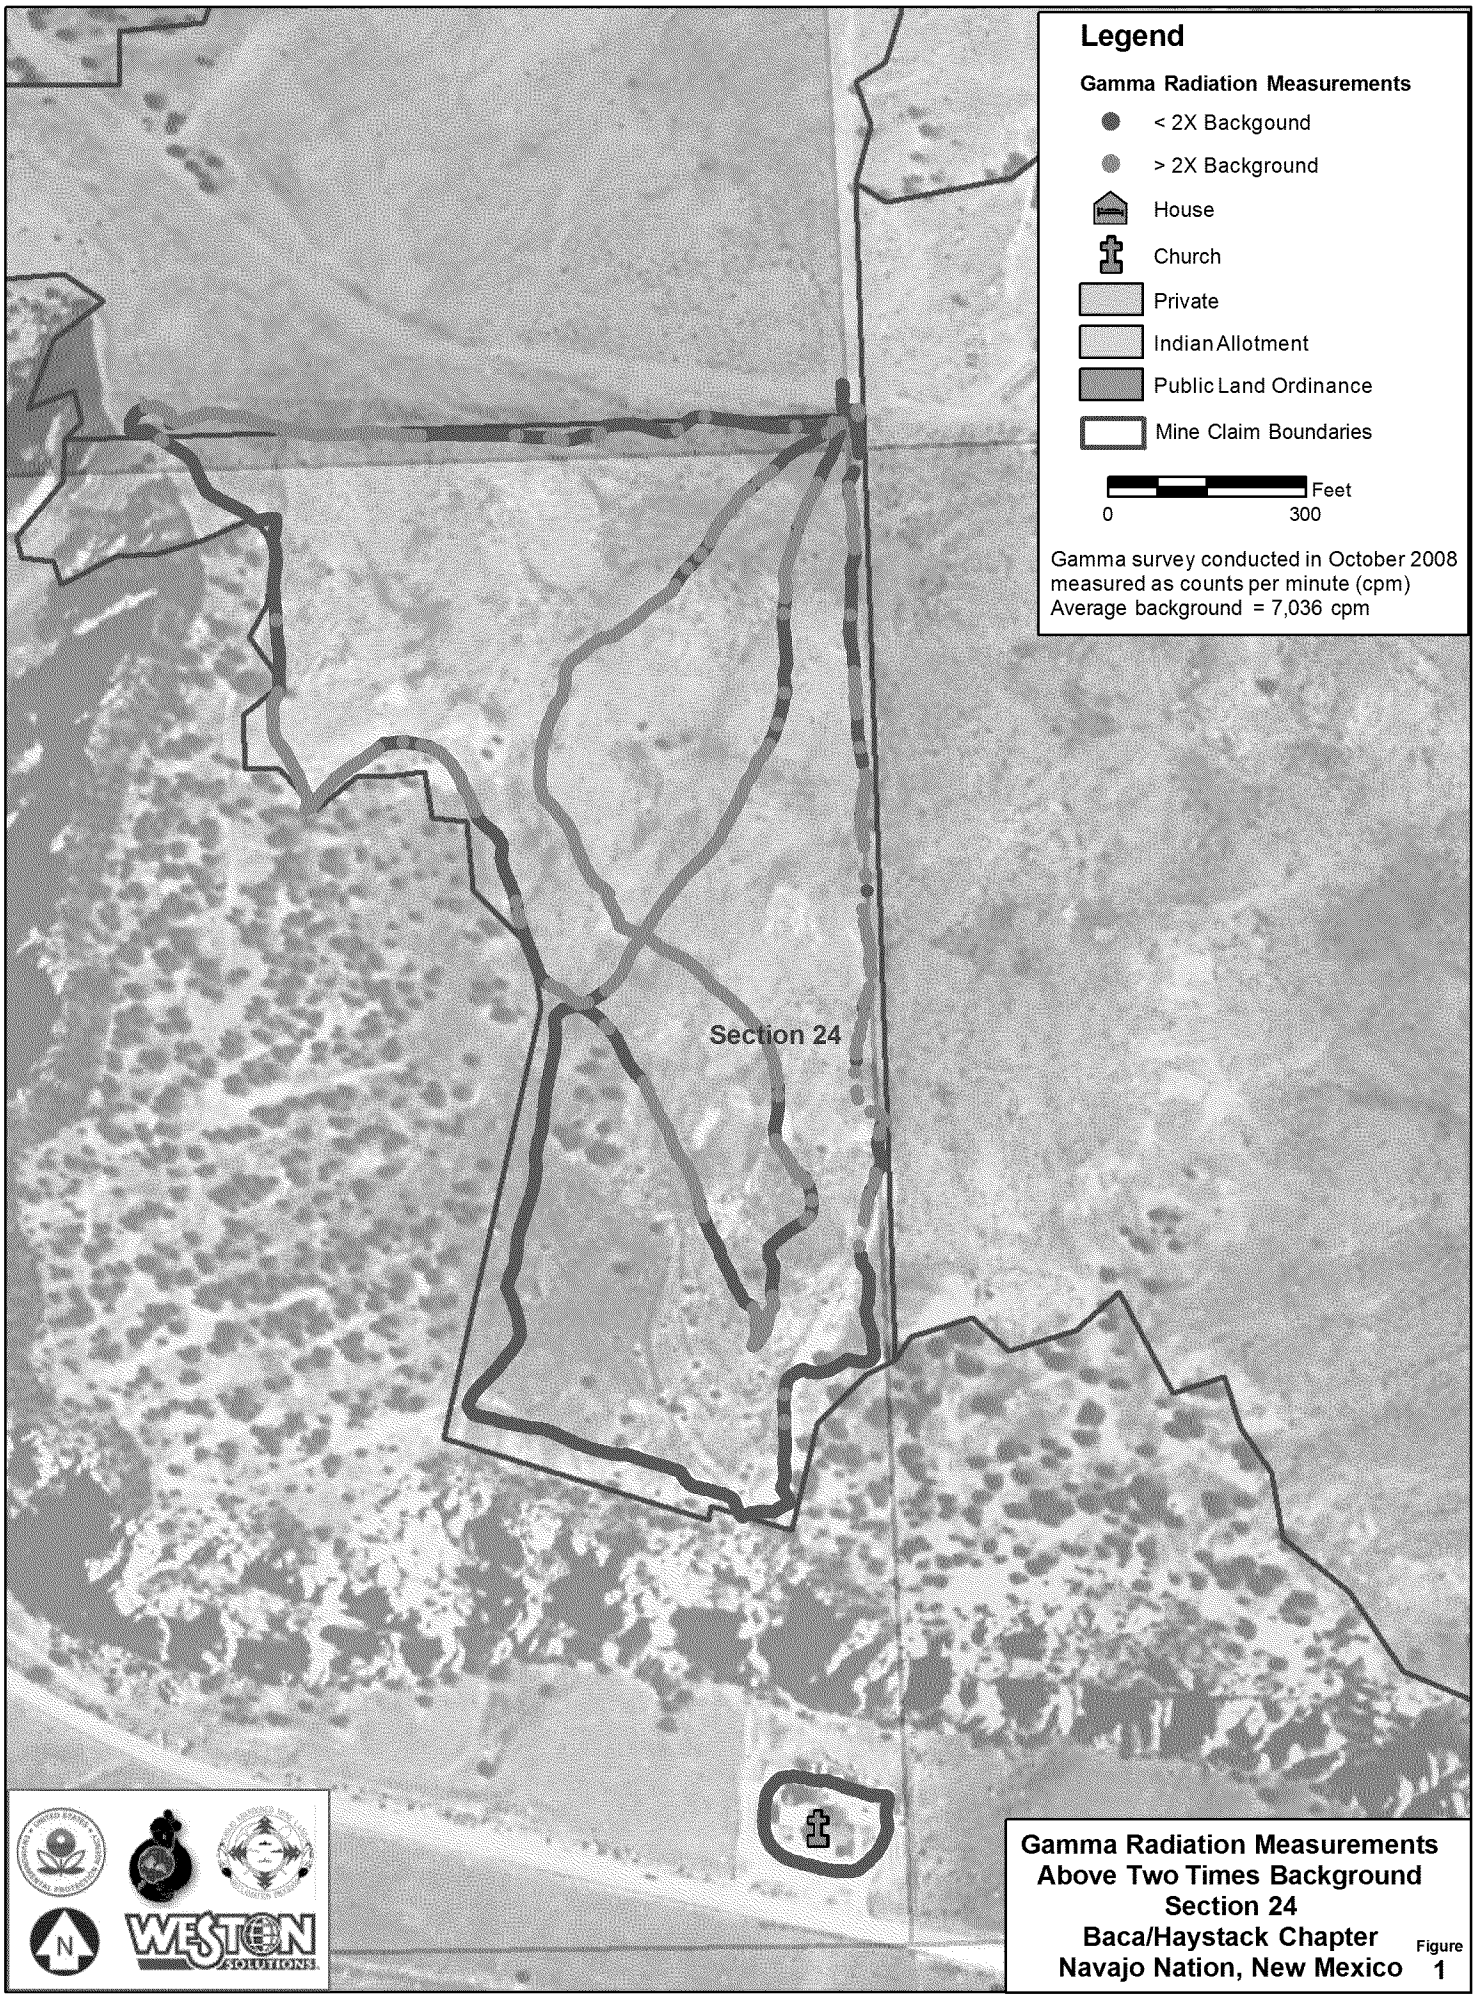
Figure **1**

A total of 3,024 gamma radiation measurements were collected from mine sites, ranging from 4,569 cpm to 594,083 cpm. The measurements are represented in Figures 1 and 2.

Gamma Radiation Measurements Above Two Times Background
Section 24
Baca/Haystack Chapter
Navajo Nation, New Mexico

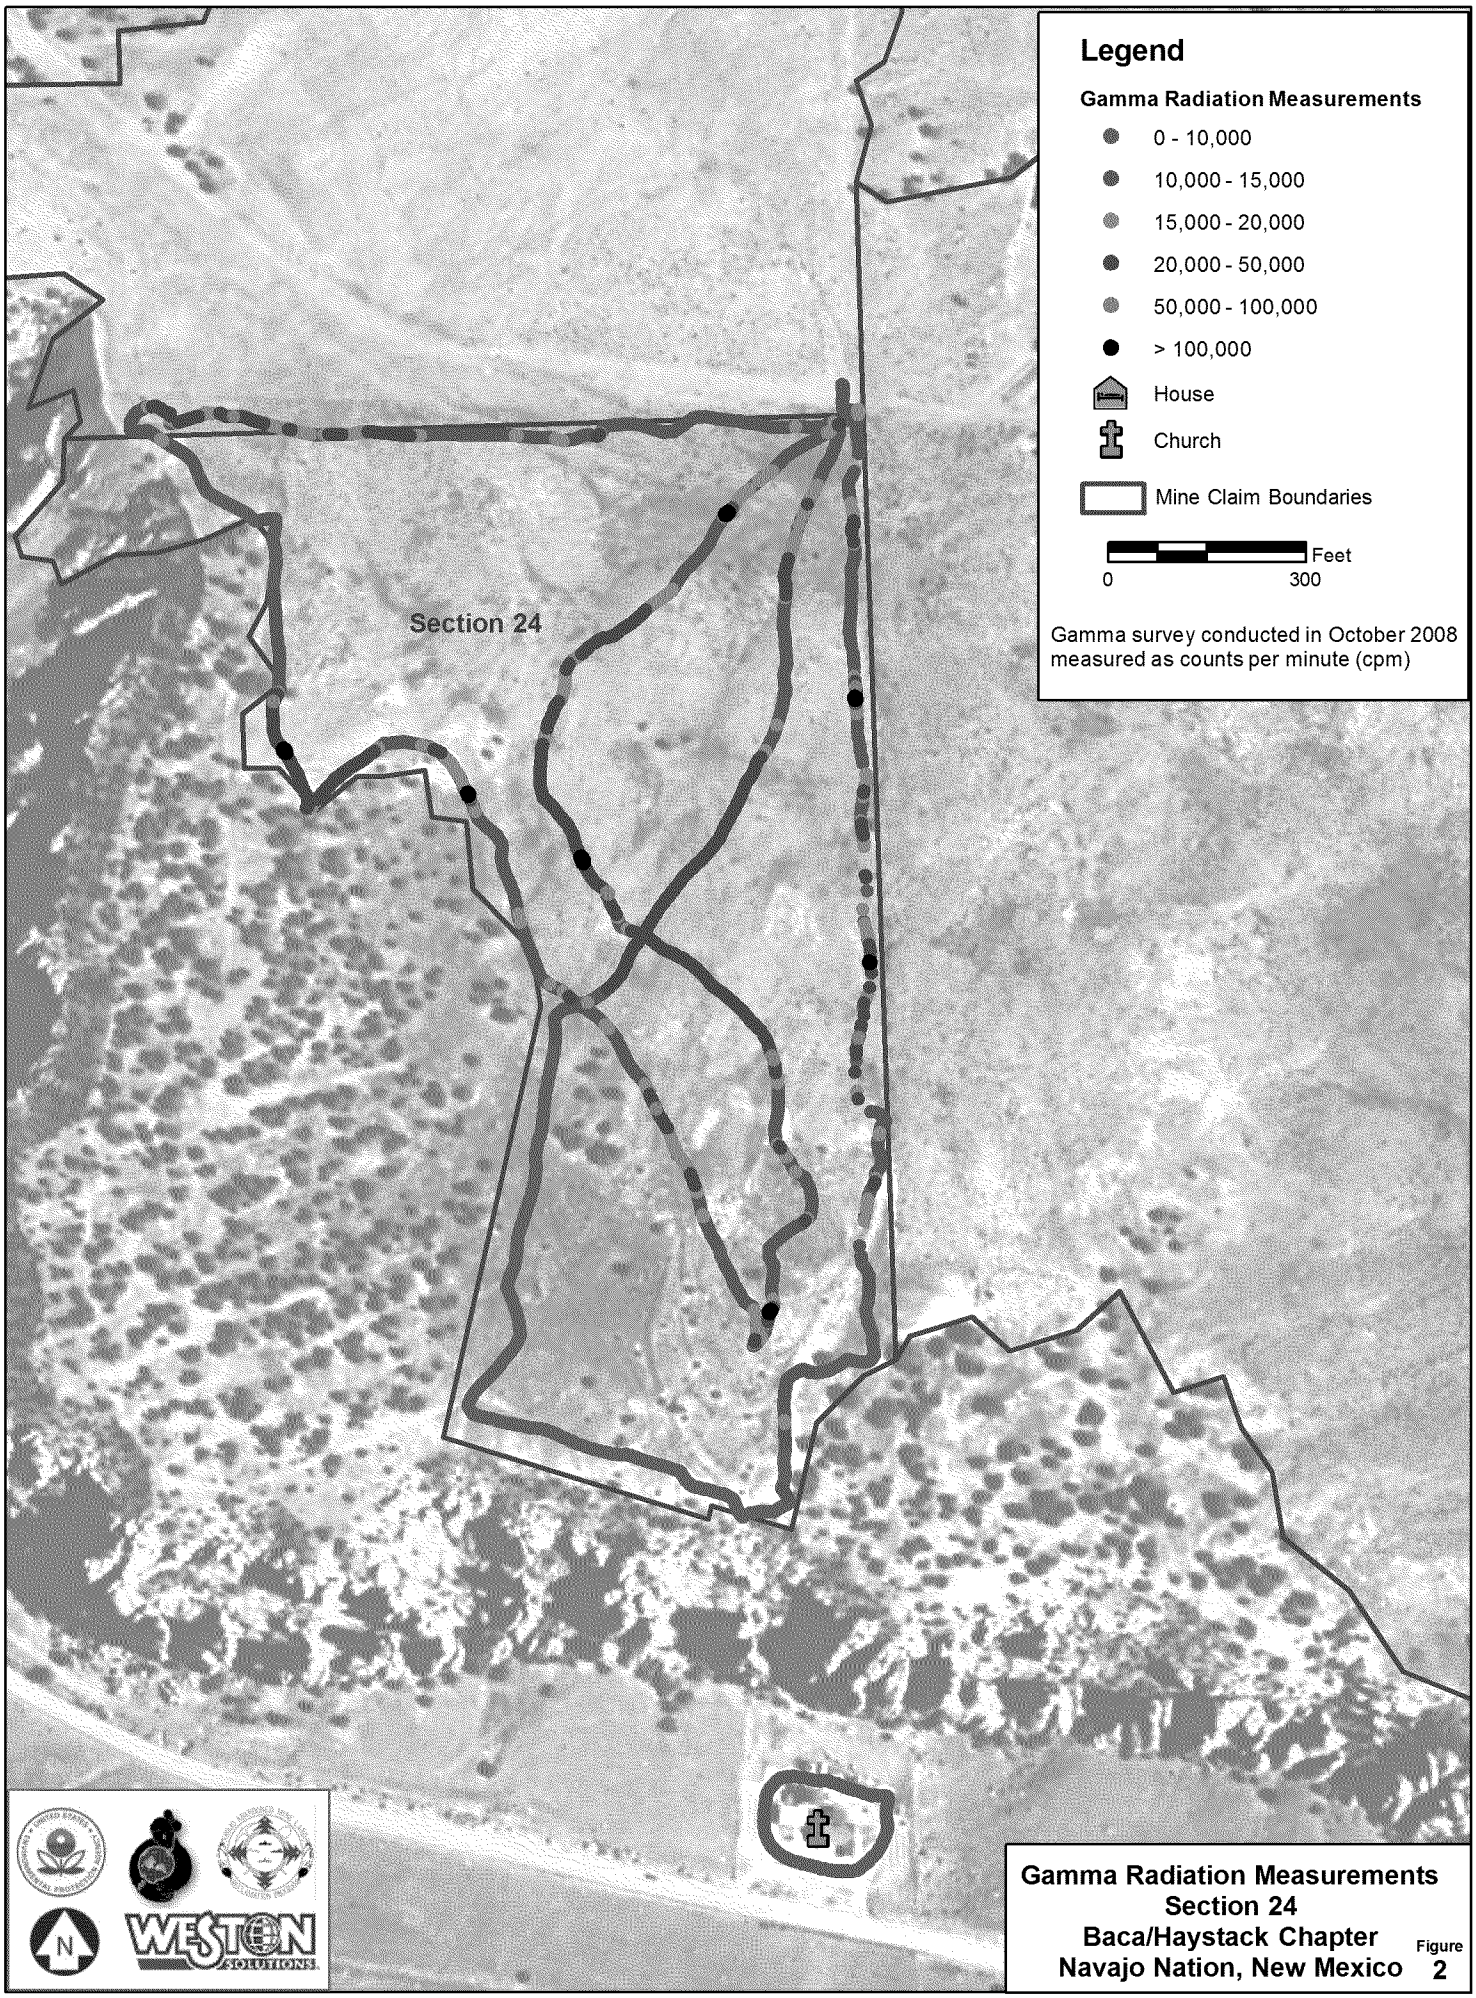
Figure **2**

Gamma Radiation Measurements
Section 24
Baca/Haystack Chapter
Navajo Nation, New Mexico
