Navajo Abandoned Uranium Mine Site Screen Report

Nanabah Vandever AUM Site

Navajo AUM Eastern Region

May 2009

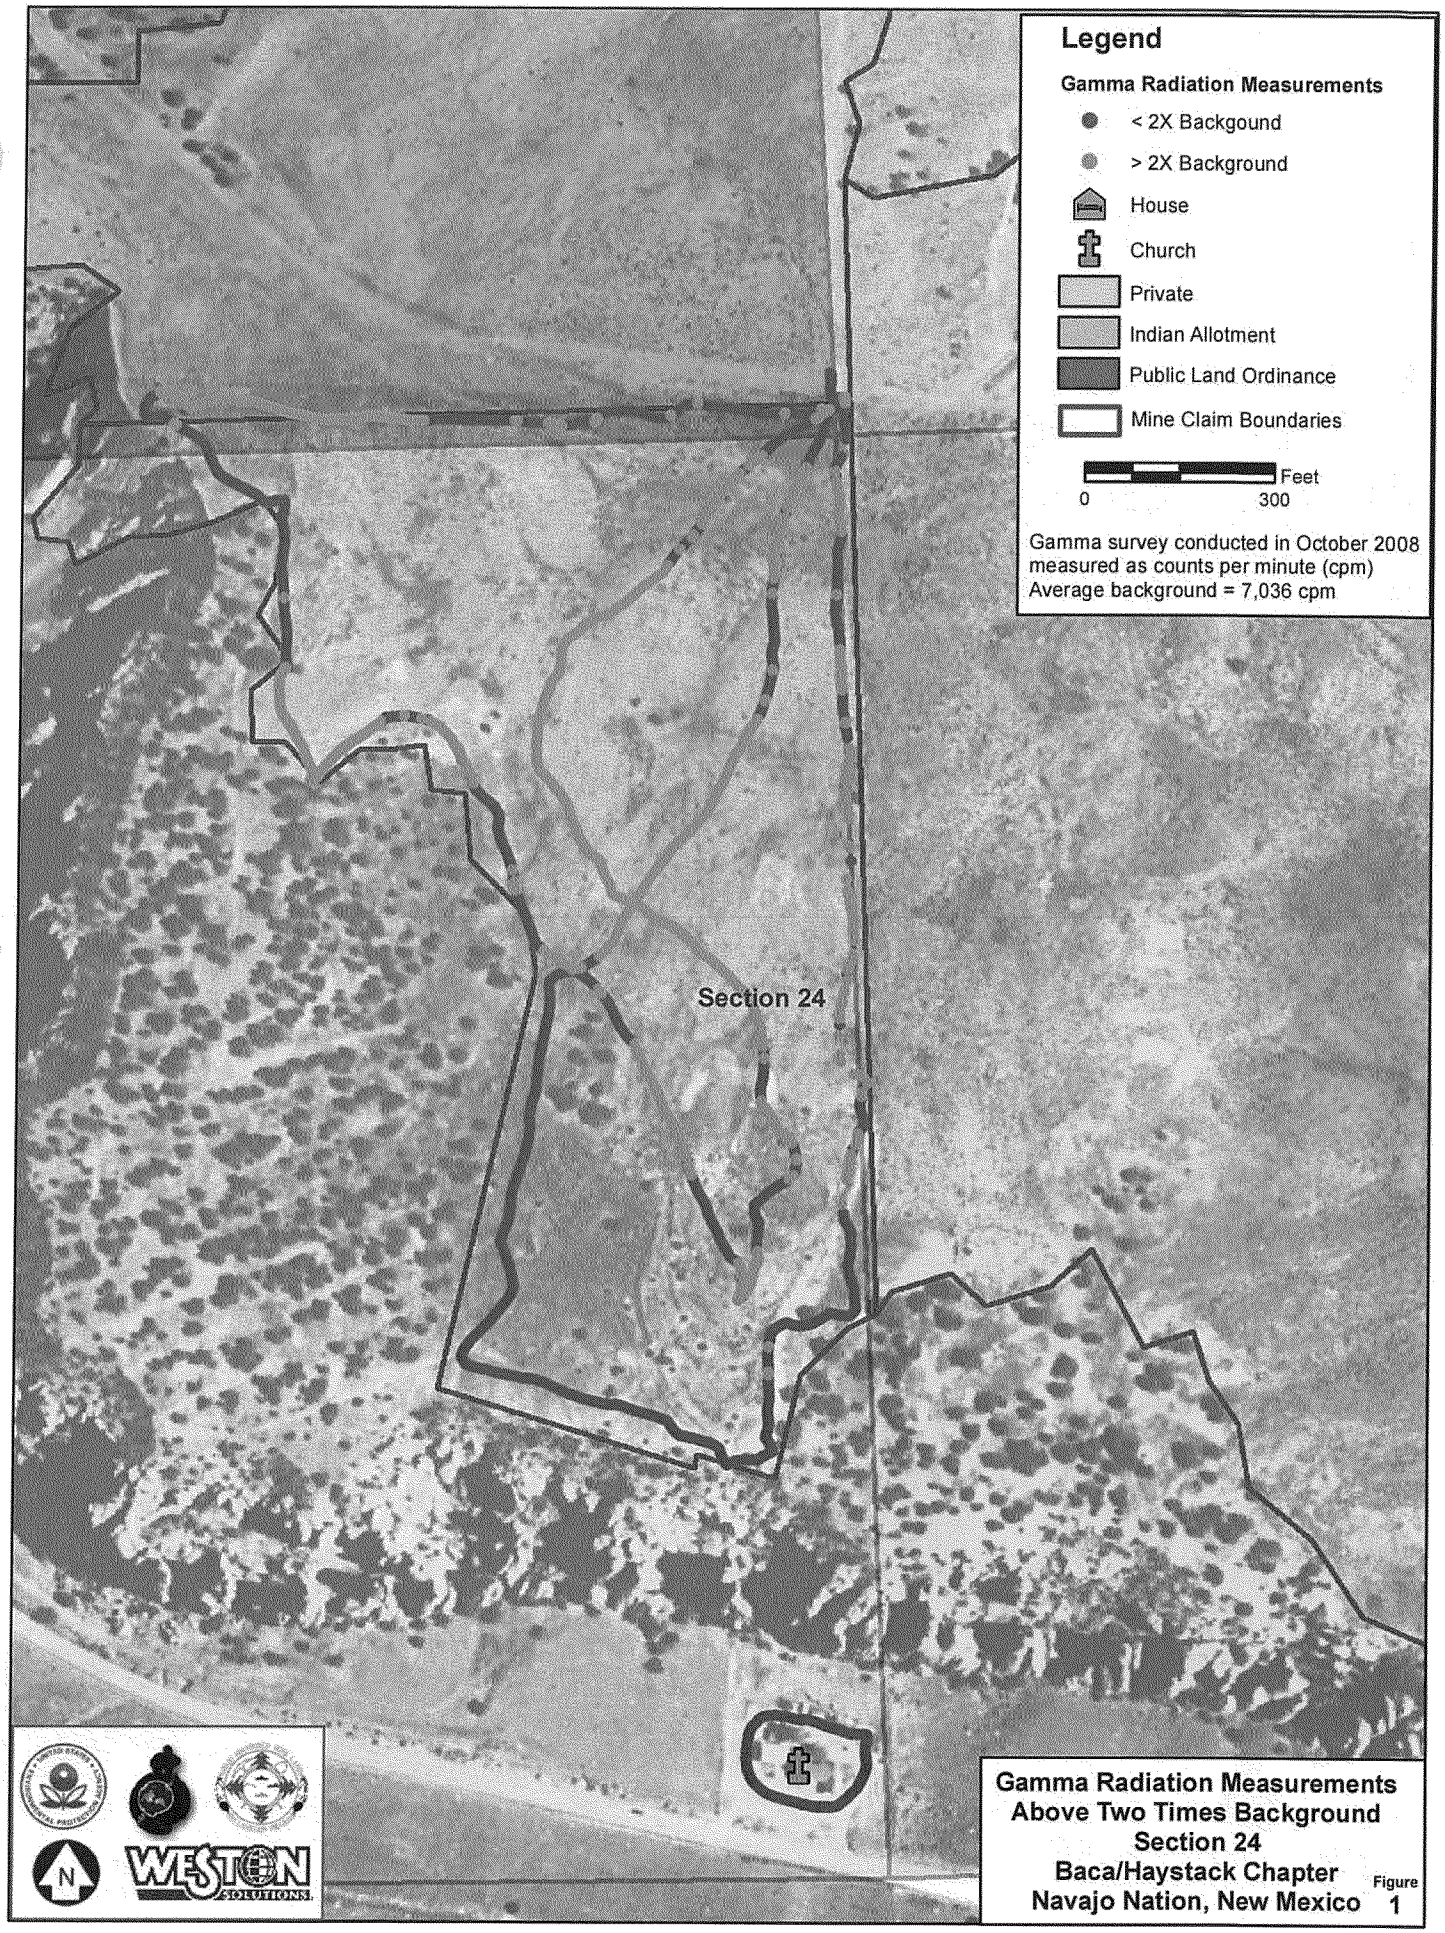
Figure 1

A total of 3,024 gamma radiation measurements were collected from mine sites, ranging from 4,569 cpm to 594,083 cpm. The measurements are represented in Figures 1 and 2.

Gamma Radiation Measurements Above Two Times Background
Section 24
Baca/Haystack Chapter
Navajo Nation, New Mexico
