REMOVAL ASSESSMENT REPORT

ABANDONED URANIUM MINE SITES
HAYSTACK NO.1, SECTION 24, AND BIBO TRESPASS

Navajo Nation, Baca/Haystack Chapter, McKinley County, New Mexico

June 2015

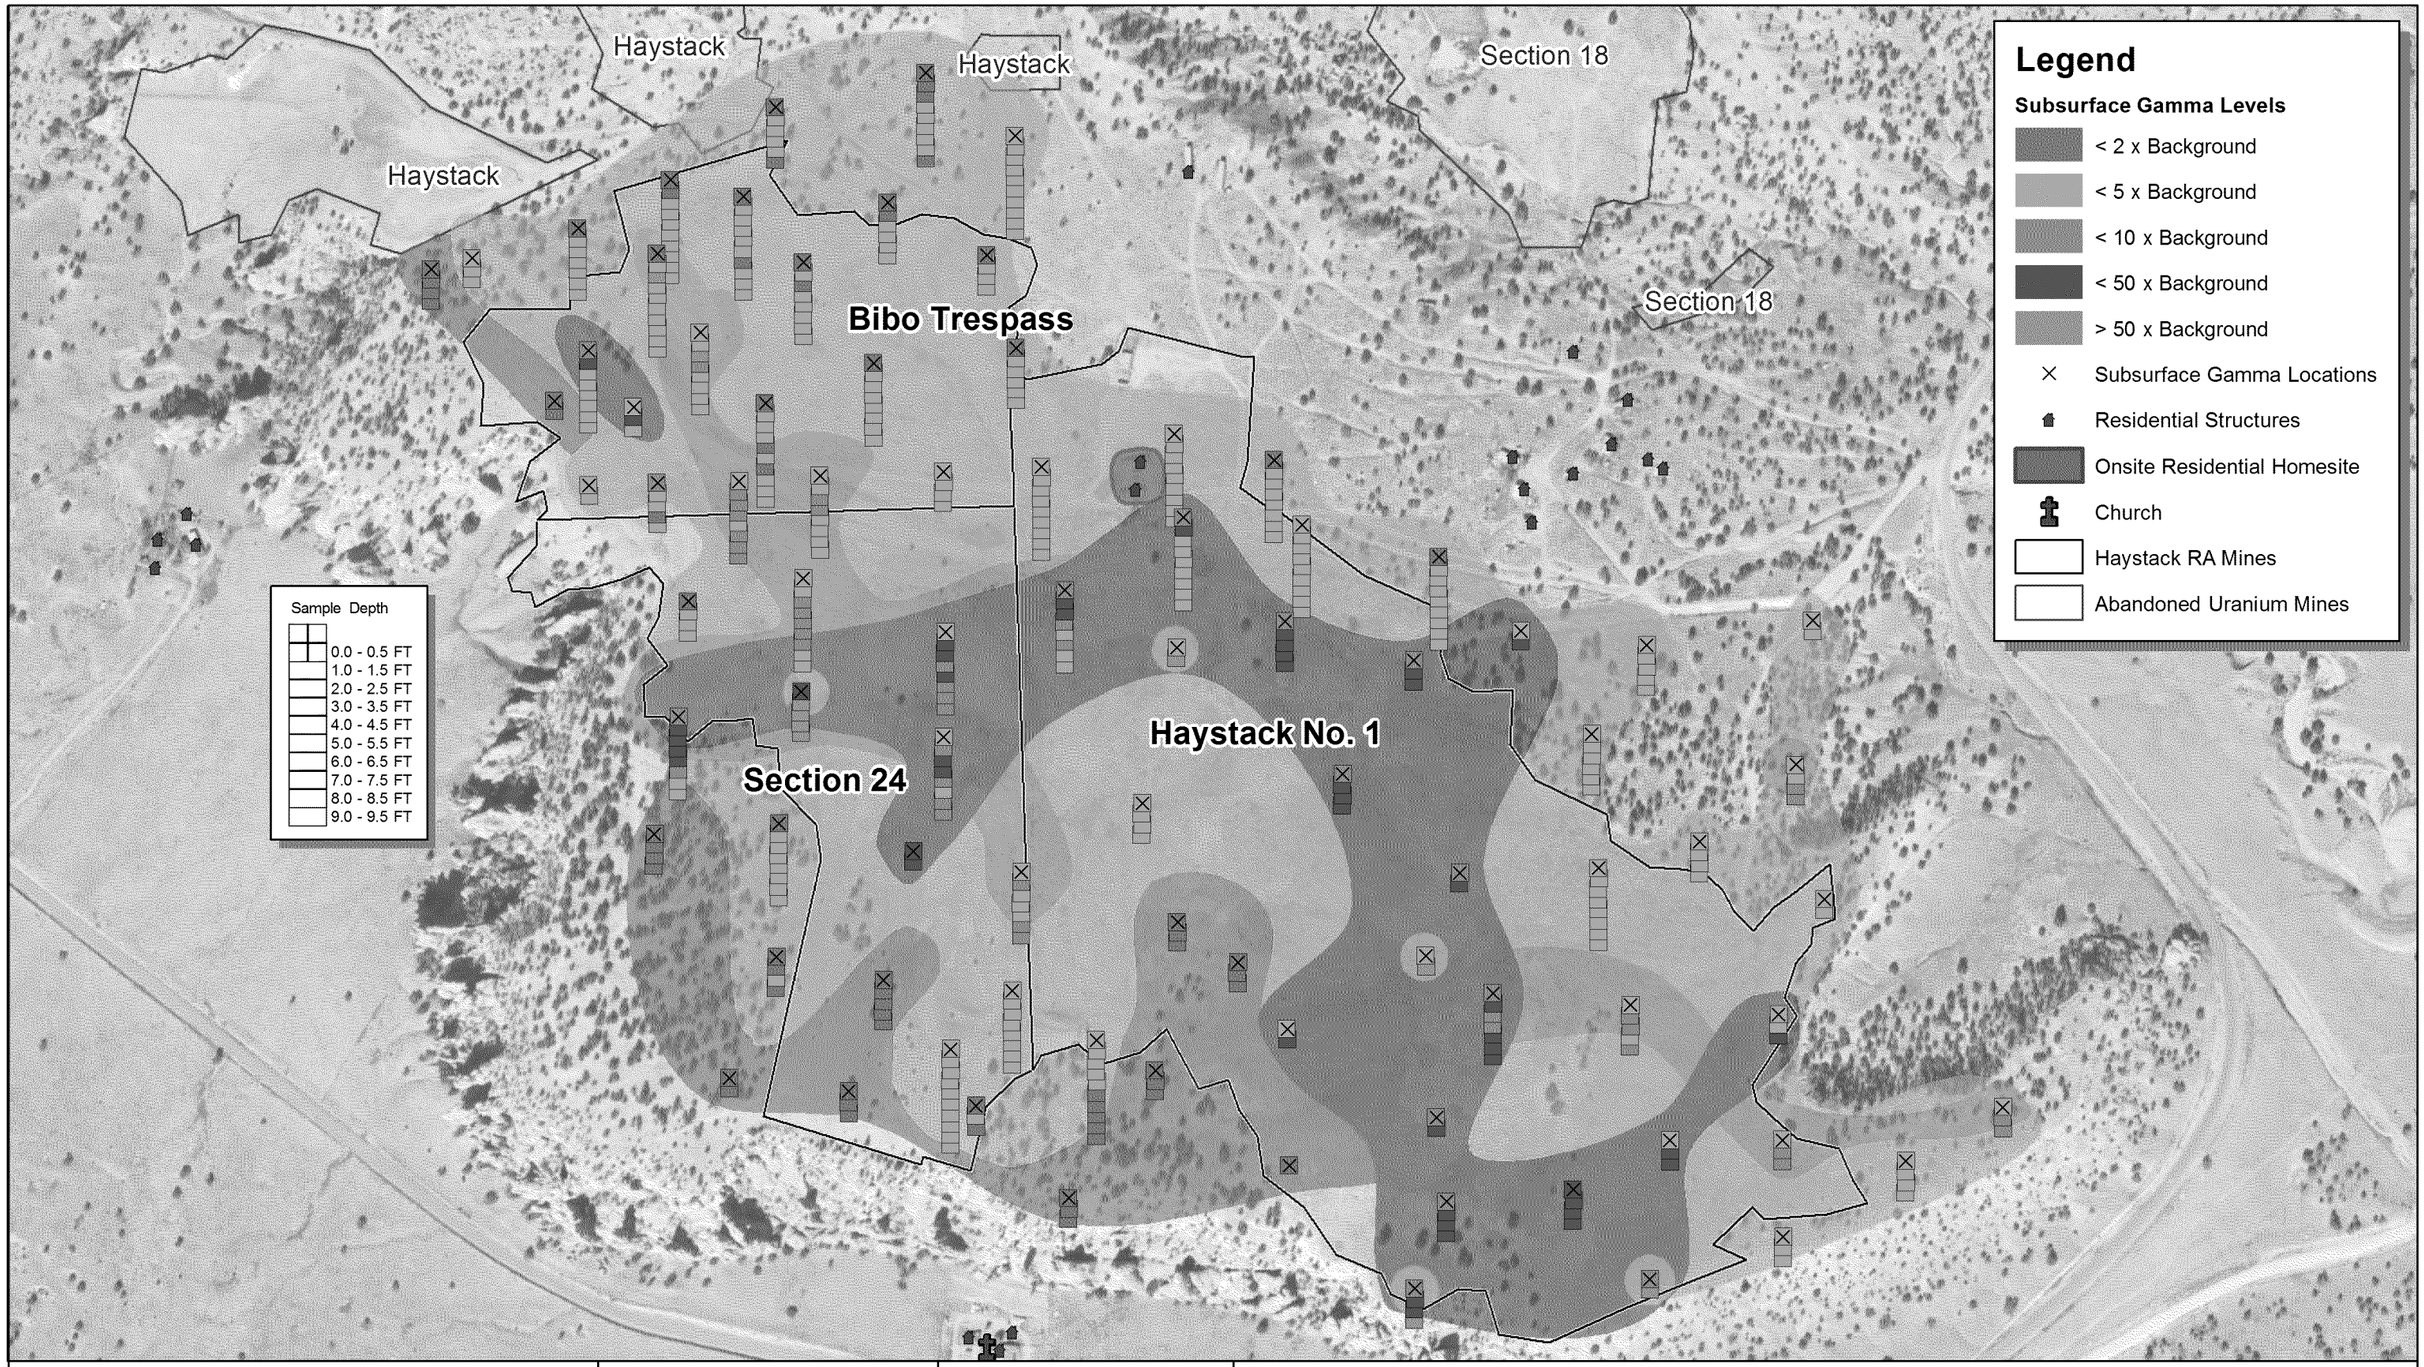
FIGURE #5
SUBSURFACE GAMMA RADIATION
Haystack No. 1 Removal Assessment
Baca/Haystack Chapter, Navajo Nation, NM

Subsurface soil was scanned by attempting to advance boreholes to a subsurface depth of approximately 9.5 feet bgs, after which a Ludlum 44-62 (0.5 inch by 1 inch) detector paired with a Ludlum 2221 meter was placed within a thin-walled polyvinyl chloride (PVC) pipe with lead-shielded base and lowered into the boreho le to collect static gamma measurements at one foot intervals. A total of 83 soil borings were distributed across the removal assessment area at depths ranging from 1.5 feet to 18 feet bgs, with total depths being dependent upon borehole refusal depths. The results from subsurface gamma screening are depicted on Figure 5 in Appendix A.

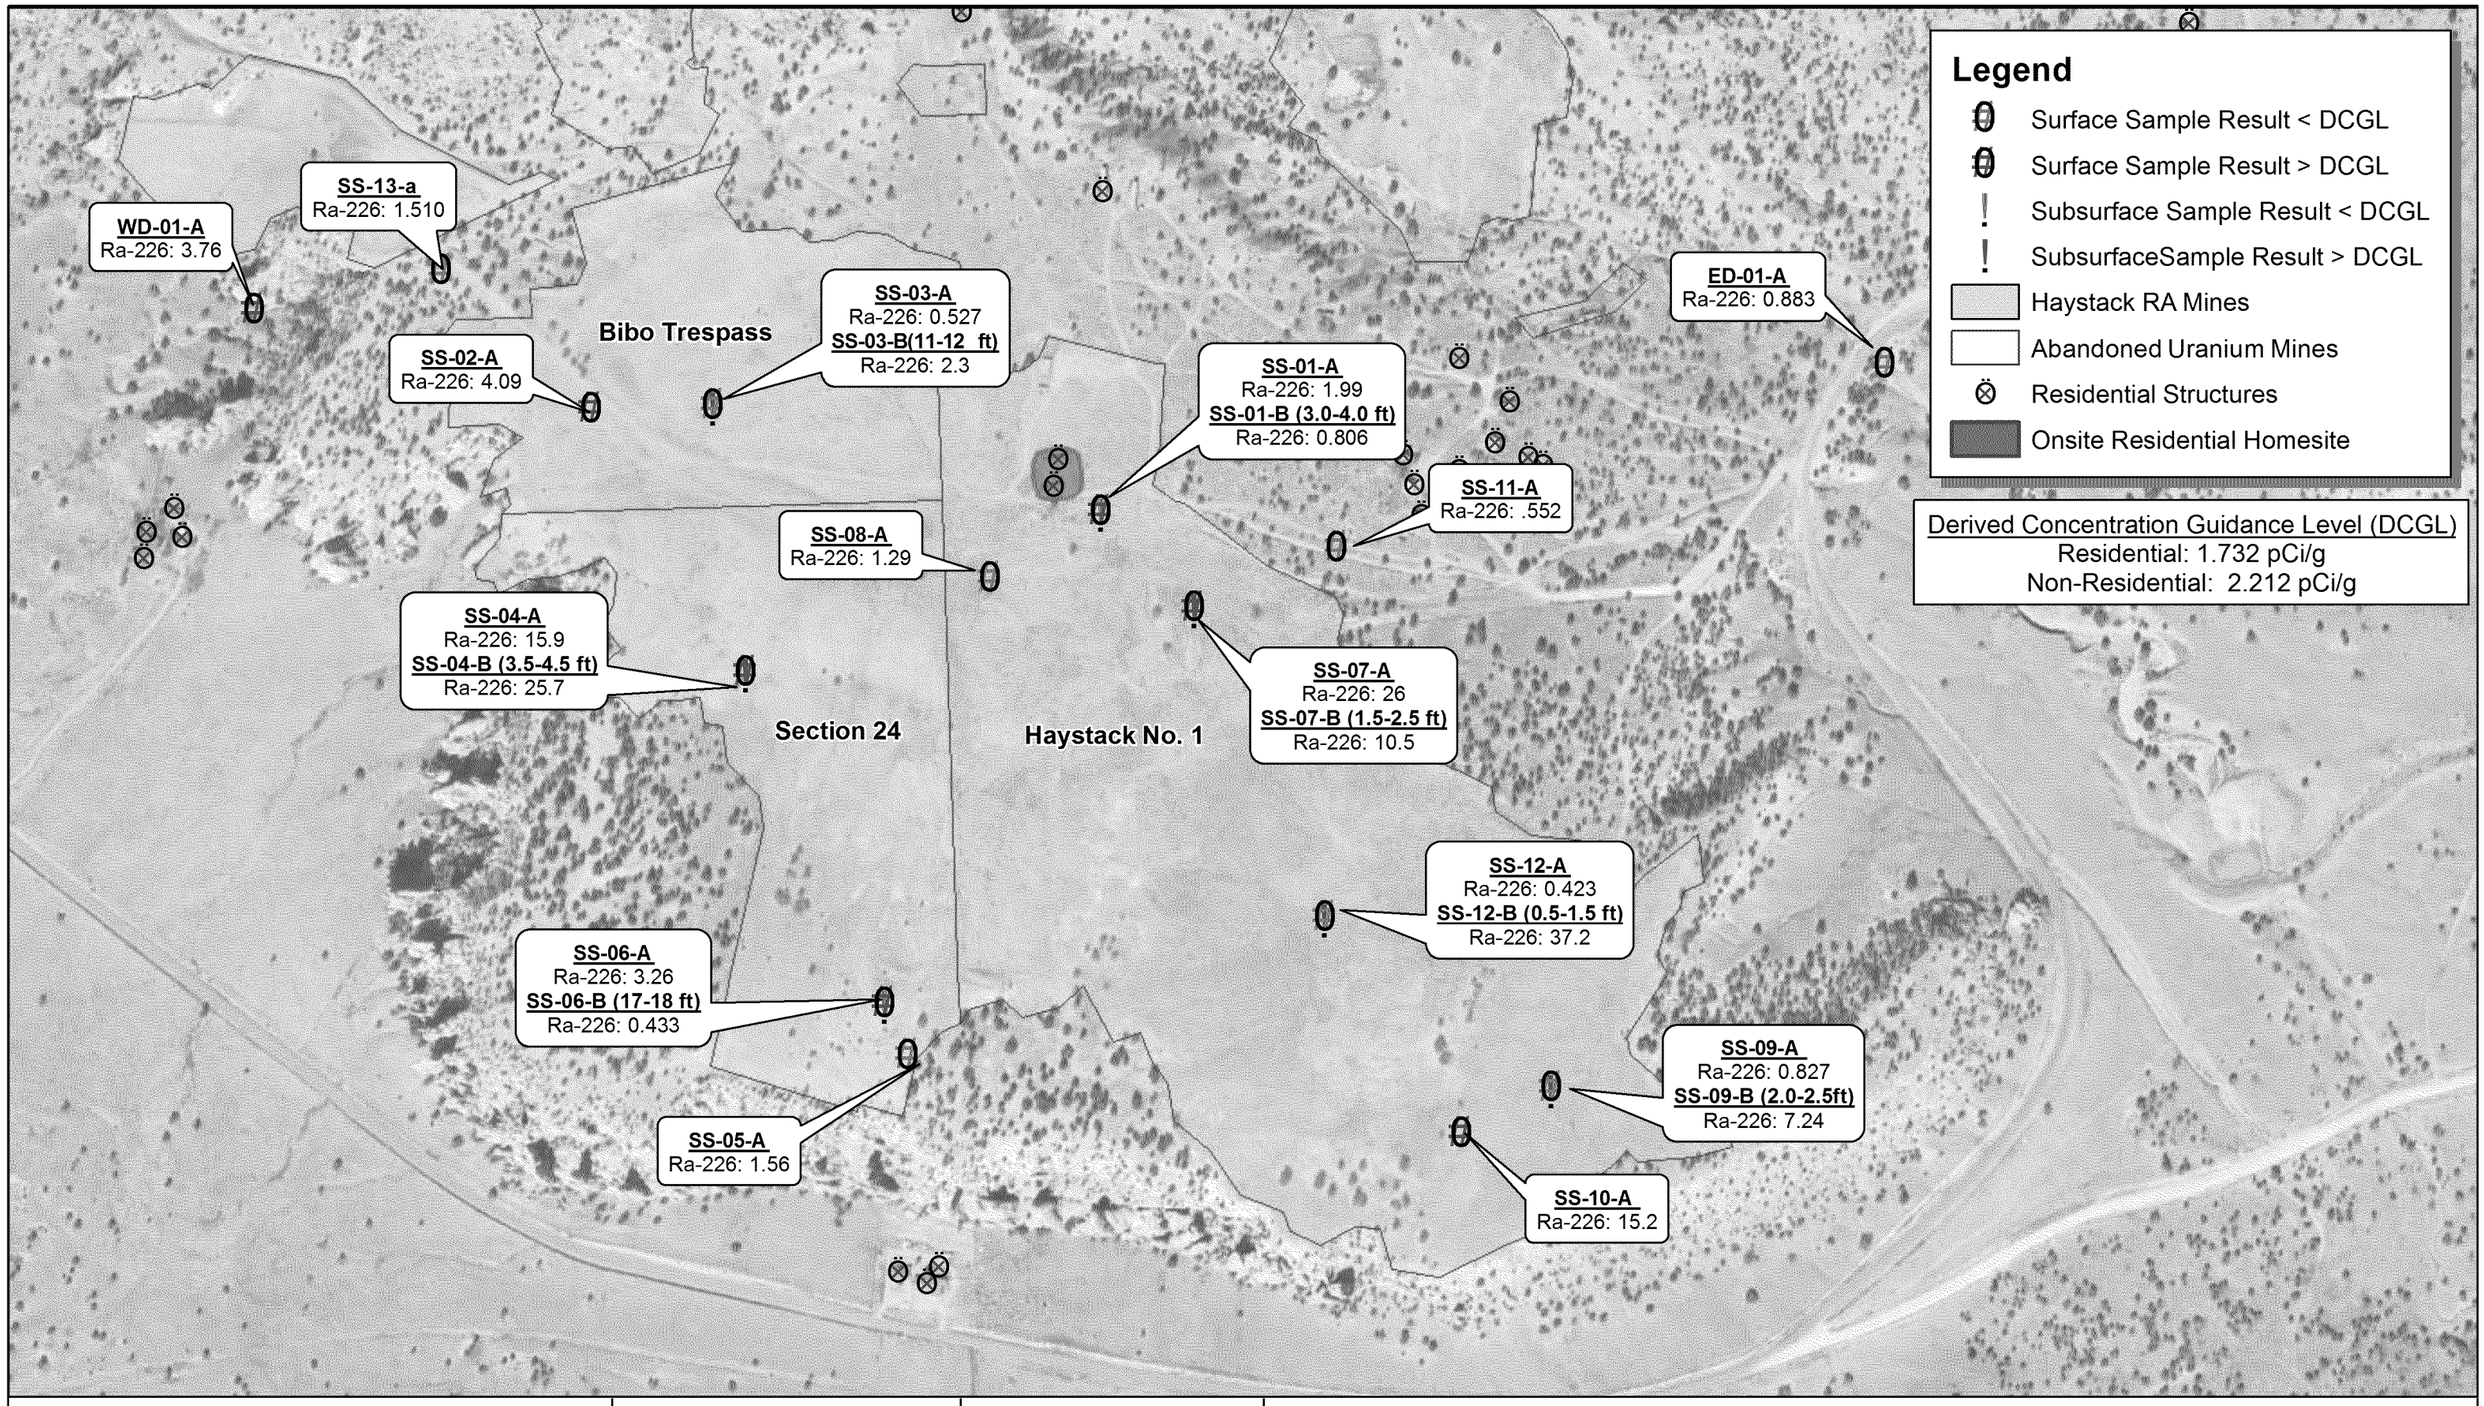
FIGURE #6
SAMPLE RESULTS
Haystack No. 1 Removal Assessment
Baca/Haystack Chapter, Navajo Nation, NM

A total of 15 surface soil samples were collected at the site and analyzed for Radium 226 (Ra-226) by EML HASL 300 4.5.2.3 method. Surface soil samples were co-located with one-minute static gamma radiation counts to establish a relationship between Ra -226 concentrations and gamma radiation measurements in counts per minute (cpm) in soil. Surface soil samples were collected from 0 to 6 inches bgs from loc ations with a wide range of gamma radiation measurement levels. Surface soil samples were collected from locations within the ranges of interest in each soil type and vegetation cover observed at the site. Before collecting surface soil samples, a one-minute surface gamma activity count was collected at each soil sampling location by placing a Ludlum 3x3 probe six inches ab ove the soil surface during the measurement. Results for all surface samples are depicted on Figure 6 in Appendix A.

the sample was collected directly from the core. Results for all subsurface samples are depicted on Figure 6 in Appendix A.

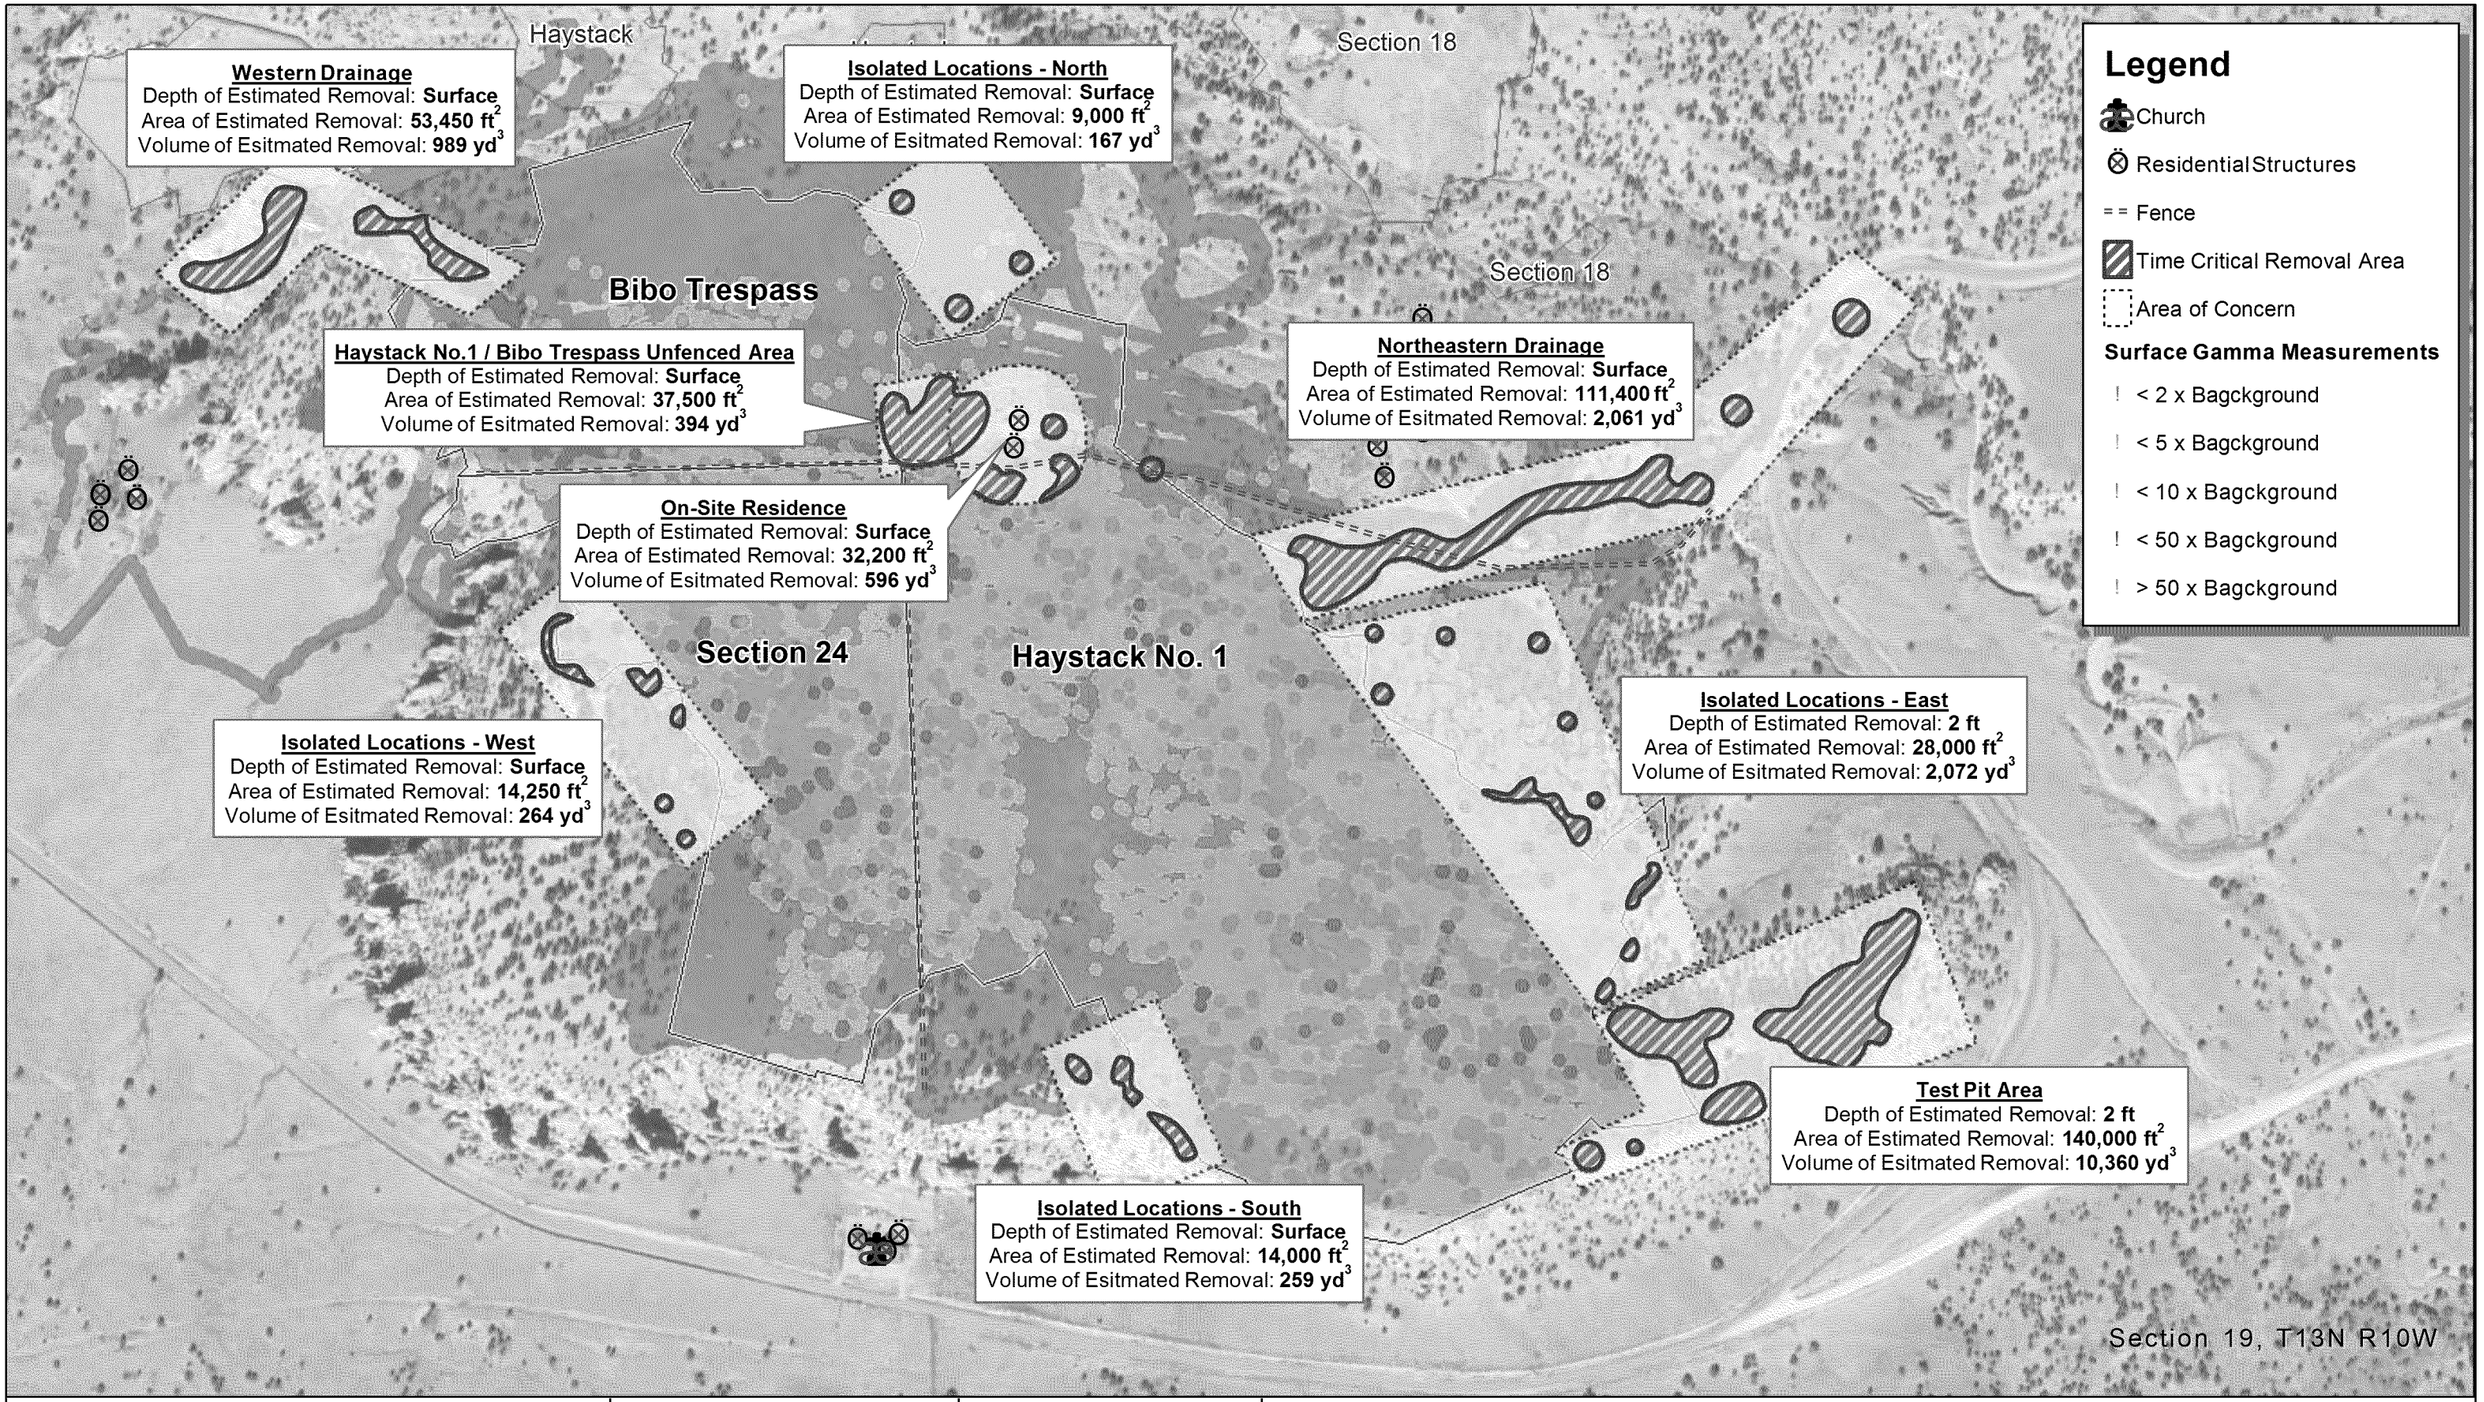
Based on soil sampling data and gamma activity scan count rates, surface soil concentrations of Ra-226 appear to exceed the site-wide DCGL of 2.212 pCi/g over an estimated area of approximately 107.4 acres, or 4,678,350 ft^2. Surface Ra-226 activity concentrations were above the action level in six of 15 soil samples. Elevated Ra-226 concentrations ranged from 1.99 pCi/g in sample SS-01-A to 37.2 pCi/g in sample SS-12-B. If any removal actions were to occur, a more detailed gamma scan should be performed, and additional surface and subsurface confirmation samples should be collected to properly define the removal area. The site wide removal area is shown on Figure 8.

surface and subsurface confirmation samples should be collected to properly define the removal area. The offsite removal areas are shown on Figure 8.

In order to protect the health of local residents, it is recommended tha t an estimated volume of 17,462 yd^3 of contaminated soil and residual contaminated mine waste be removed from the above areas of concern. Under the direction of EPA, a surgical assessment will be conducted to define the full lateral and vertical extent of the removal area , and gamma spectrometry measurements will be collected to confirm that the removal objectives have been met.
