PHOTOGRAPH LOG

Project Name:	Site Location:	Project No.
Gold King Mine – September 11, 2014	Silverton, San Juan County, Colorado	NA

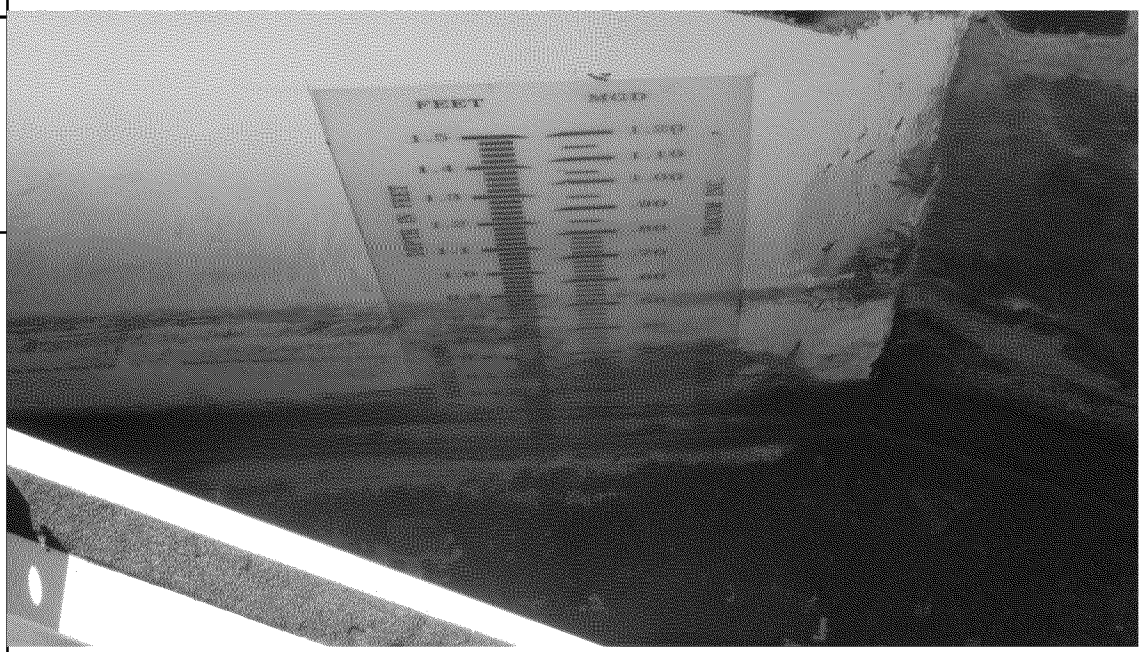
Photo No.	Date:
3	09/11/2014

Gold King Mine 3-inch Parshall flume. Note low flow in channel. Photo taken on 9/11/2014 at 12:42 prior to the start of work. Water is at 0.1 feet, which corresponds to 12.55 gallons per minute flow.

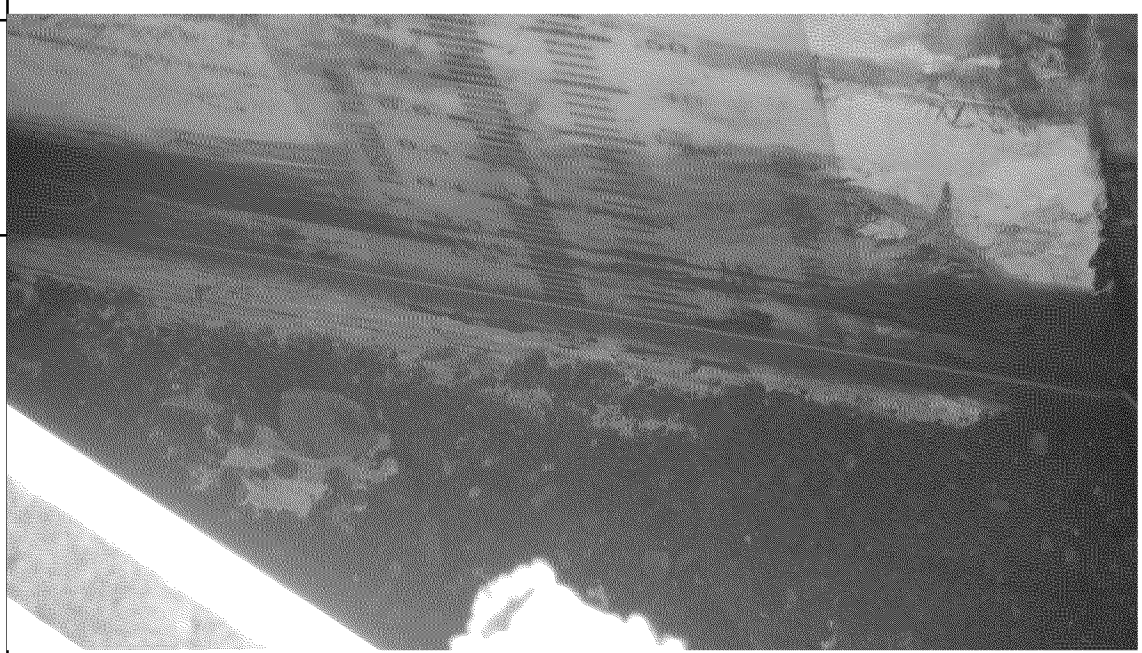
Photo No.	Date:
4	09/11/2014

Gold King Mine 3-inch Parshall flume. Note low flow in channel. Photo taken on 9/11/2014 at 12:43 prior to the start of work. Water is at 0.1 feet, which corresponds to 12.55 gallons per minute flow.
