April 12, 2001

MEMORANDUM

SUBJECT: Hunters Point Building 364 Removal Action Findings

Building 364 Removal Action

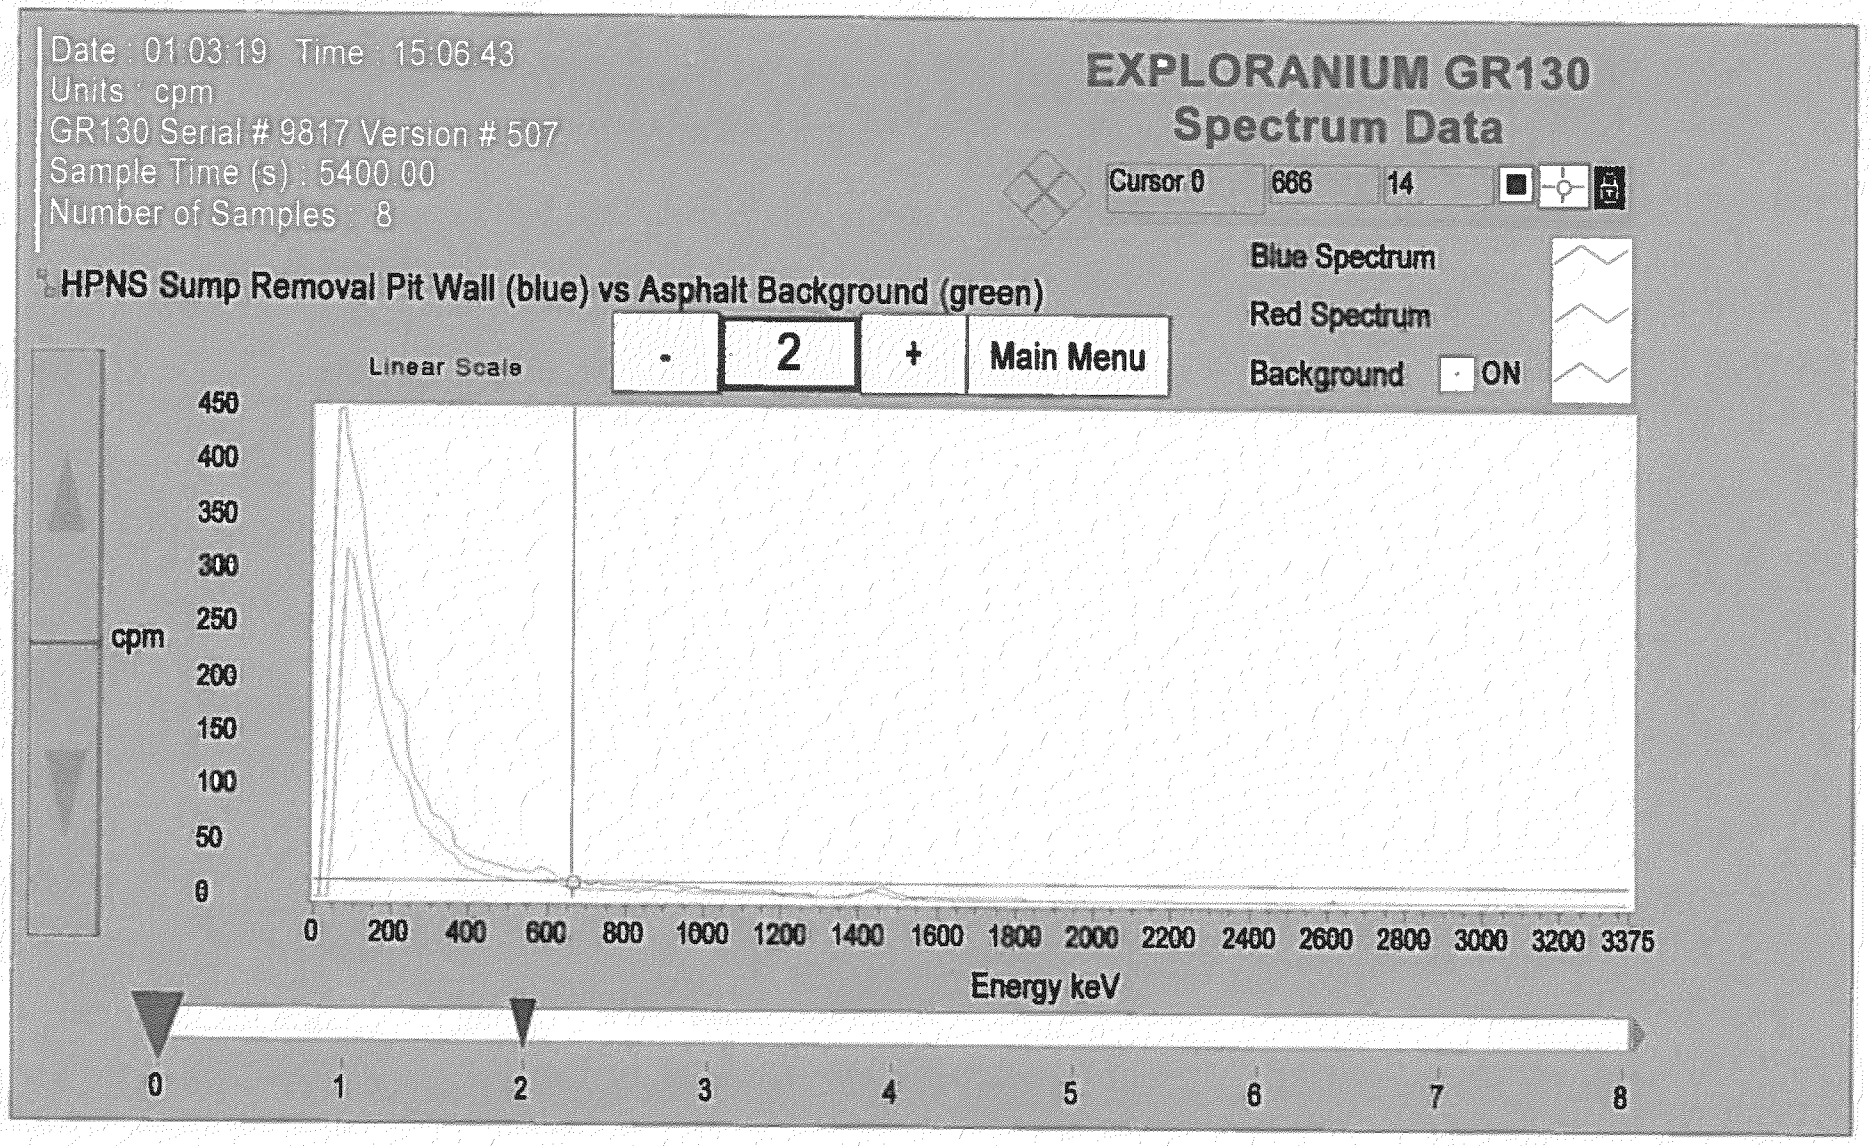
Sump Removal Pit Wall Spectrum Analysis

Sump Removal Pit Wall Spectrum Analysis:
While this area exhibited the highest gross gamma reading in the pit, the gamma spectrum shows that no gamma emitting radioactive contaminant is present. The elevated background was from the configuration of the wall's undercutting and nearby concrete structures which changed the counting geometry and thus increased the probe's detection efficiency. This translates into a slightly higher peak in the Compton scatter region, from zero to about 400 kilo-electron-volts (kev), of the spectrum. With this one exception, the wall's spectrum compares well to a background spectrum taken on unimpacted asphalt near Building 364. No Radium-226 (Ra226), Cs-137, or other radionuclide contaminants of concern are present in the spectrum.

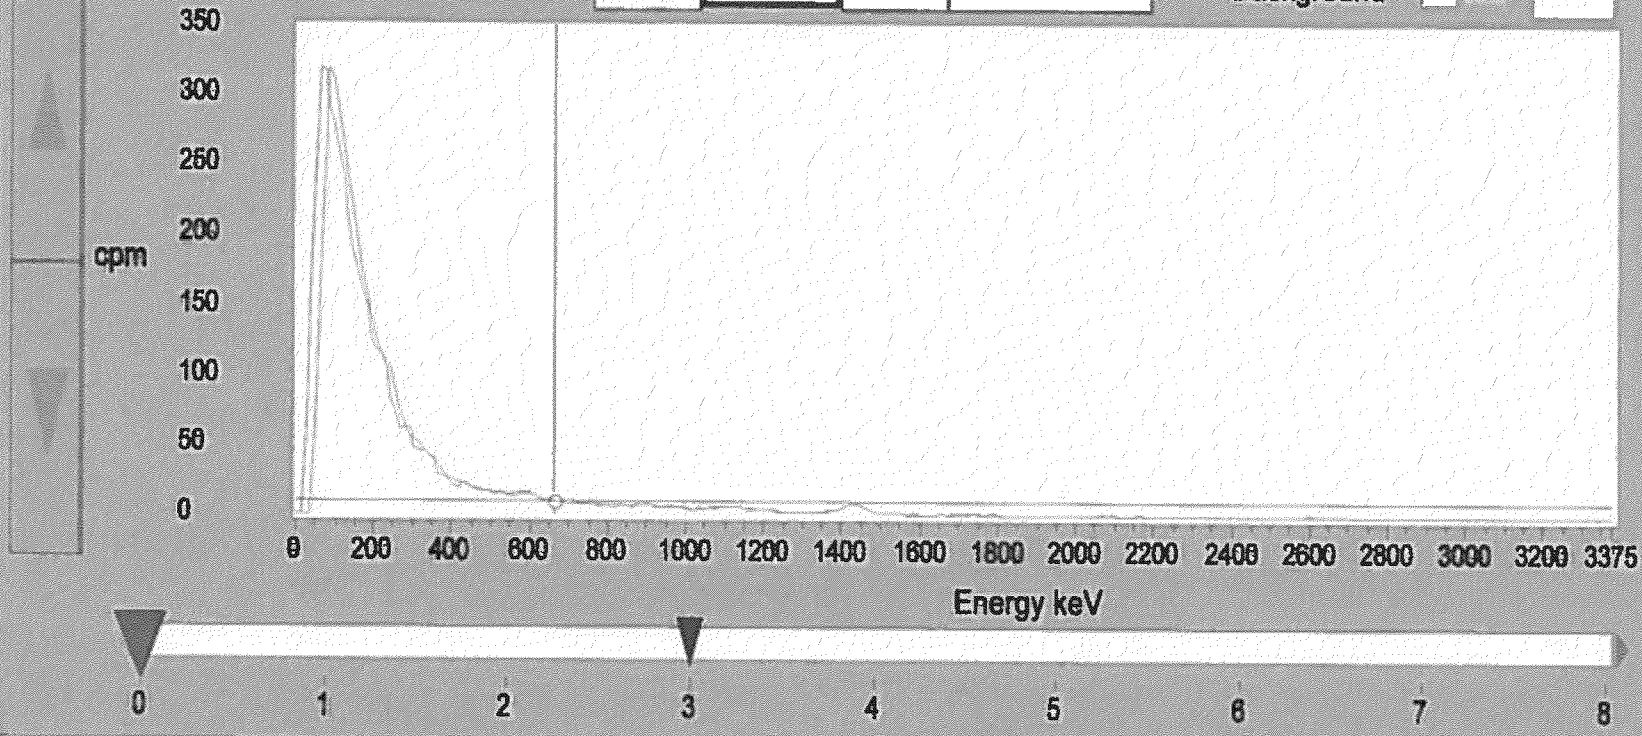
Sump Removal Pit Floor Spectrum Analysis

Sump Removal Pit Floor Spectrum Analysis:
One small indentation in the concrete floor had slightly higher gamma counts. The

indentation was made by workers while removing a small area of fixed contamination on the concrete floor. The spectrum of this area revealed no evidence of any residual radioactive contamination.

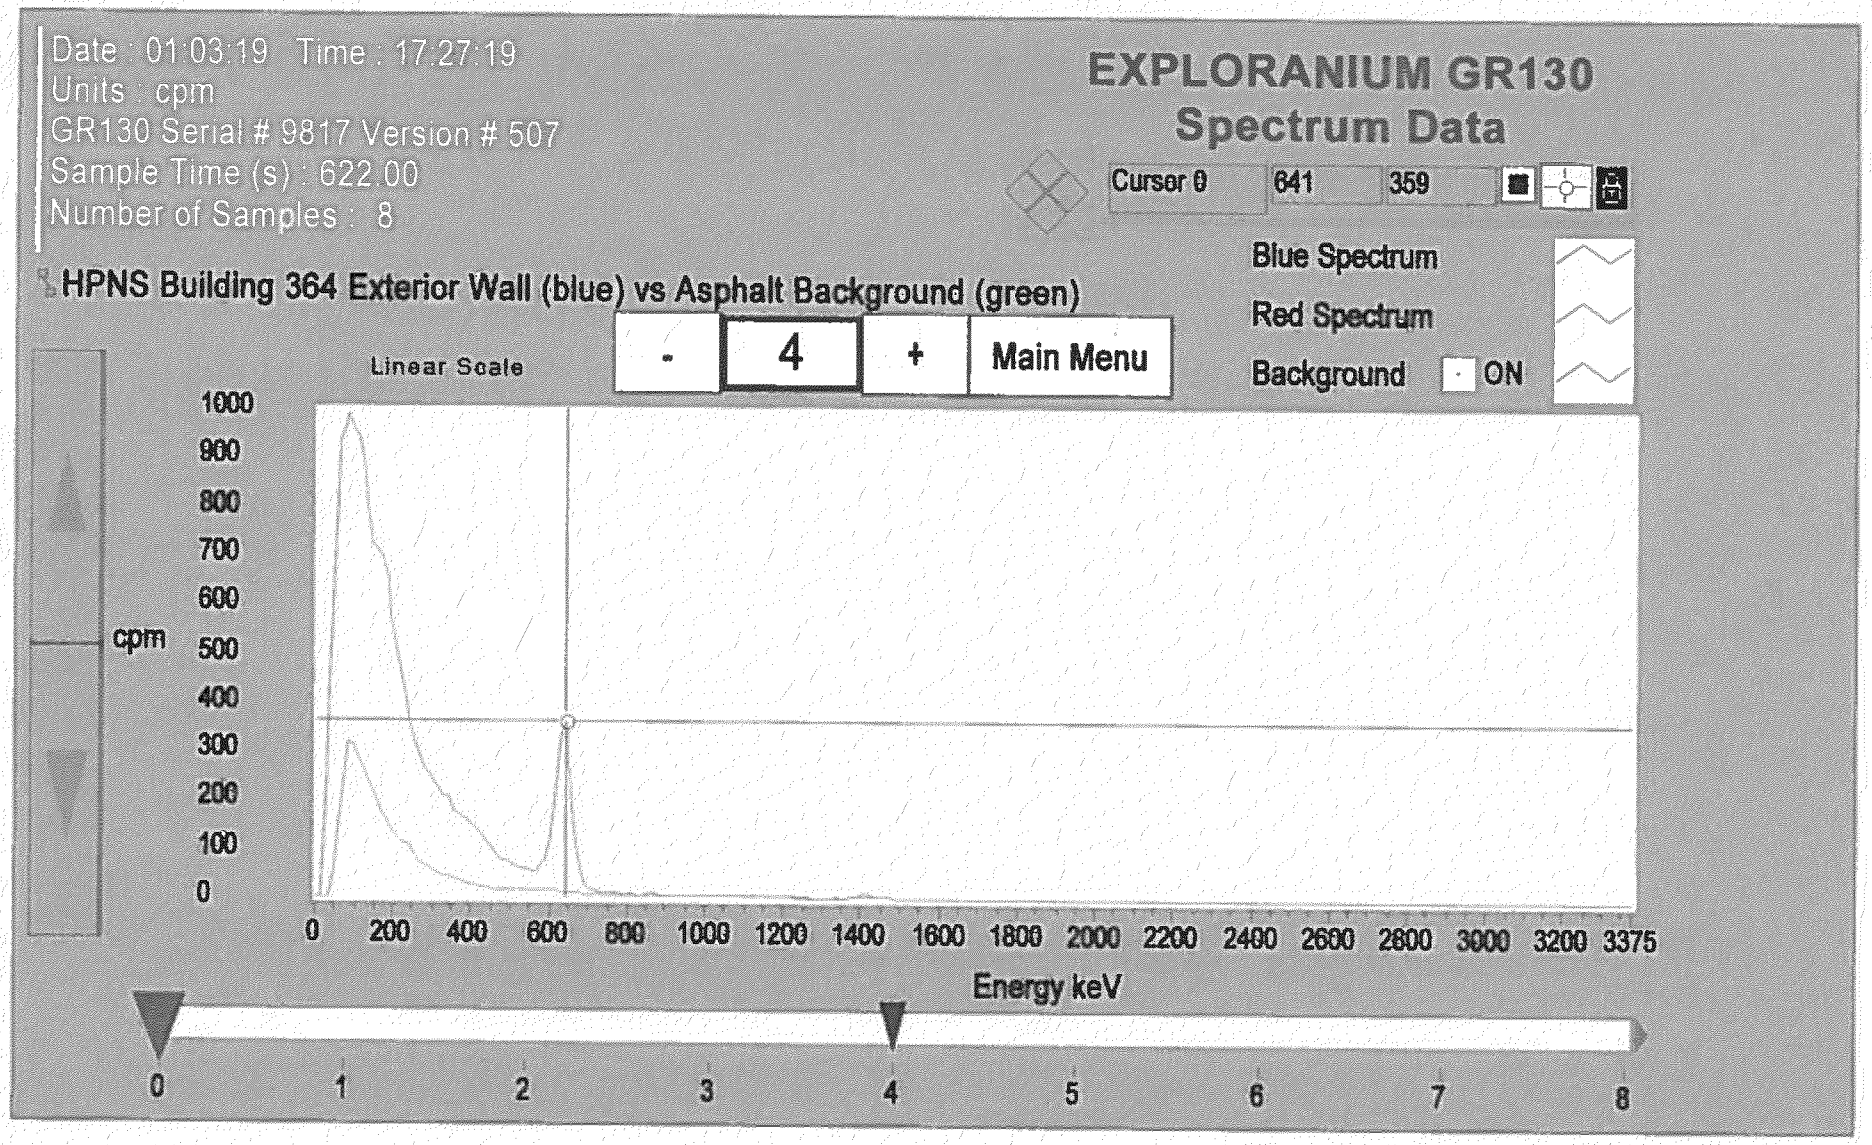
B364 Vent Wall Spectrum Analysis

B364 Vent wall Spectrum Analysis:
A spectral analysis of the exterior wall of Building 364 exhibited conclusive evidence that considerable Cs137 contamination is present. The Cs137 is localized in a seam between the original wall and a concrete patch that was applied to an old ventilator duct that passed through the exterior wall. This area requires remediation.

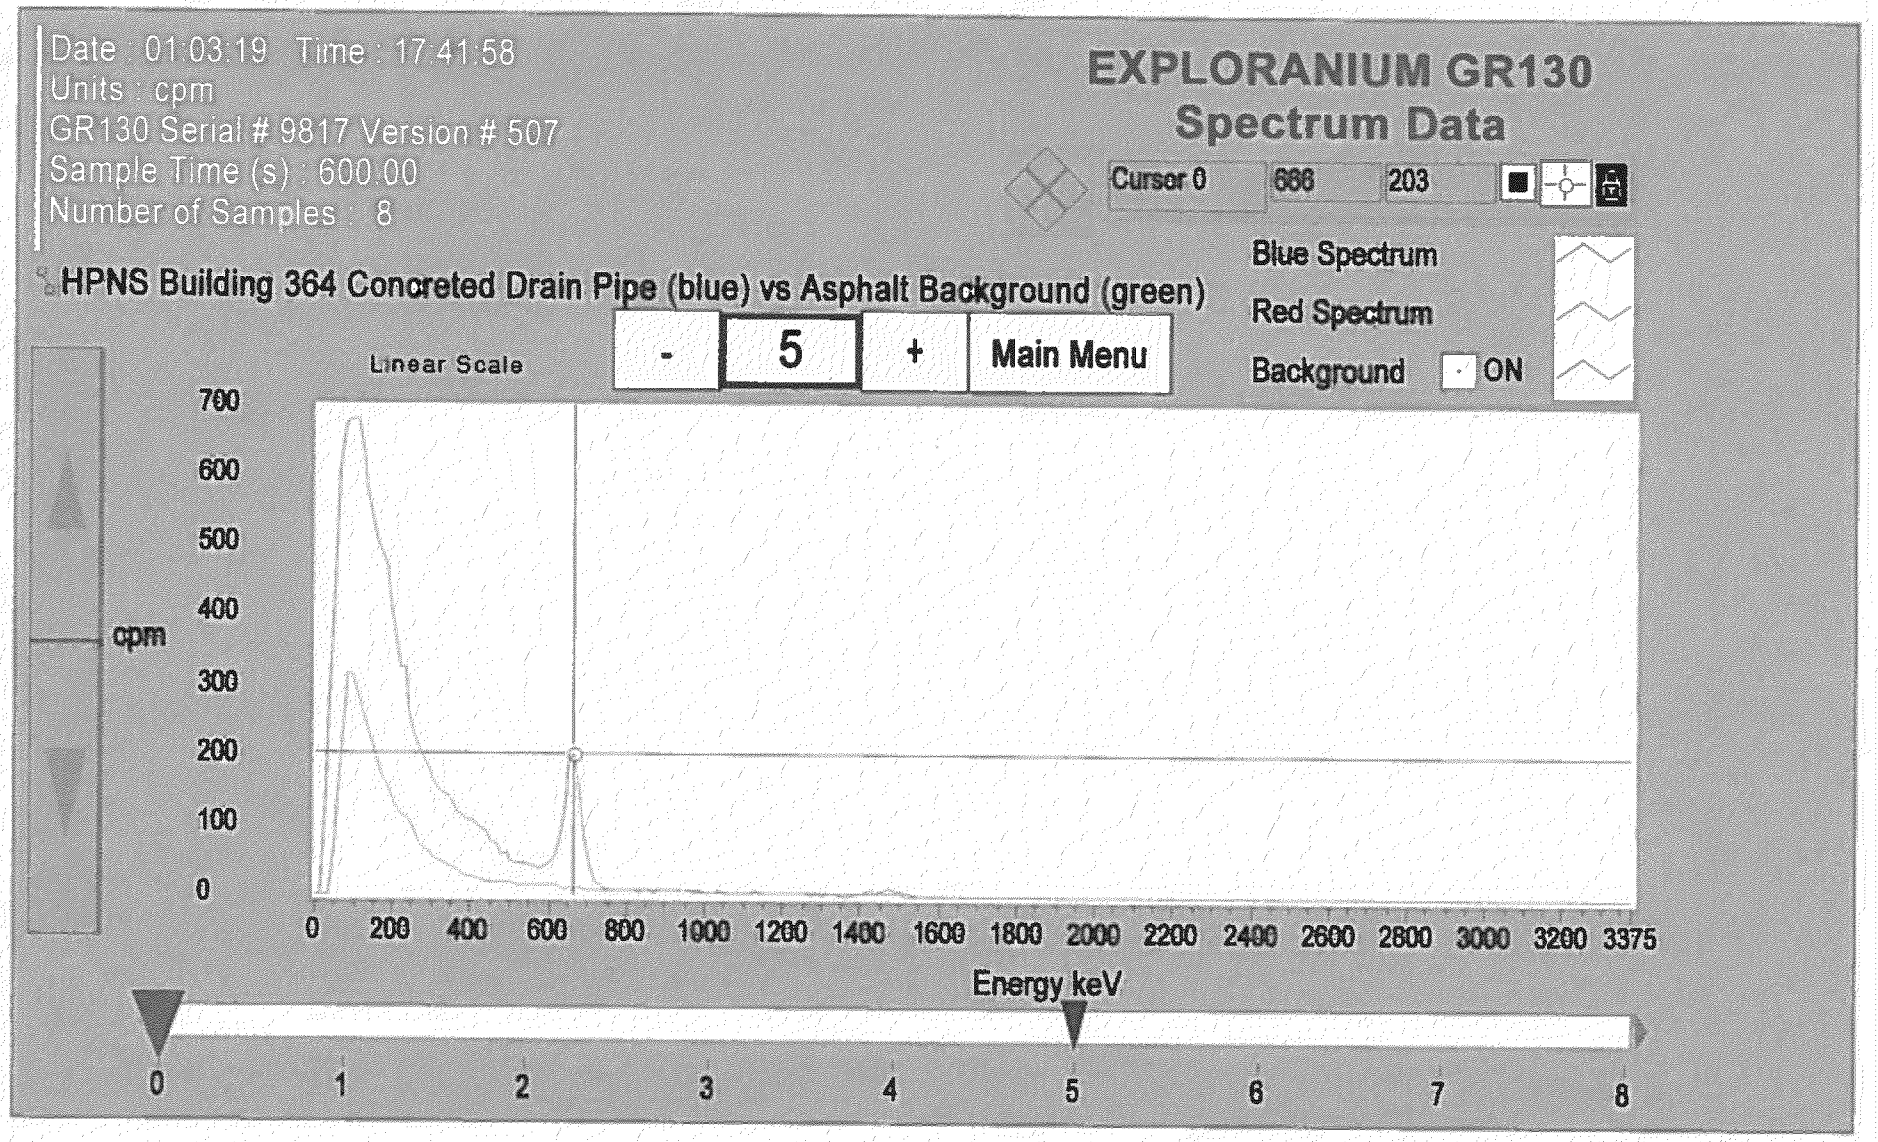
B364 Drain Pipe Spectrum Analysis

B364 Drain Pipe Spectrum Analysis:
A concrete fill iron drain pipe is located under the building just below the ventilator duct area. The pipe also exhibited considerable Cs137 contamination which was confirmed by the spectrum data. A spectrum peak at around 662 kev indicates the presence of Cs137. This pipe should be removed for radiation waste disposal.

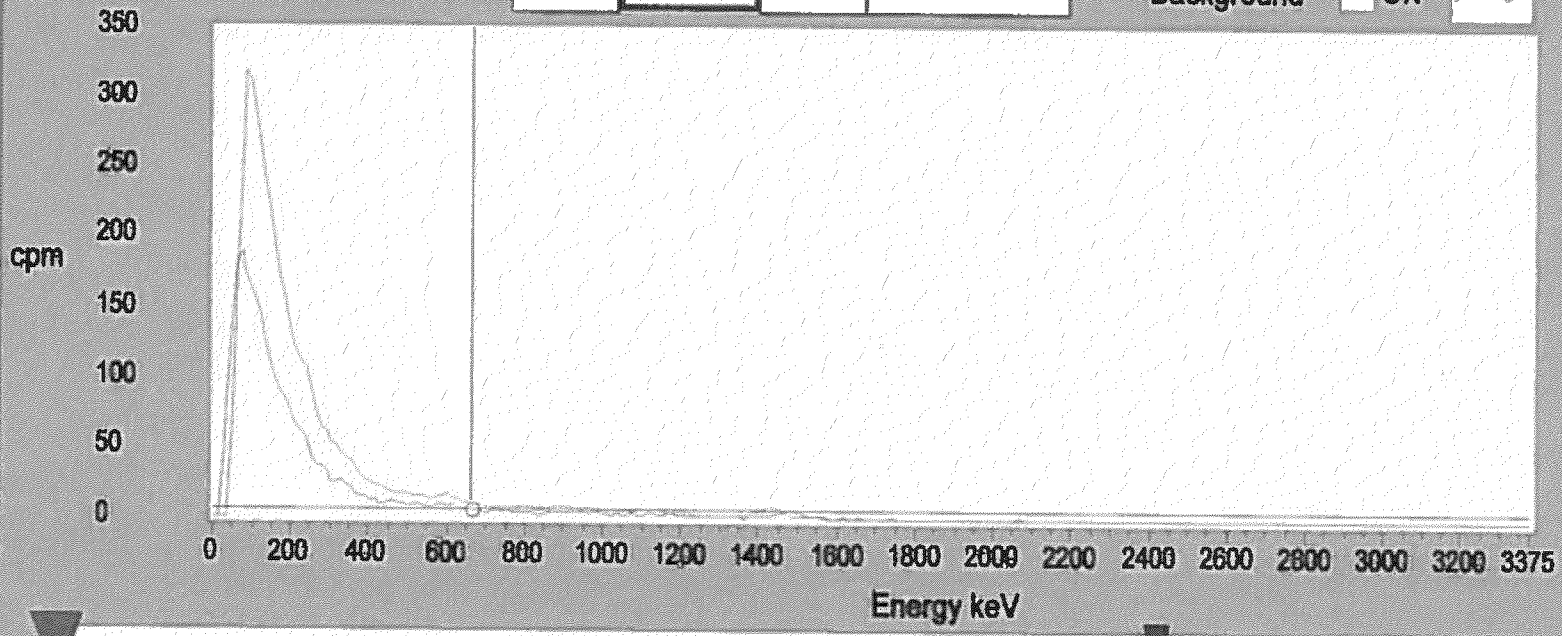
Peanut Spill Removal Pit Spectrum Analysis

Peanut Spill Removal Pit:
My gross gamma survey did not reveal any leveled gamma areas. So, I chose, as closely as I could recall, the region in the spill where the last Cs137 hit had been detected by the GR-130. The spectrum data did not reveal the presence of cesium or any other radionuclide contaminant.

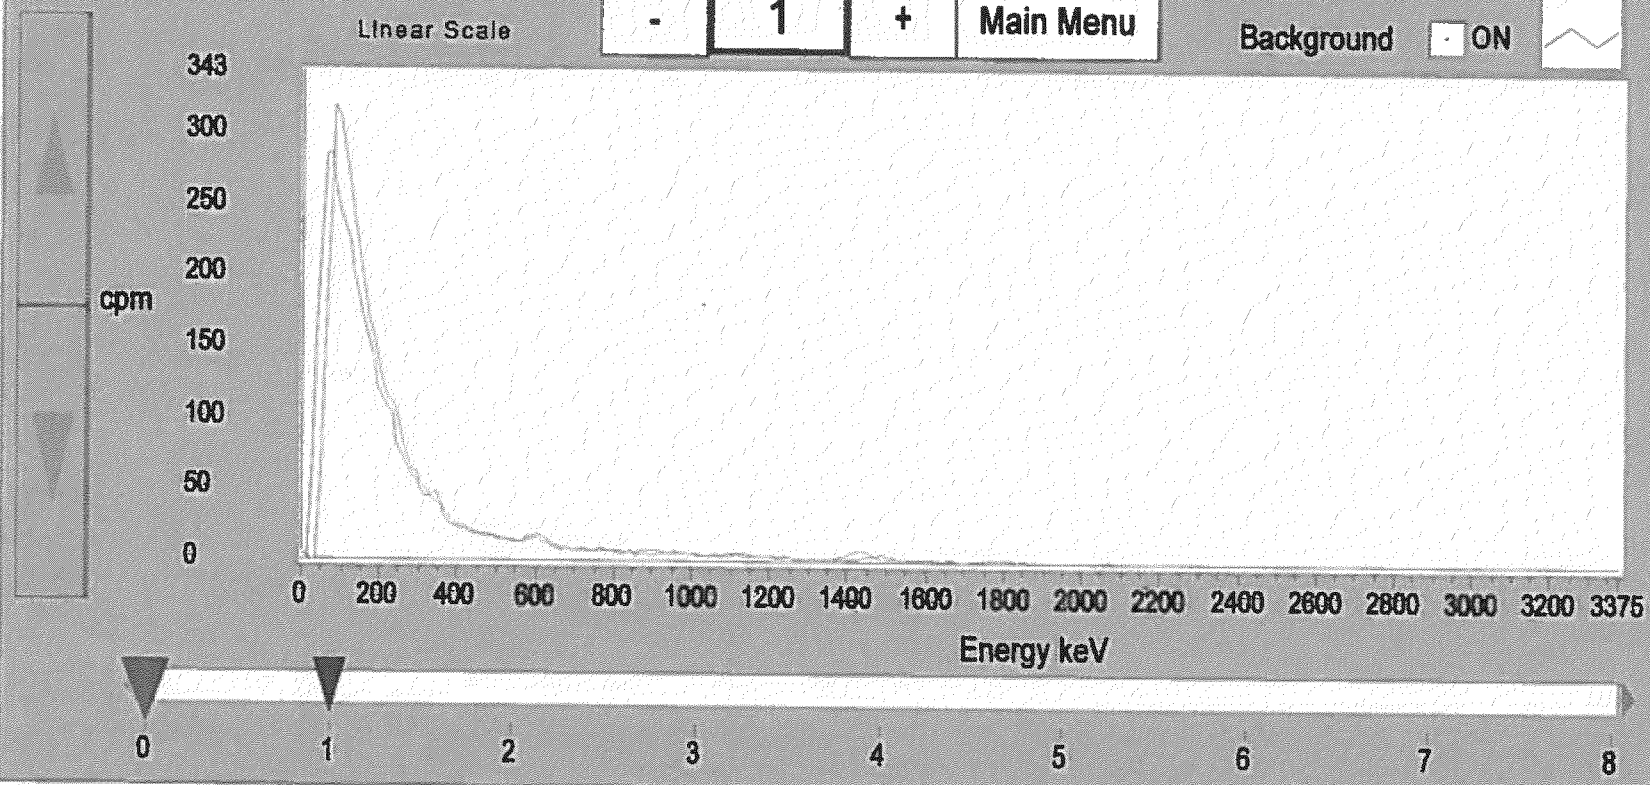
Black Beauty Sandblast Grit

Black Beauty Sandblast Grit:
I analyzed an area in Parcel E impacted by black beauty sandblast grit to determine whether or not this material meets the requirements for removal as a radium-226 waste material. The spectrum on very close scrutiny does reveal a slightly elevated peak at 352 kev, a region associated with lead-214 (Pb214) which is a radium decay daughter. The Navy has agreed to remove and dispose of the sandblast grit even though the radium concentration in the grit may not require it.
