Water Compliance Inspection Report

NPDES Permit No. DC0000019
Department of the Army, Baltimore District, Corps of Engineers, Washington Aqueduct Division Washington, DC.

Inspection Date: May 13, 2015

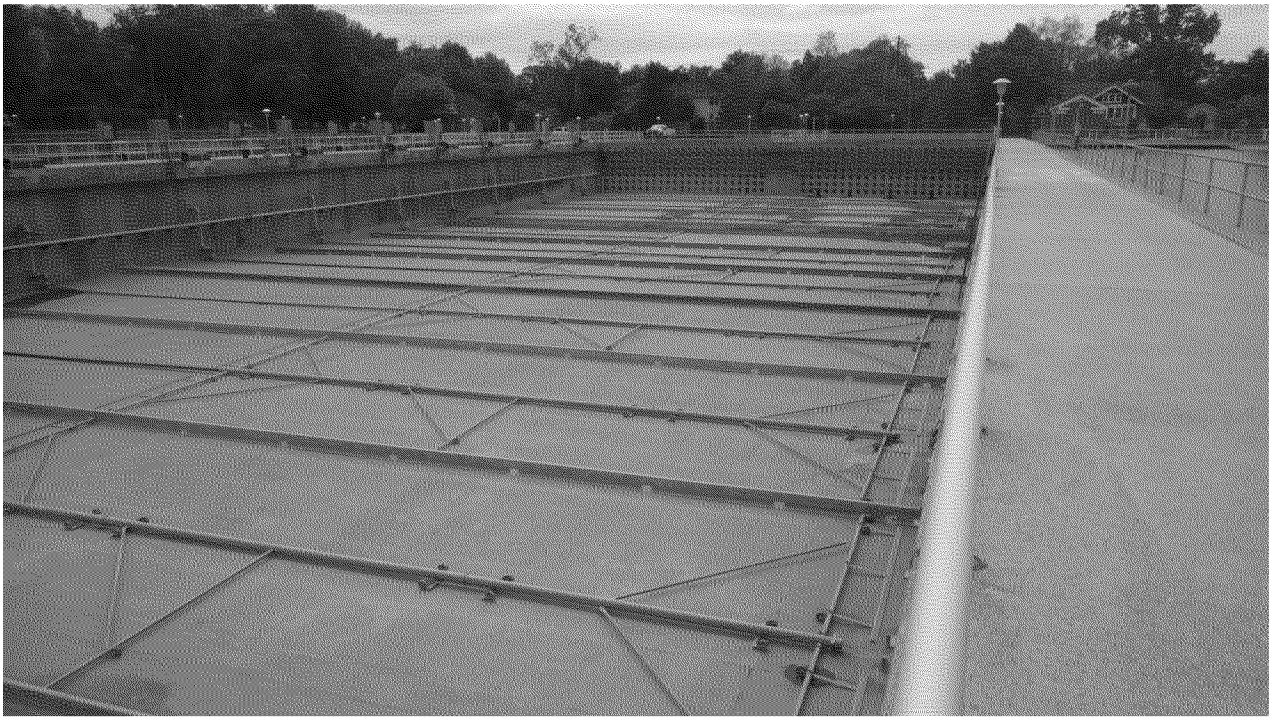
Photo 2: Sediment scrappers in Delcarlia sedimentation tank that is out of service for repair.

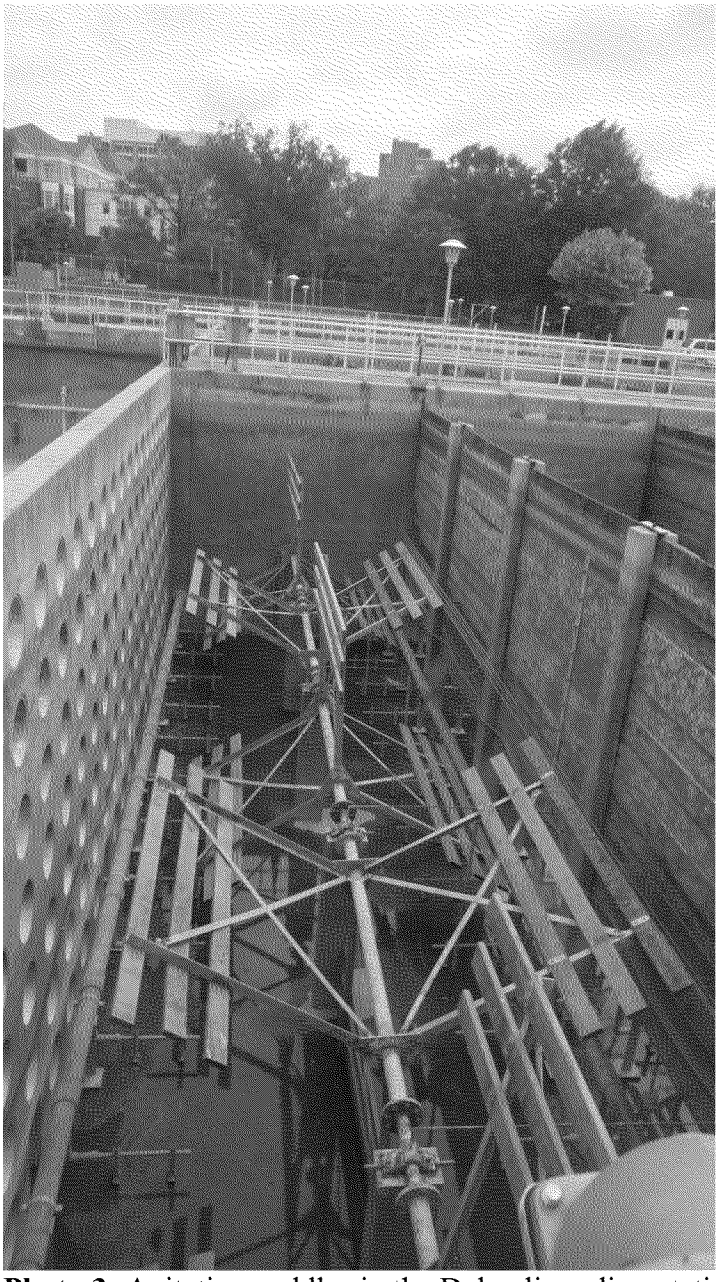
Photo 3: Agitation paddles in the Delcarlia sedimentation tanks used to re-suspend sediments so they can be pumped to the residual processing facility.

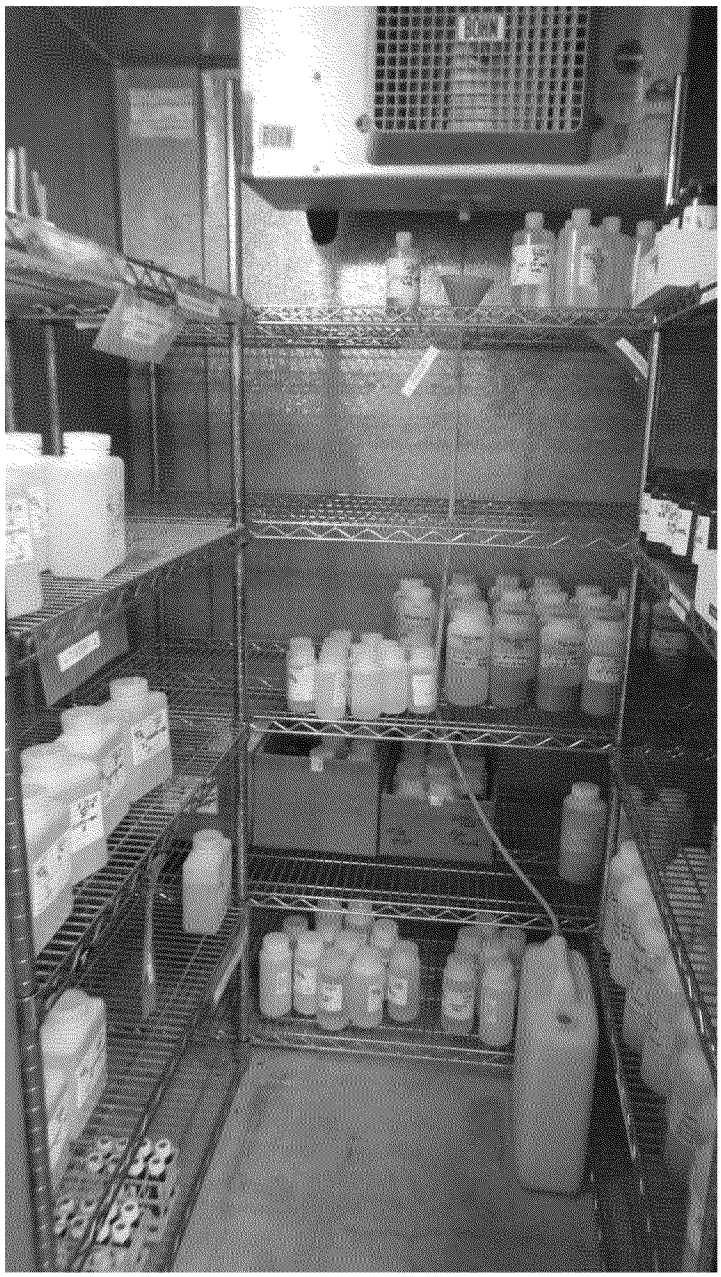
Raw and processed waters are monitored at different stages of the treatment process. Samples are collected **(Photo 8)**, stored **(Photo 9)**, and processed according to the permit requirements.

Photo 9: Sample storage cooler where samples are kept prior to processing.

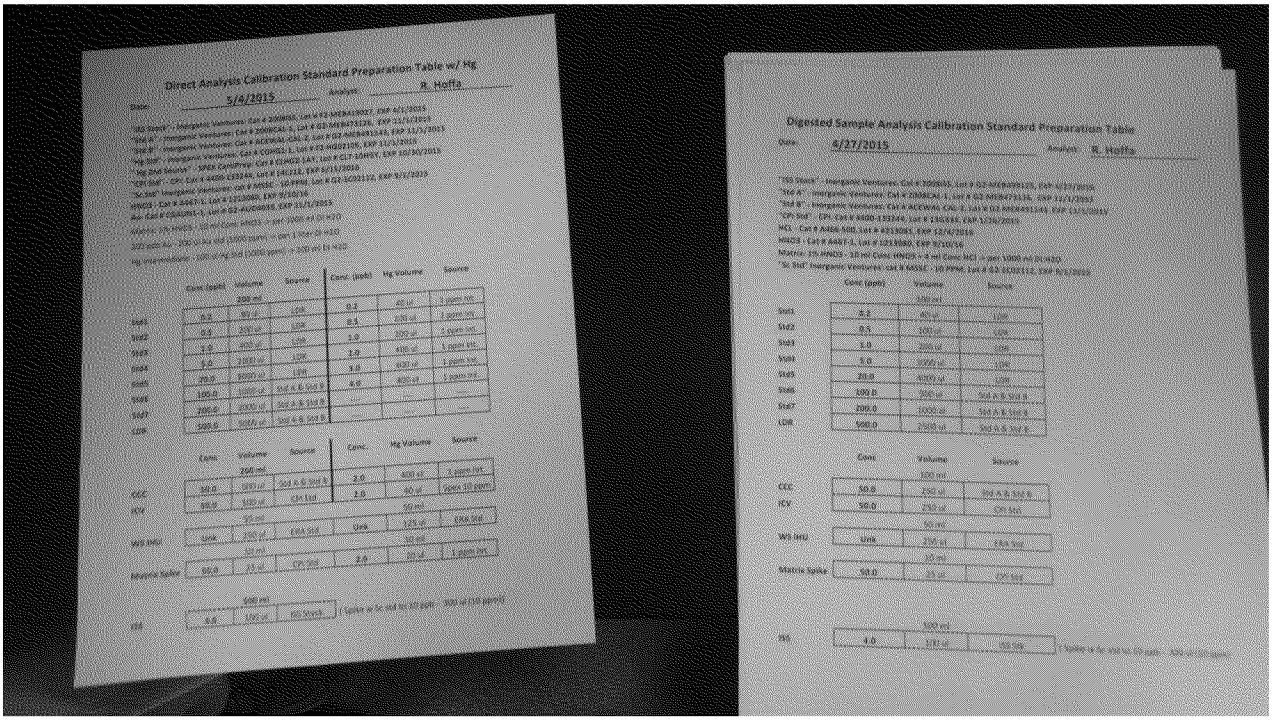
The lab employs comprehensive quality control procedures including two source calibrations ; a seven point calibration is conducted using a standard from a distributer and the n the calibration is verified with a standard from a second source. Continuing calibration verification is conducted after every 10 th sample run. Matrix Spike (5%) / Matrix Spike Duplicates (10%) (MS/MSD), blank and field blanks samples are analyzed on a regular basis **(Photo 11)**.

Photo 11: Laboratory calibration sheets.

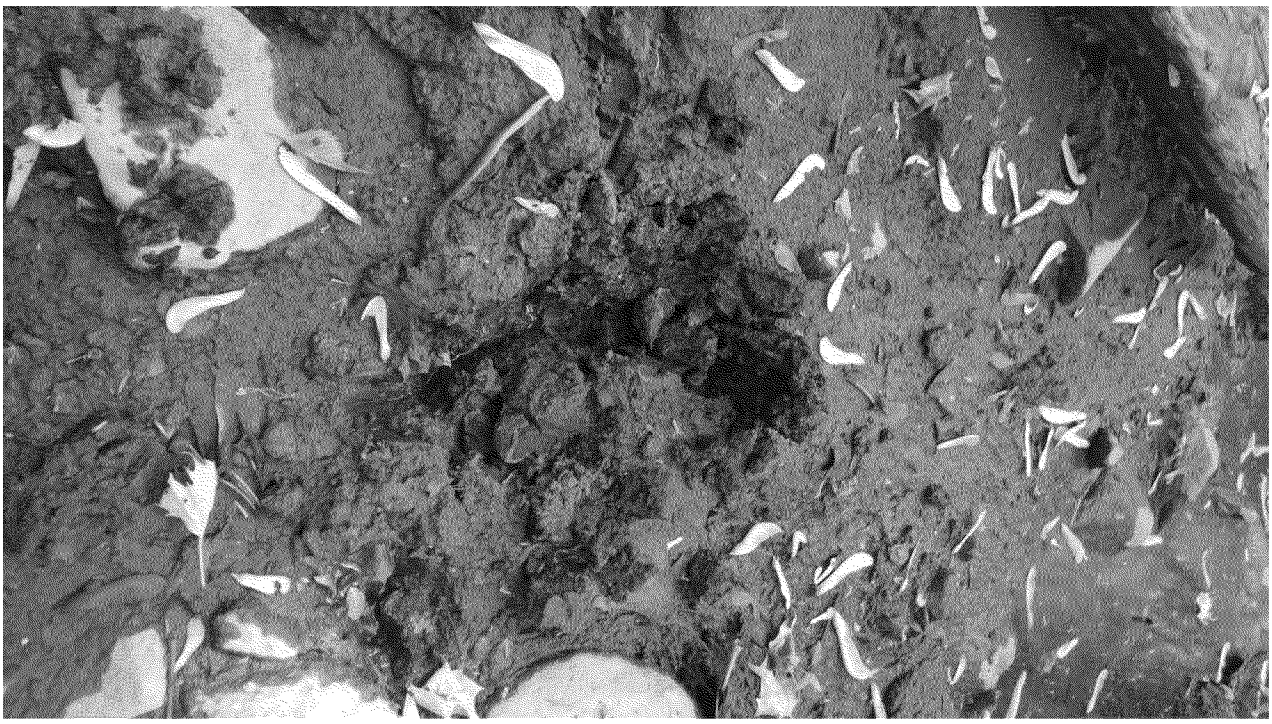
- Sediment accumulation from the discharges in December 2014 and January and February 2015 are still present in the 003A and 004A discharge channels that lead to the Potomac River. The sediment deposits are light brown on the surface where oxidation has occurred, dark grey to black just below the surface and made up of very fine grains; these physical characteristics are indicative of the sediments within the Georgetown Sedimentation Basins and are consistent with the observed discharge **(Photo 14)**.

Photo 14: Sediments accumulated in Outfall 004A channel that leads to the Potomac River. The sediment has the same physical appearance as sludge that was discharged during the 2014 bypass.
