Water Compliance Inspection Report

Water/NPDES Compliance Inspection Report

NPDES Permit No. DC0000019
Department of the Army, Baltimore District, Corps of Engineers, Washington Aqueduct Division Washington, DC.

Inspection Date: May 13, 2015

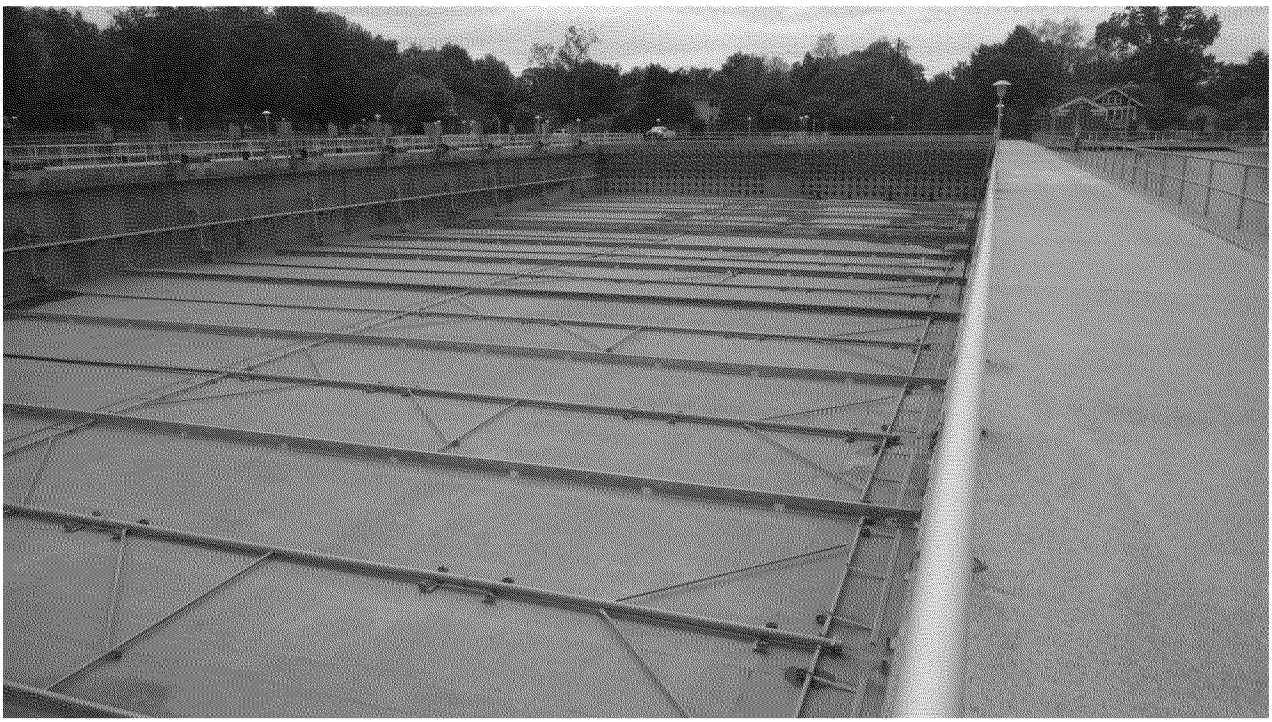
Photo 2: Sediment scrappers in Delcarlia sedimentation tank that is out of service for repair.

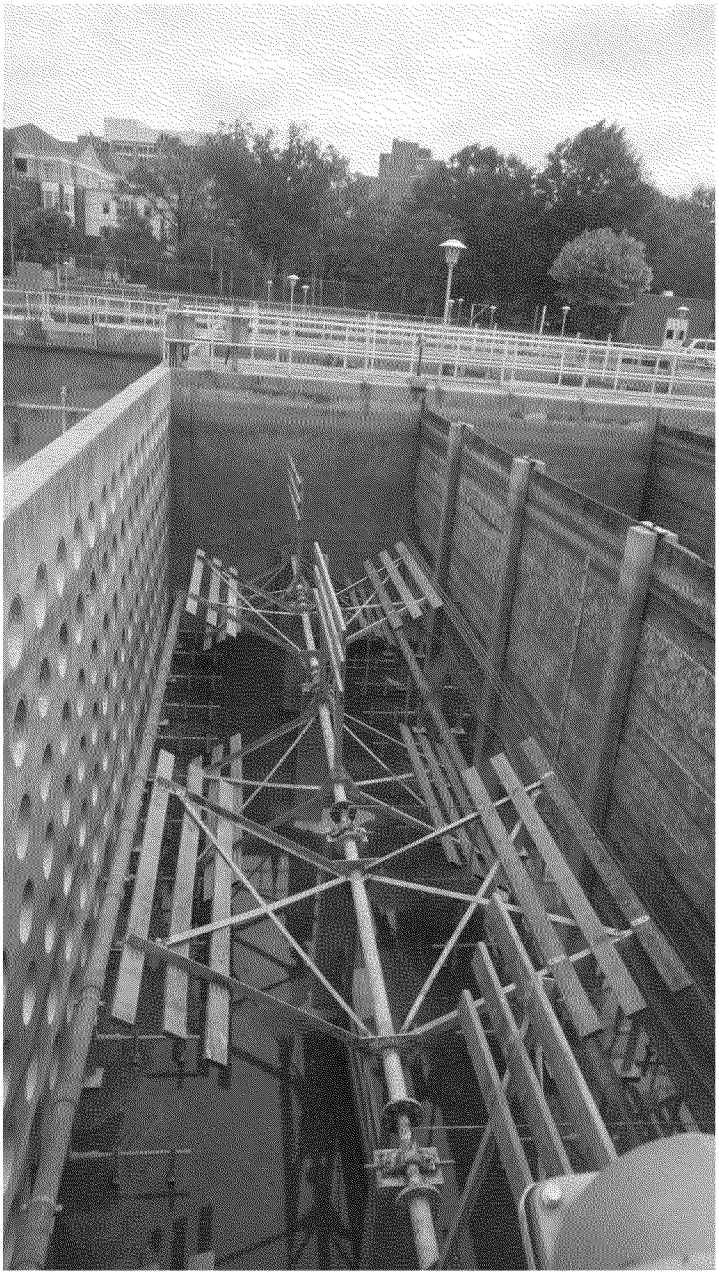
Photo 3: Agitation paddles in the Delcarlia sedimentation tanks used to re-suspend sediments so they can be pumped to the residual processing facility.

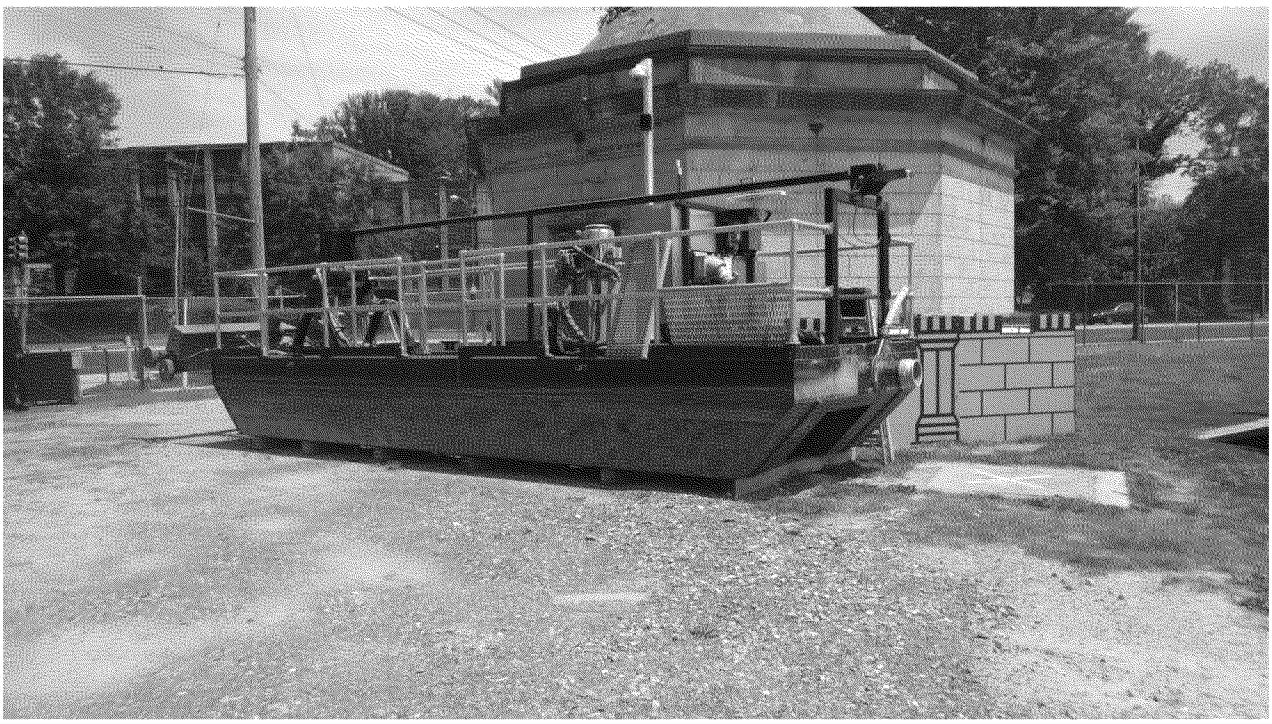
During the inspection, one of the sediment tanks at the Dalecarlia plant (Georgetown Basin #1) was out of service for maintenance and repair **(Photo 6)**. Facility representatives stated that the sediment removal barge for Georgetown Basin #2 has been in service for the previous four weeks; inspectors noted that the barge in basin #2 was not in operation during the inspection.

Photo 5: Sediment removal barge for basin #1. Sediment basin #1 was drained and being repaired at the time of the inspection.

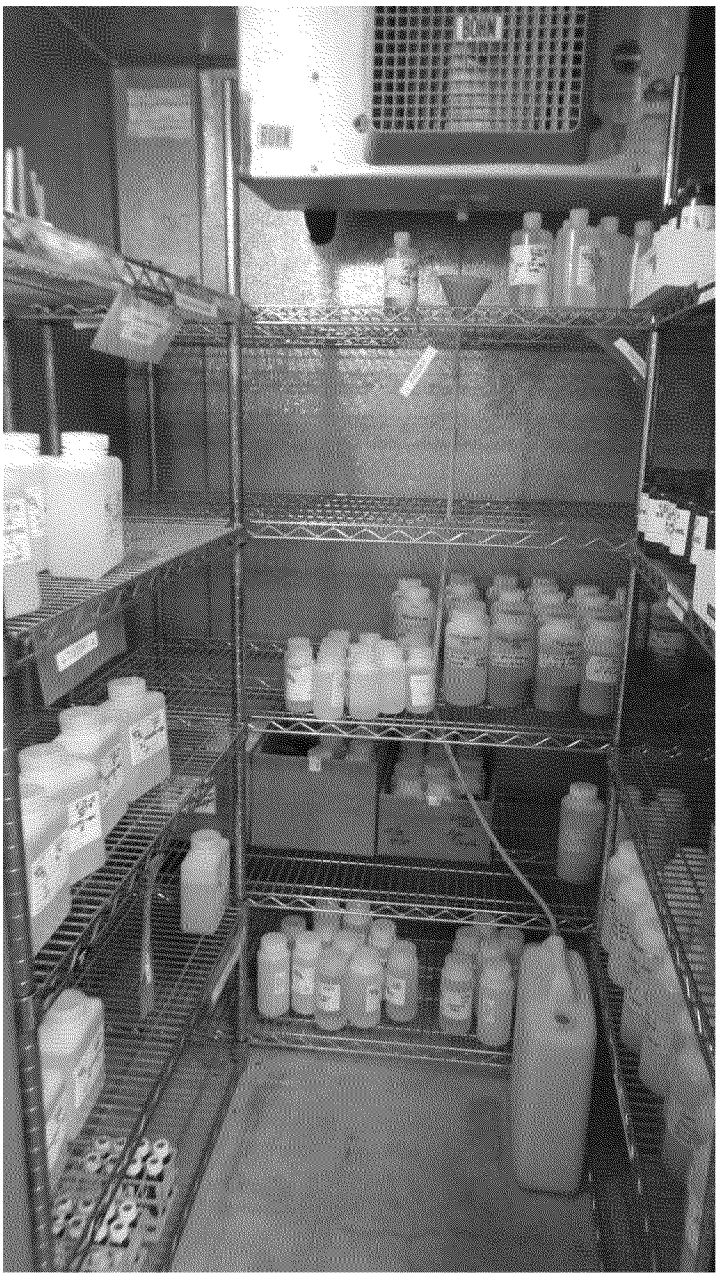
Raw and processed waters are monitored at different stages of the treatment process. Samples are collected **(Photo 8)**, stored **(Photo 9)**, and processed according to the permit requirements.

Photo 9: Sample storage cooler where samples are kept prior to processing.

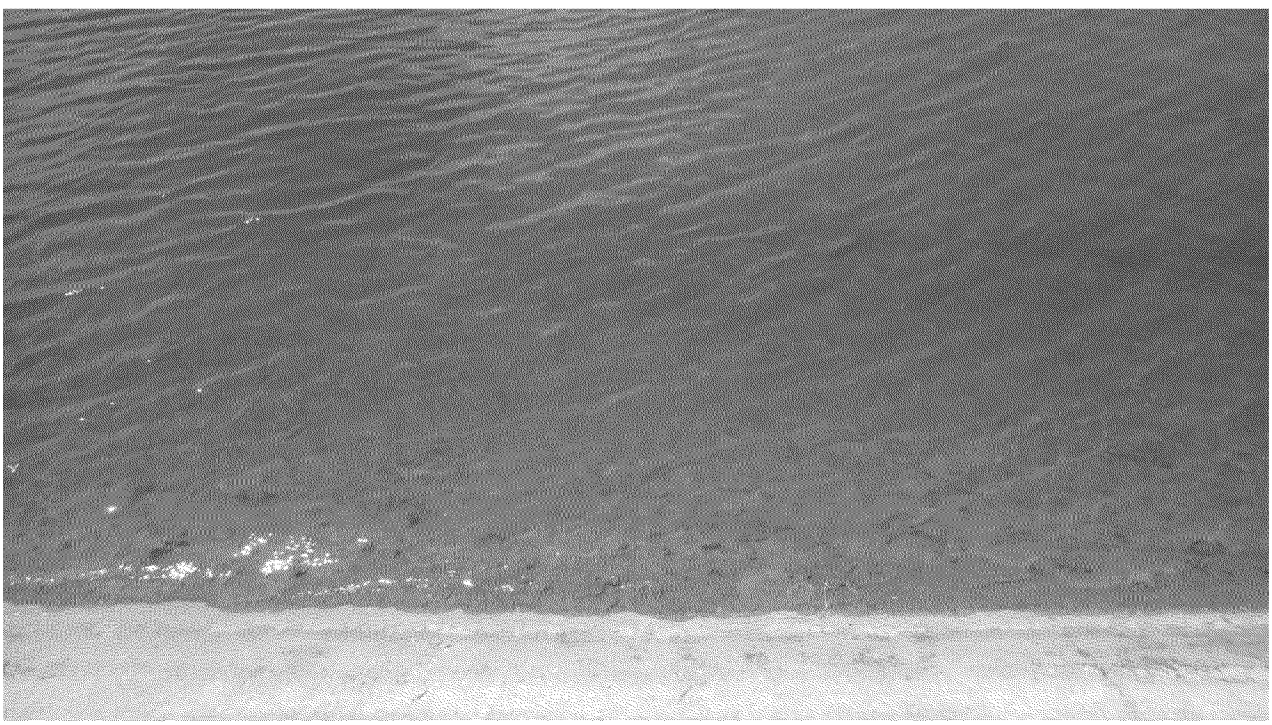
- The deficiencies with the sediment removal in the Georgetown Basins have not been resolved and sediment has begun accumulating in Georgetown Sedimentation Basin #2 **(Photo 15)**.

Photo 15: Six months after the 2014 bypass and basin cleaning sediments have begun to accumulate on the floor of Georgetown Sedimentation Basin #2.
