Water/NPDES Compliance Evaluation Inspection

Department of the Army, Baltimore District,
Corps of Engineers, Washington Aqueduct Division
Washington, DC.

NPDES Permit No. DC0000019

July 12, 2016

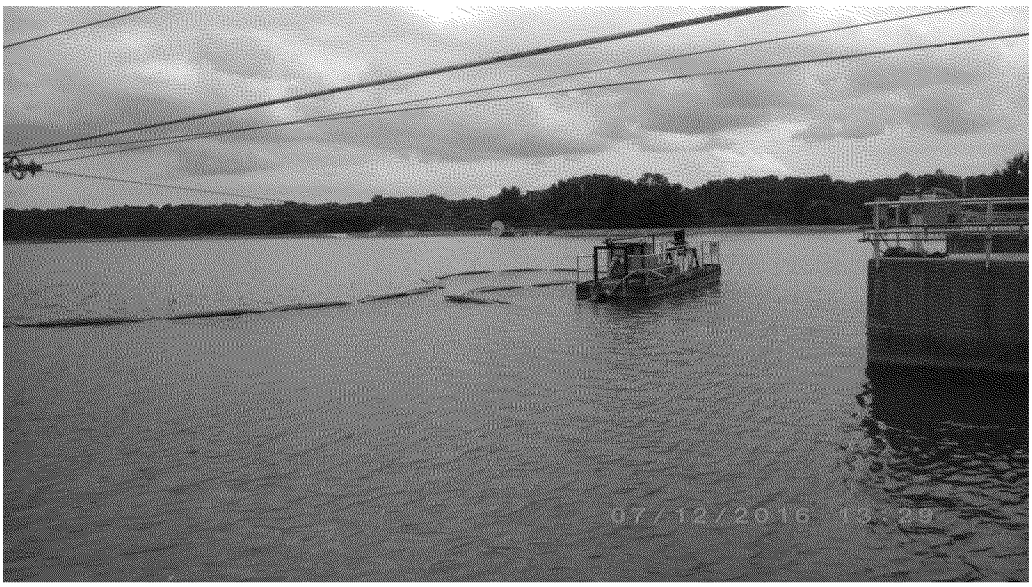
During the 2016 inspection, facility representatives stated operation and maintenance of the RPF and dredging system was moved from the maintenance department to the operations department. The operations department has staff on-site 24 hours a day and can perform both daytime and night time dredging operations increasing sediment removal and improving the effectiveness of the system. The facility is still working to address design issues which do not allow the dredging system to reach the deepest parts of the reservoir. They have hired an independent dredging operation which is scheduled to begin dredging activities in late July or early August 2016. The facility has also installed a real-time monitoring system of sediment levels and removal activities **(Photos 3 and 4)**. Inspectors could see on-screen when the dredging operations started and stopped and when residuals were being collected and hauled away. During the inspection, the dredging equipment was being reset and was not seen in operation **(Photo 5)**.

Photo 5. Dredging barge not operating, was in the process of being reset
