Water Compliance Inspection Report

Water/NPDES Compliance Inspection Report

NPDES Permit No. DC0000019
Department of the Army, Baltimore District, Corps of Engineers, Washington Aqueduct Division Washington, DC.

Inspection Date: May 13, 2015

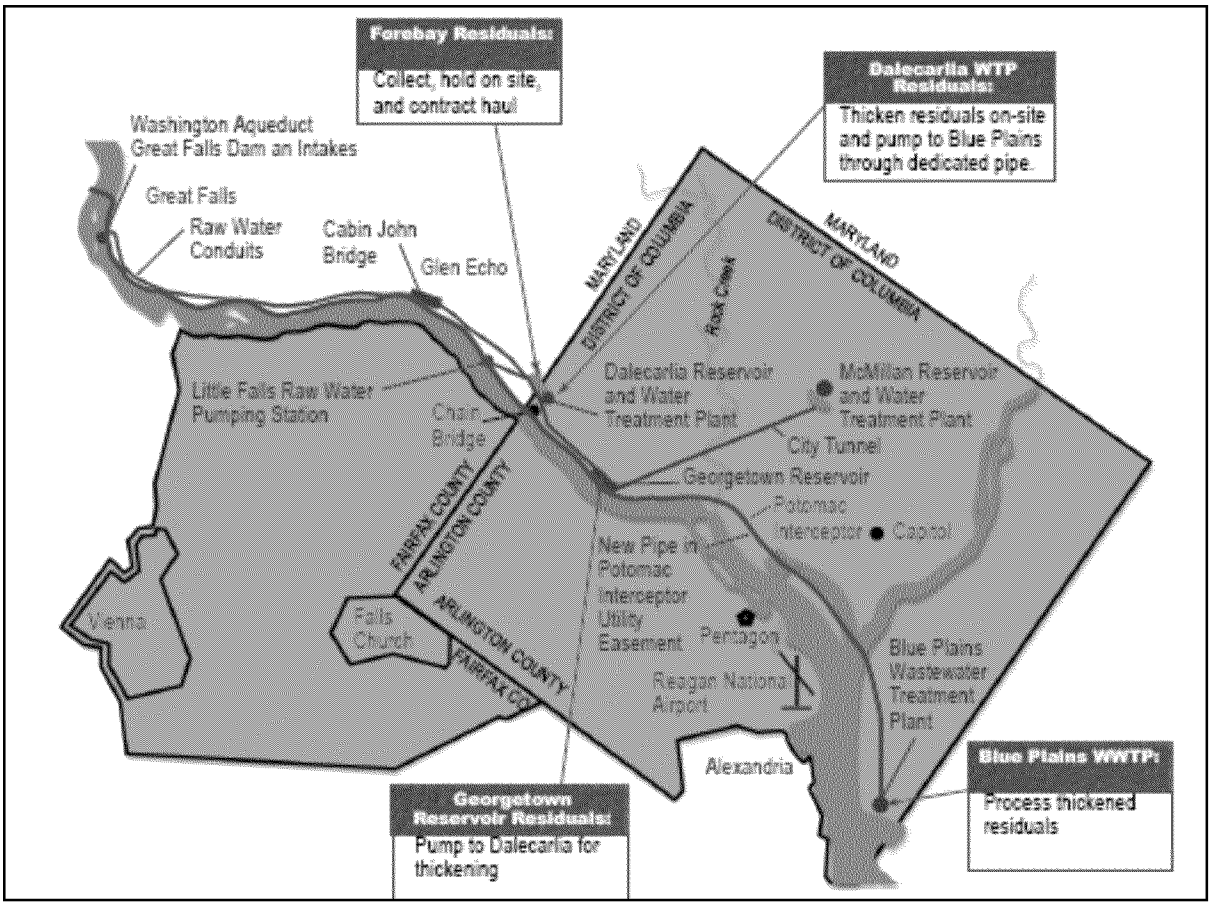
Figure 1: An overview of the service area of the Washington Aqueduct Facility.

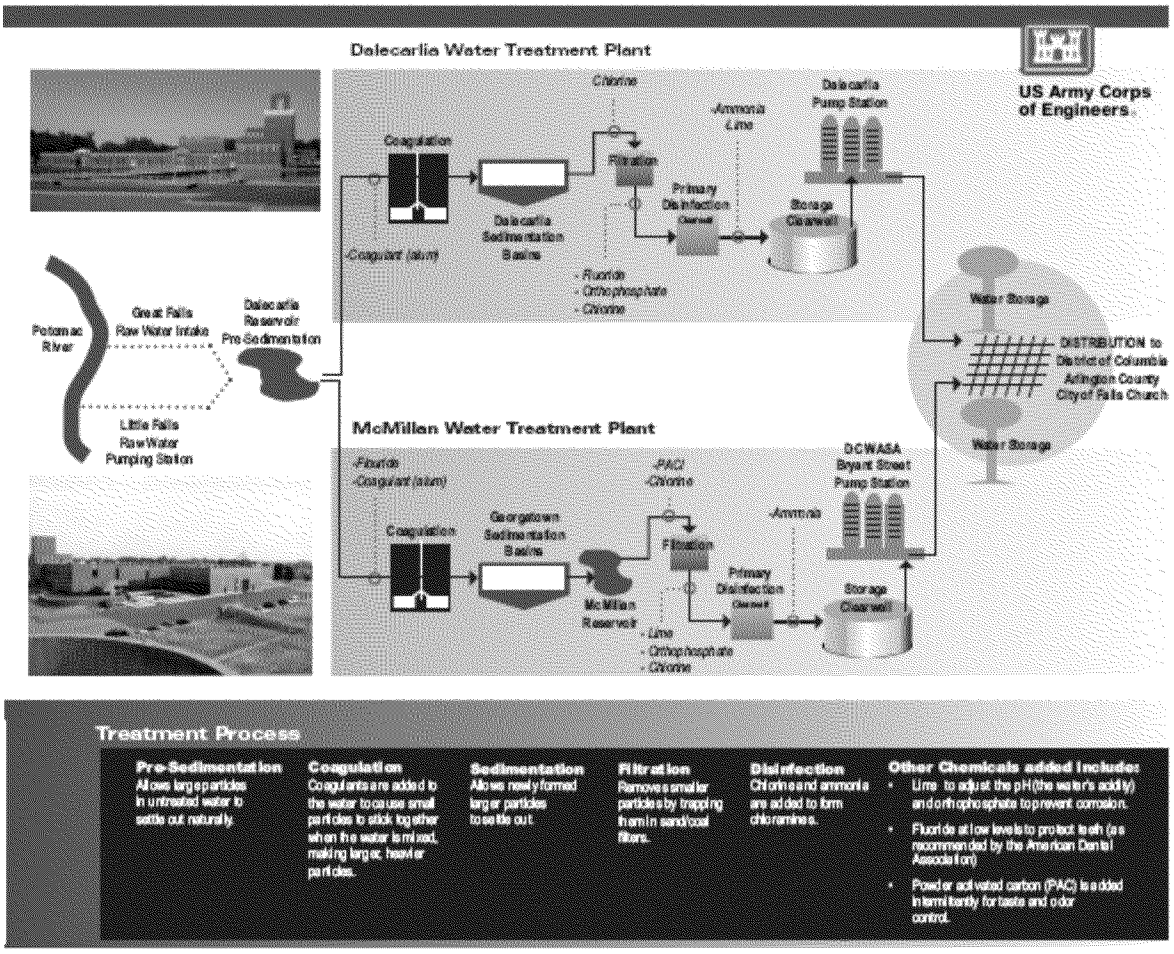
Under normal operating conditions, r aw water is diverted from the Potomac River at (i) Great Falls Dam intake point, located in Great Falls , Maryland and flows under gravity to the Forebay Reservoir through two 100-MGD capacity conduits and then pumped into the Dalecarlia Reservoir. During low flow or flooding conditions in the Potomac River , raw water is pumped from the Little Falls Dam to the Dalecarlia Reservoir. At both Dalecarlia and McMillan treatment plants, raw water is subjected to a full conventional water treatment process (shown in **Figure 2)** to remove suspended solids, sediments, bacteria, and microorganisms to produce drinking water.

Figure 2: Washington Aqueduct water treatment process.

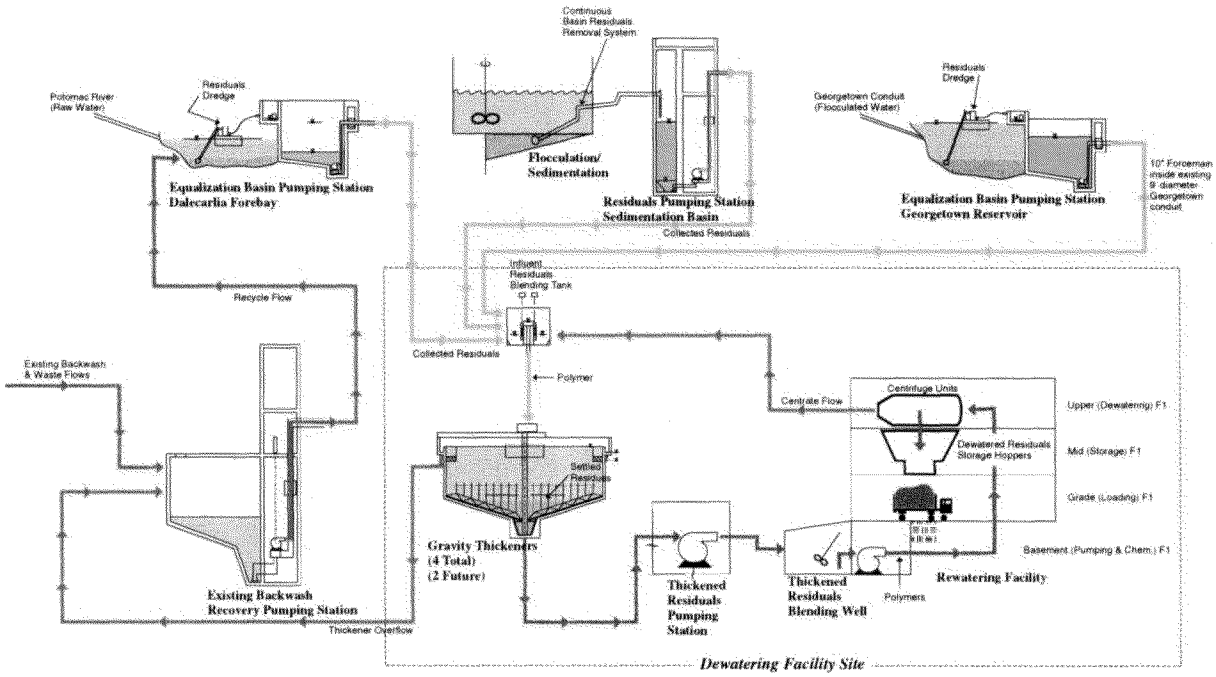
The RPF collects and treats (through a combination of solids concentration and drying processes) all sediments/residues from the sedimentation basins, reservoir dredging, and filter backwash. The facility representative stated that the sediment treatment process involves scrapping the sediments from the bottom of sedimentation tanks, or dredging from the reservoirs, followed by pumping them into the Thickener Influent Splitter Chamber (TISC) (also known as influent residuals blending tank (**Figure 3)**. At this point, the percent solid is less than 0.5%; the contents of the blending TISC are transferring into four Gr avity Thickeners (GTs) where the p ercentage solid is increased . The residuals from the GTs are subsequently pumped to centrifuges where all remaining water is removed and the dried sediment (cake) is dropped into storage silos and the spent water that was removed returned to the splitter box . After drying, the residuals (cake) are sent to storage bins - ready to be weighed and trucked offsite. The treated residual is about 25 percent solids and is currently being trucked to a landfill for disposal. The Aqueduct pays contractors to transport and dispose of the residuals.

Figure 3: Washington Aqueduct residual management/treatment system.
