9540 Niagara Falls Boulevard (N002)

Figure 2: Property N002 Soil Sample Gamma Screening Results Map

Niagara Falls Boulevard Radiological Site
Niagara Falls, New York

U.S. ENVIRONMENTAL PROTECTION AGENCY
Removal Support Team 3
CONTRACT # EP-S2-13-01

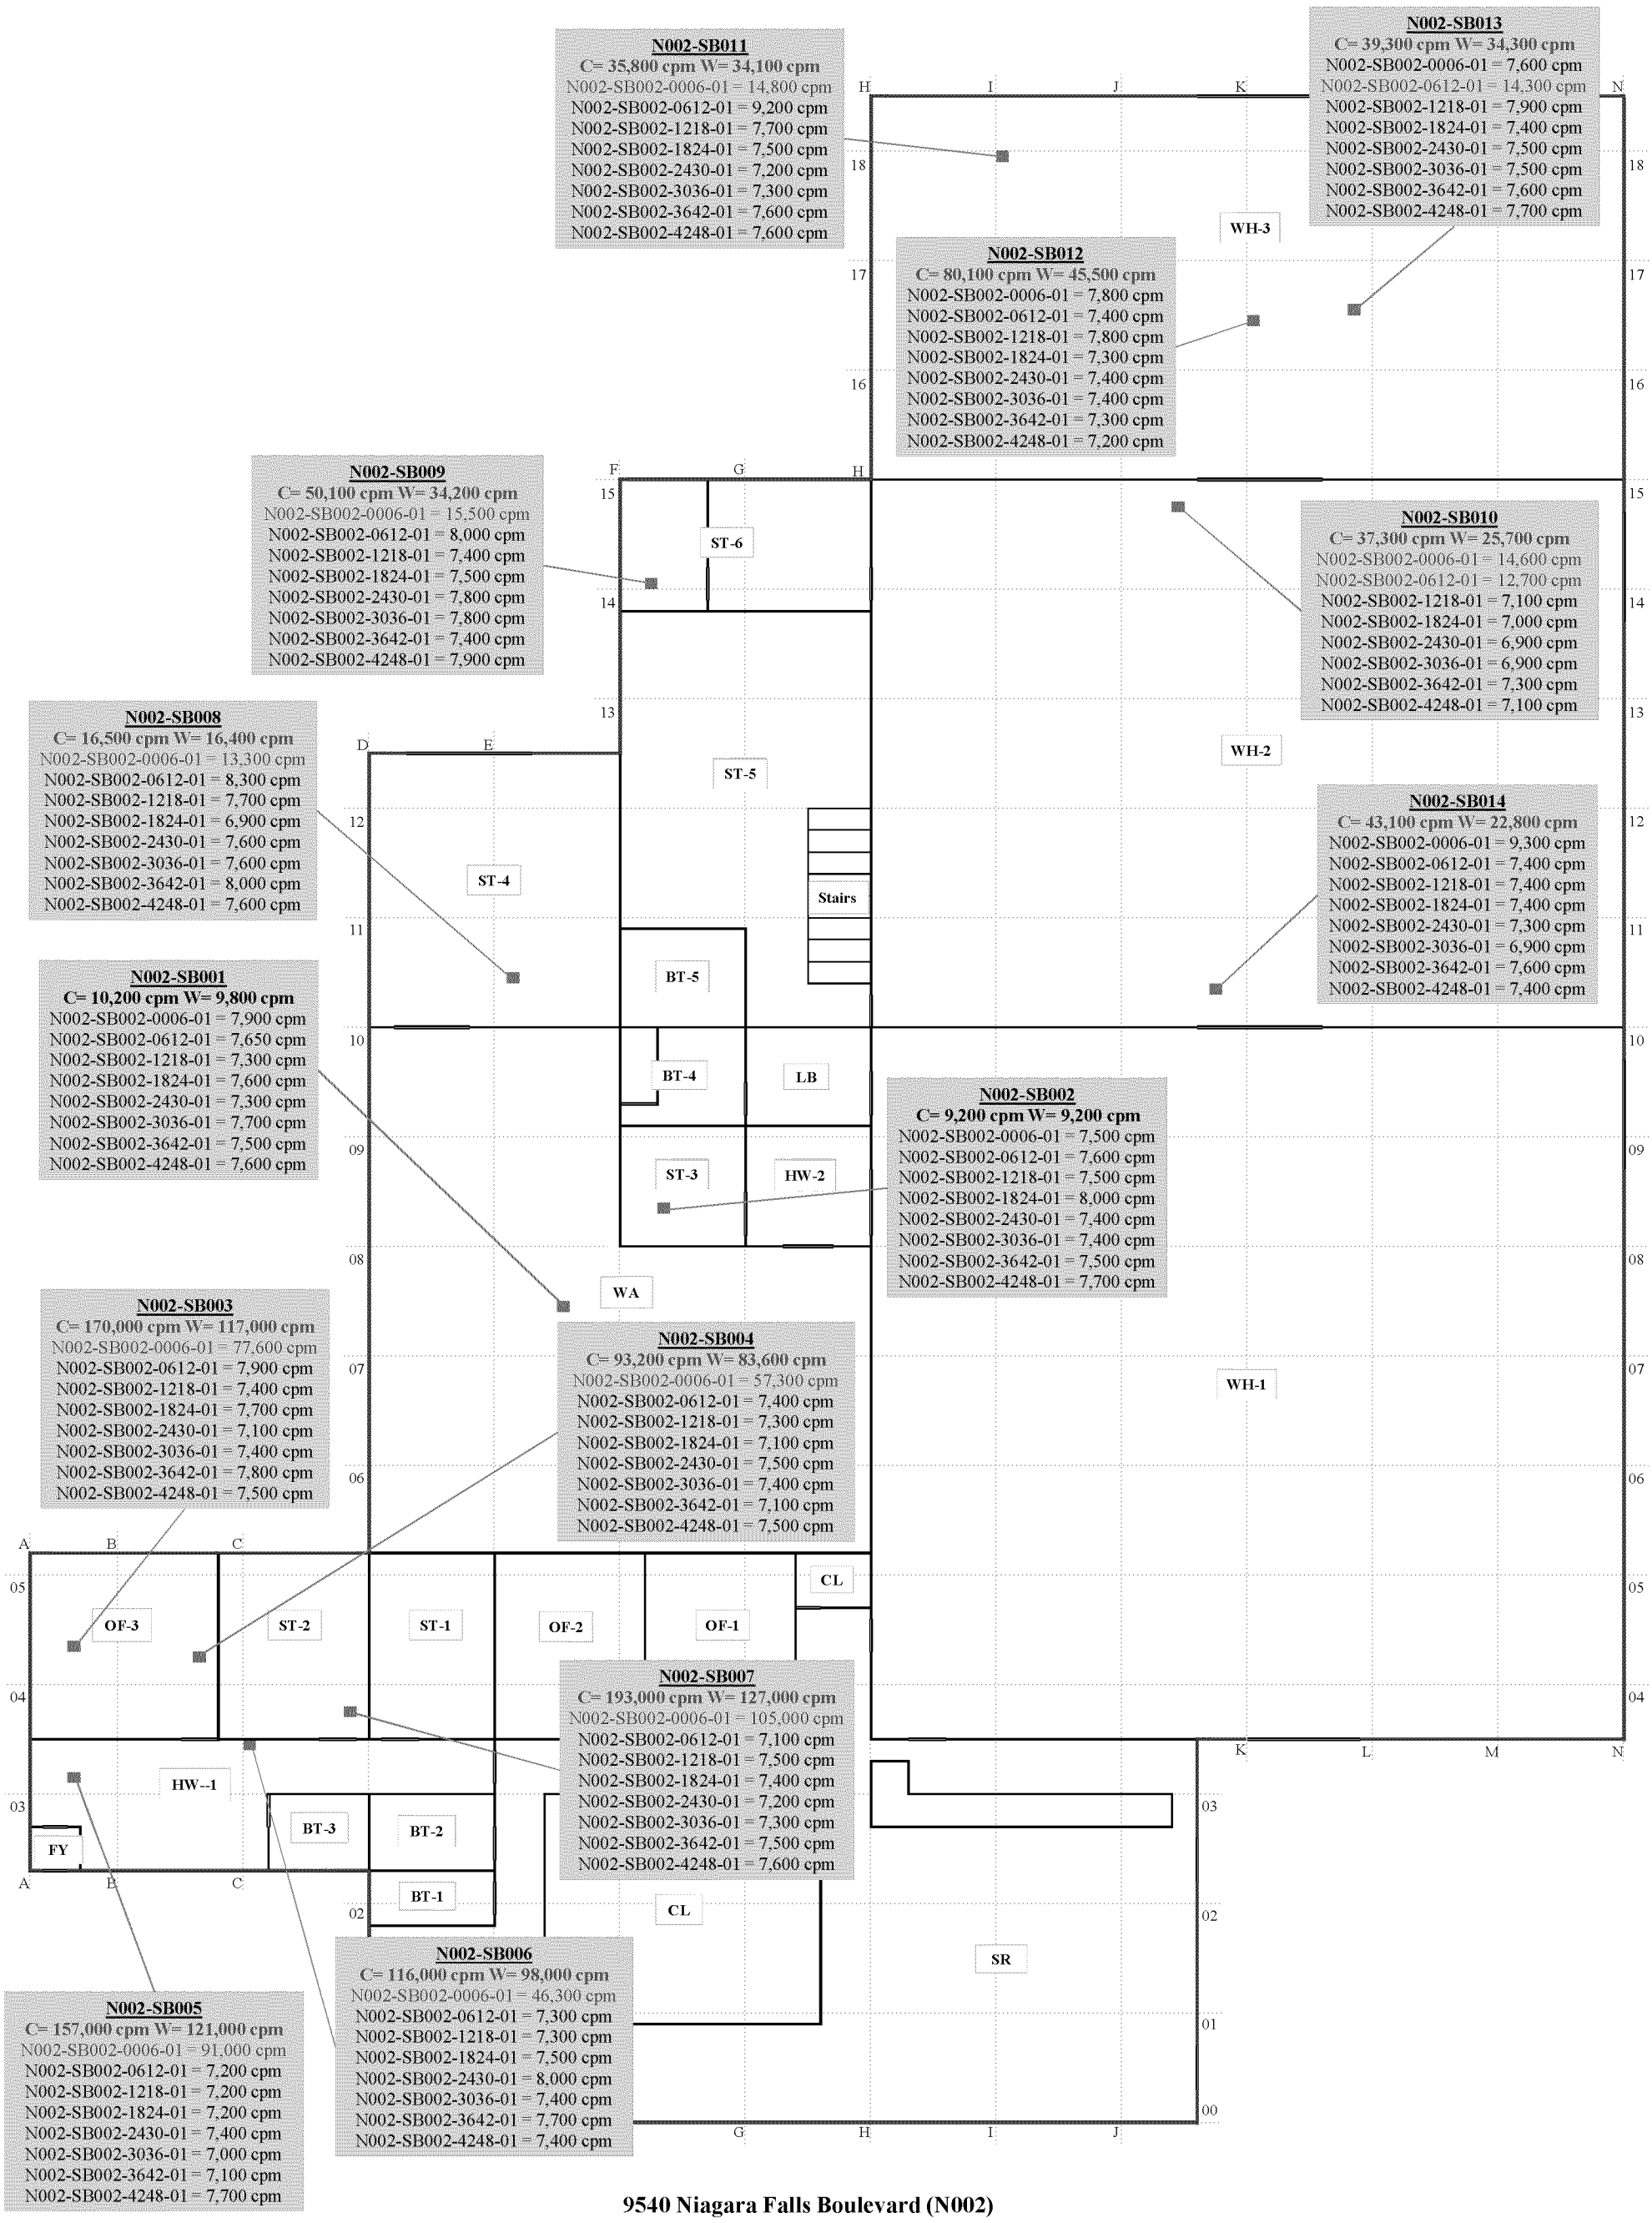
Soil Sample Location Gamma Screening Results collected at Waist (W) and Contact (C.)
Gamma Screening was conducted using Ludlum-2241.
Gamma Screening Results are in counts per minutes (cpm)
