9540 Niagara Falls Boulevard (N002)

Figure 2: Property N002 Soil Sample Gamma Screening Results Map

Niagara Falls Boulevard Radiological Site
Niagara Falls, New York

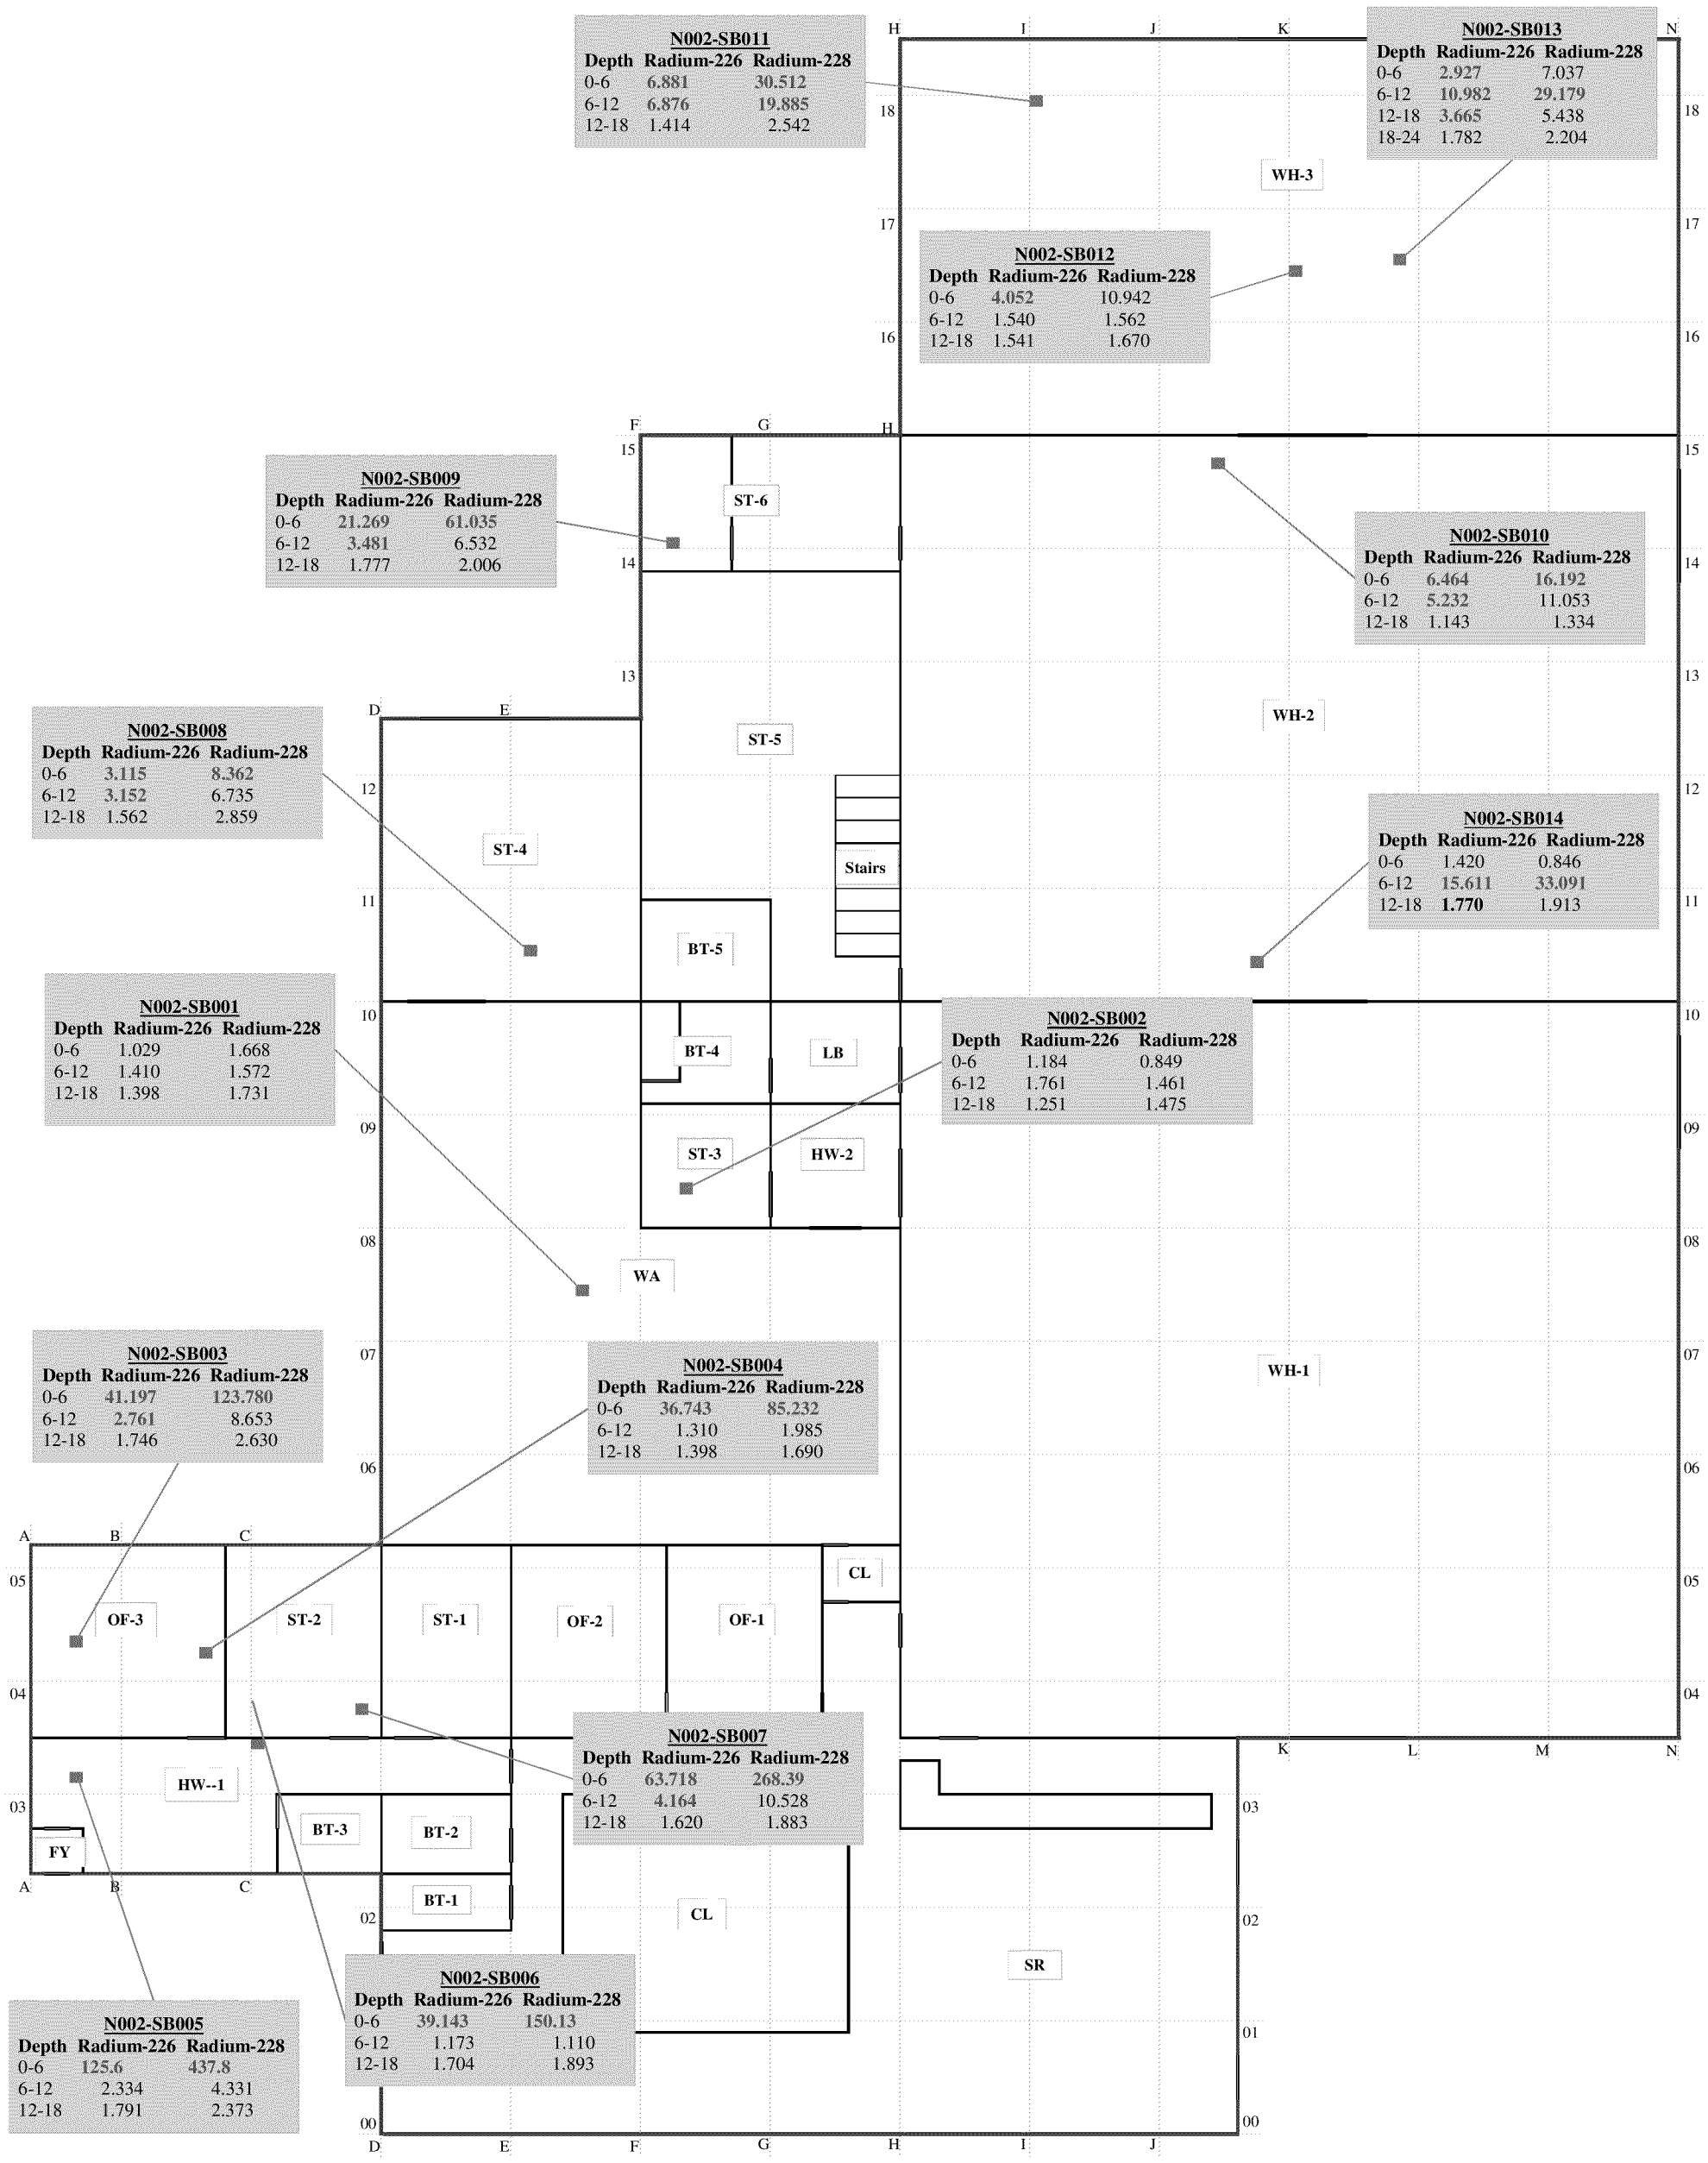
Results presented in picoCurie per gram (pCi/g).
Depth measurements presented in inches below bottomof concrete slab.
Revised: 2016-08-04
