March 31, 2016 Dico Site Visit

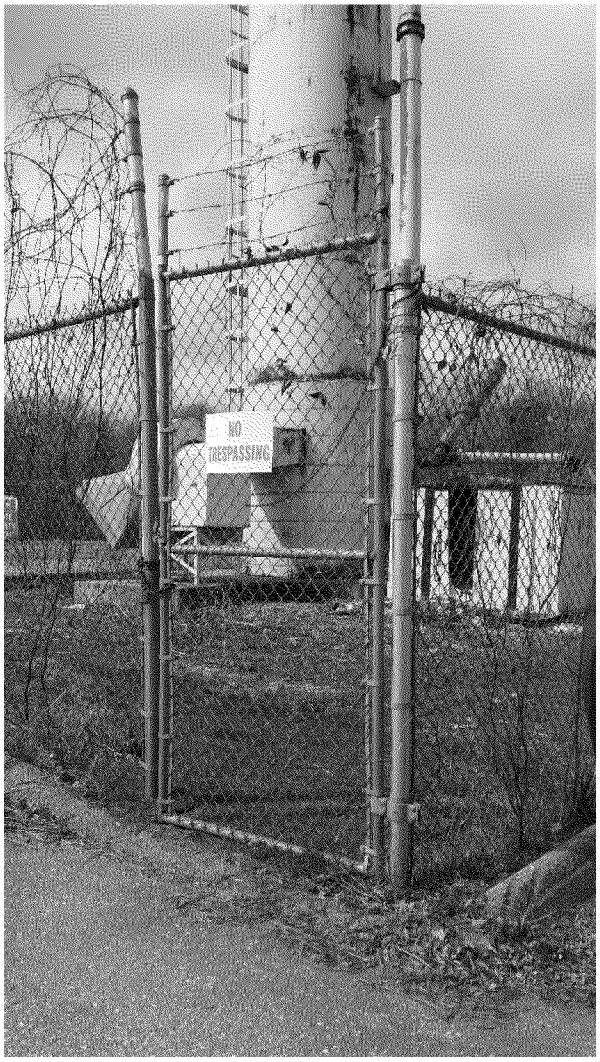
The treatment area was fenced, though Brian mentioned that at one time a homeless man was living in the attached shed. The area is completely surrounded by a chain link fence with barbed wire on top.
