CURRENT STATUS OF ARMY PROGRAM TO UPGRADE DEACTIVATION FURNACES TO MEET RCRA--LESSONS LEARNED

Jerry R. Miller
Chief APE Division
Directorate of Ammunition Equipment
Tooele Army Depot, Tooele, Utah 84074

Presented at the 27th
Department of Defense Explosive Safety Seminar
Sahara Hotel and Casino
Las Vegas, Nevada
20-22 August 1996

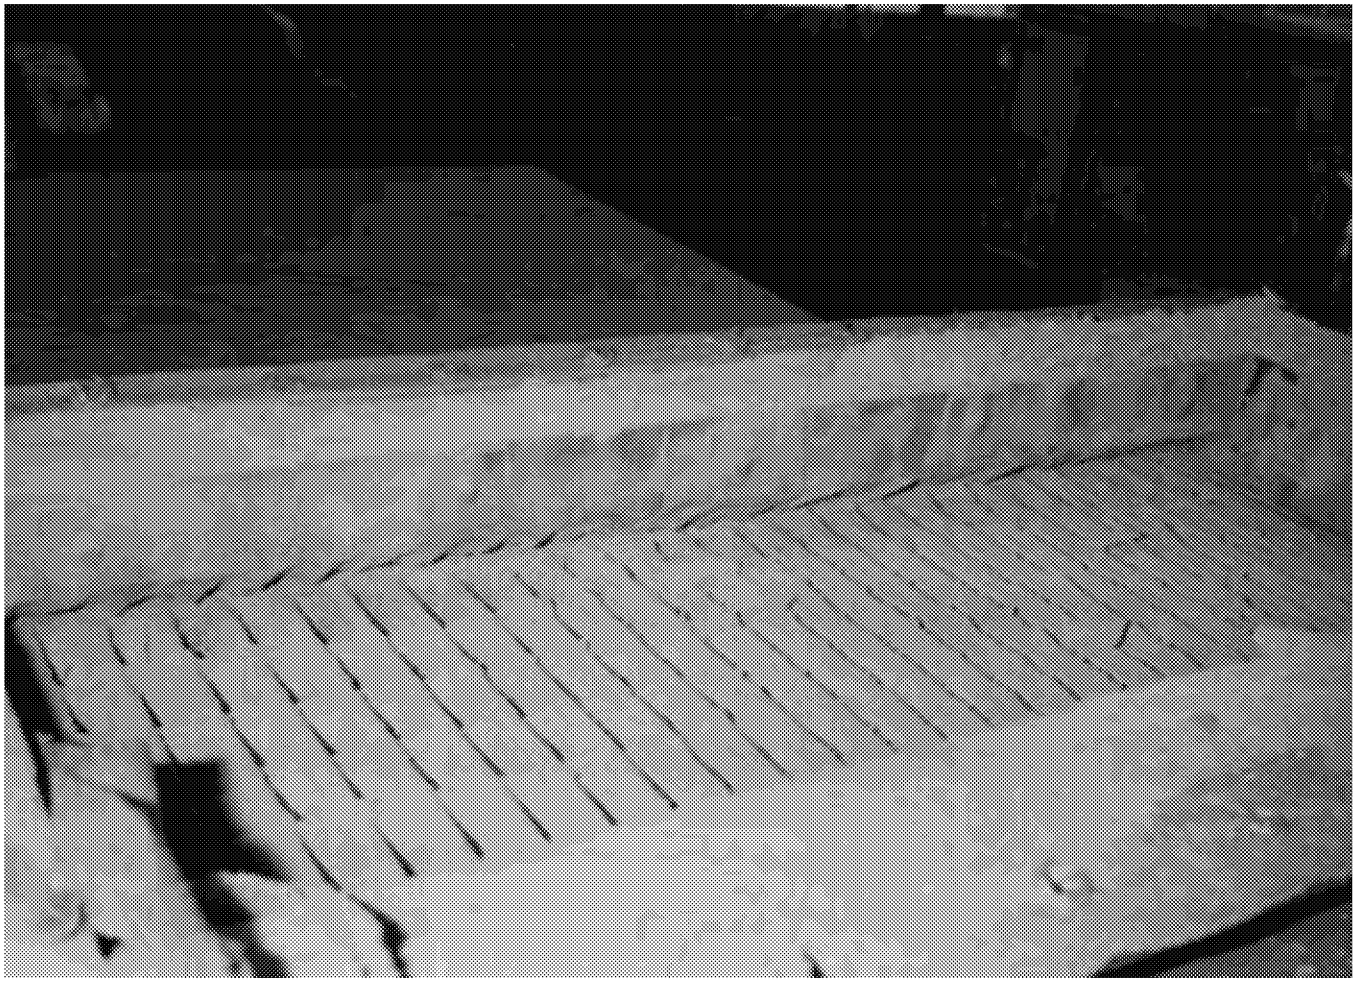
Pictures of the particulate plugging of two damaged high temperature gas coolers are given in Figures 3 and 4. A side view of one of the plugged high temperature gas coolers is shown in Figure 5. Cooling air flows through the plates and spacing observable in the picture. Figures 6 and 7 show the buildup of particulate on the walls of the ducting ahead of the coolers.

An extensive investigation followed the aborted TBT to try and resolve the gas cooler problems. The cooler block manufacturer was approached to assist in resolution of the corrosion problems. Particulate removed from the cooler was analyzed. The main constituents were barium, lead oxide and sulfate compounds.

Both plugging and warpage of the plates in hot side of the high temperature cooler block caused major loss of the furnace draft. Warpage of the plates was addressed by rerouting the cooling air through the high temperature gas cooler block. Originally the cooling air made one pass through both the hot (input) and cool (output) cooler block sections. The change routed all of the cooling air first through the hot side and then through the cool side. This change more effectively cooled the plates, thus minimizing warpage of the plates due to overheating.

FIGURE 3: TOP VIEW OF CLOGGED
HIGH TEMPERATURE GAS COOLER

repositioning of the cyclone between the furnace and the afterburner showed an advantage of removing most inorganics before they enter the afterburner and become molten causing premature damage and failure of the high temperature gas cooler (HTC) block. The addition of an expansion chamber, just ahead of the HTC, removed additional particulate from the flue gas stream and contributed to cooling the flue gas stream and solidification of the lead oxide prior to entering the HTC.

Clean out ports were added in the plenums above each section of the high and low temperature gas cooler blocks to allow for periodically checking the buildup of particulate on the edge of the plates. Through these ports mechanical cleaning/knocking loose of the particulate buildup could be performed. Also recommended, was to add inspection ports at strategic places in the ductwork to check on any buildup of residue on the inside of the ducting. The changes and modifications made at the TEAD Ammo Mission Furnace were provided, upon request, to all of the other furnace sites to assist them in improving their furnace system operations and obtaining their Part B operating permit.

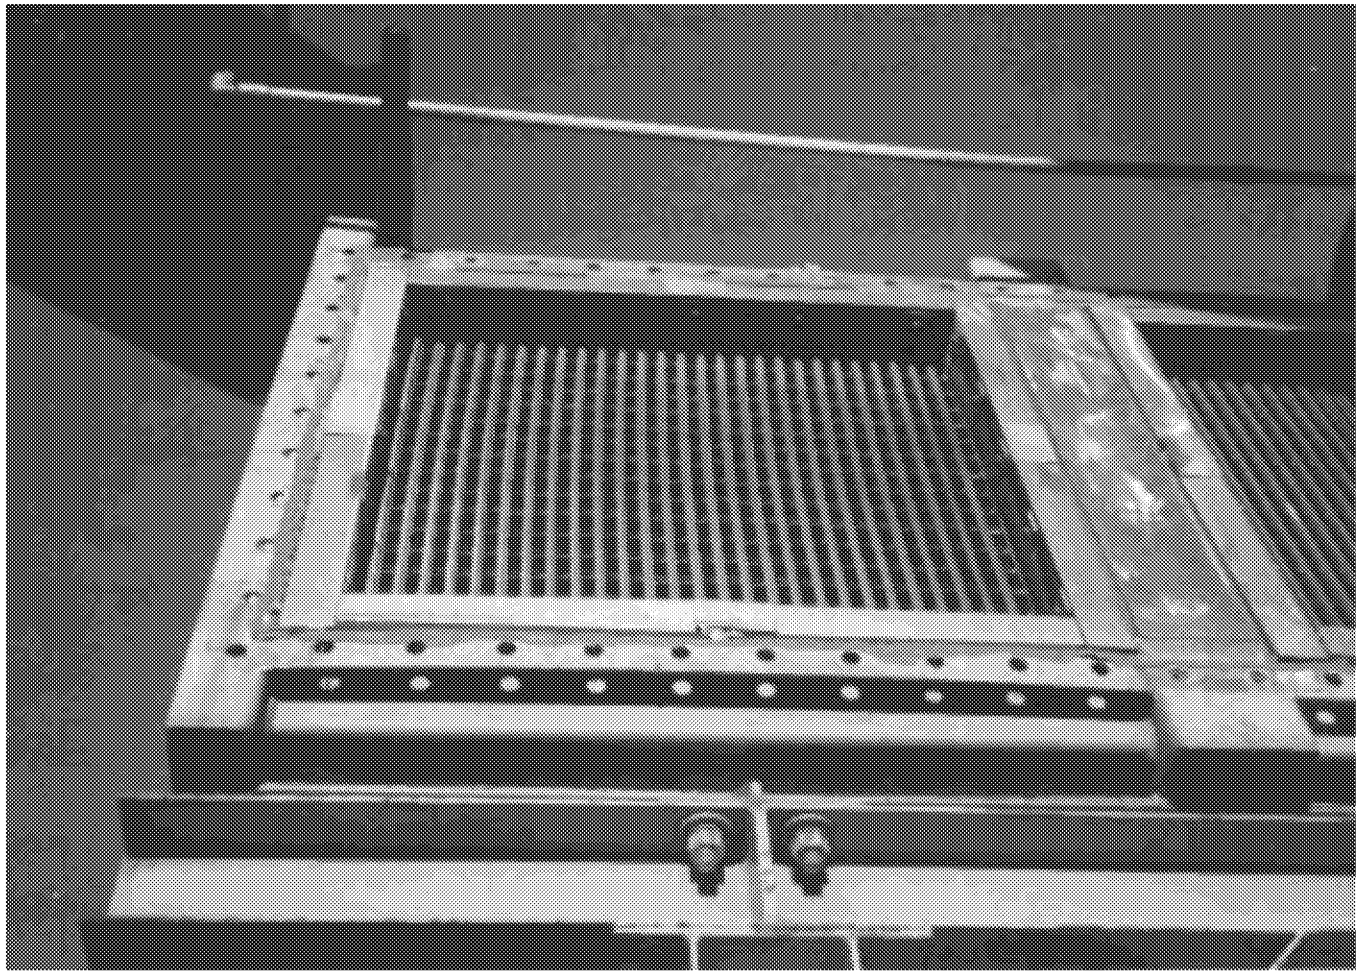
FIGURE 5: SIDE VIEW OF PLUGGED HIGH TEMPERATURE GAS COOLER SHOWING DISTORTED /WARPED PLATES

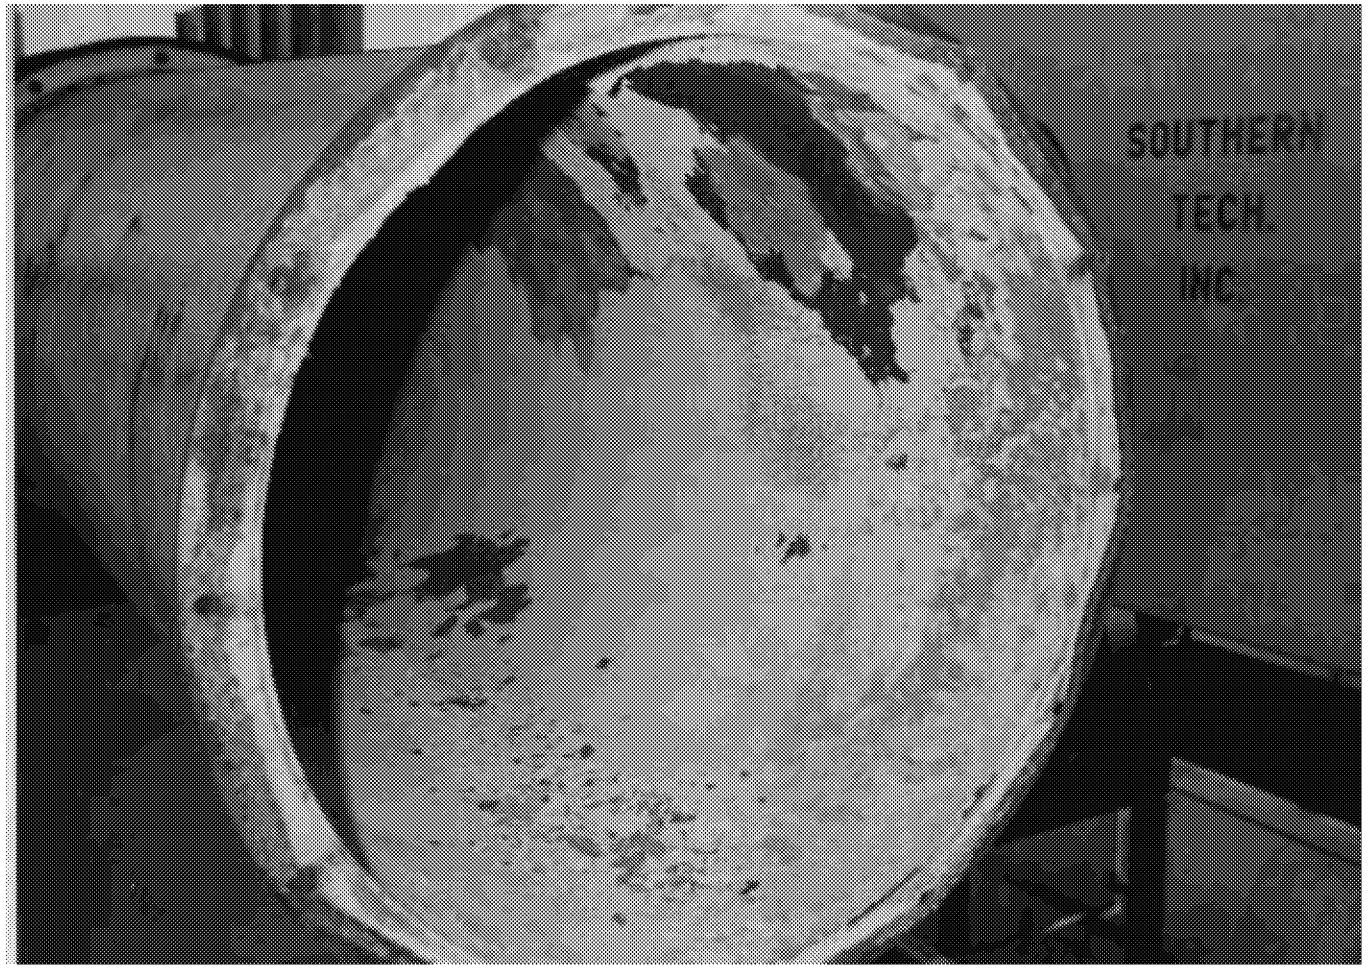
FIGURE 6: PARTICULATE COATING IN FURNACE DUCTING AHEAD OF HIGH TEMPERATURE GAS COOLER

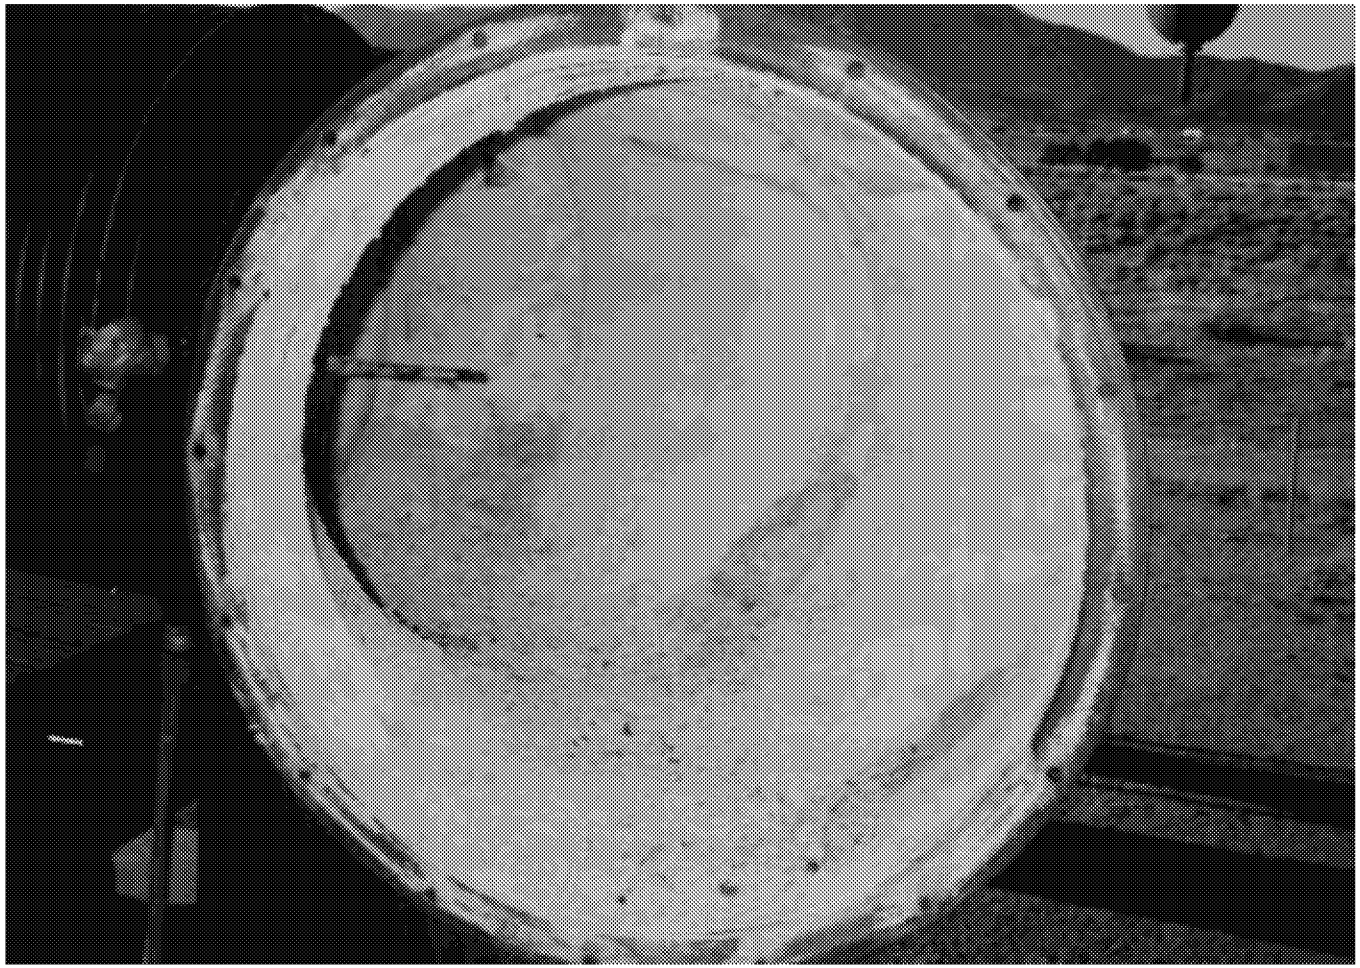
FIGURE 7: PARTICULATE COATING IN ANOTHER SECTION OF DUCTING AHEAD OF HIGH TEMPERATURE GAS COOLER

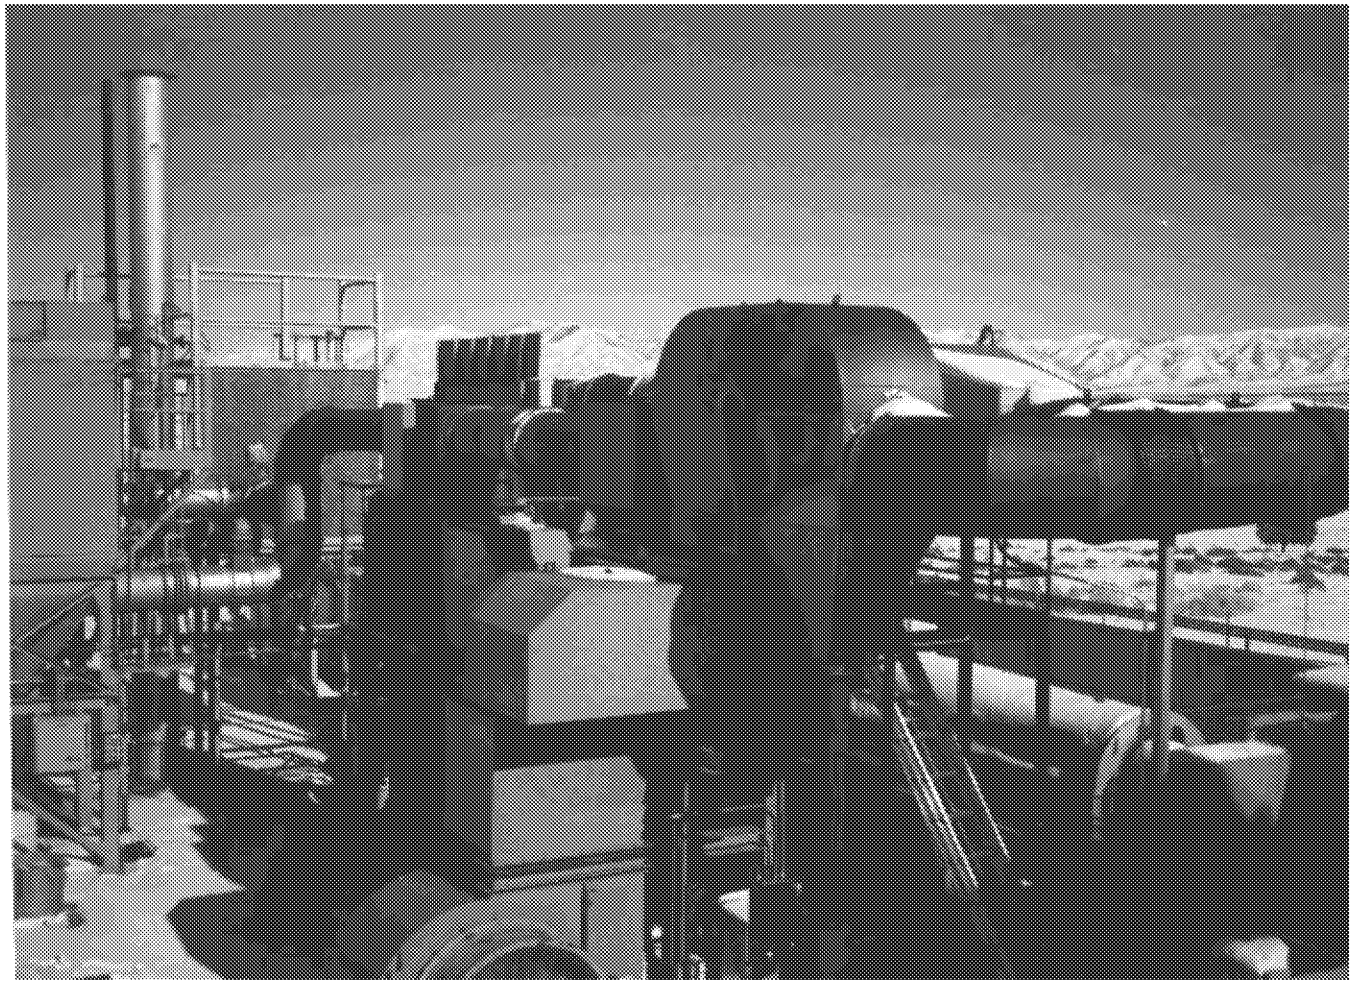
FIGURE 9: VIEW OF DEACTIVATION FURNACE SYSTEM
(EXPANSION CHAMBER AND HIGH TEMPERATURE GAS COOLER IN FOREGROUND)

The moving and installation of equipment at the TEAD Ammo mission furnace was completed in Feb 95. The cyclone was repositioned between the furnace and the afterburner. An AED designed expansion chamber was fabricated and installed just ahead of the high temperature gas cooler. A double tipping valve was installed as part of the expansion chamber. New ducting was fabricated and installed. Thermocouples have been installed at the afterburner and into the new ducting where needed. Conduit was installed and electrical wiring was completed. See Figures 8 & 9 for pictures showing the repositioned and added equipment.
