Leviathan Mine Site

Upper Pond Conveyance System (UPCS) Project

Daily Report

April 24, 2017

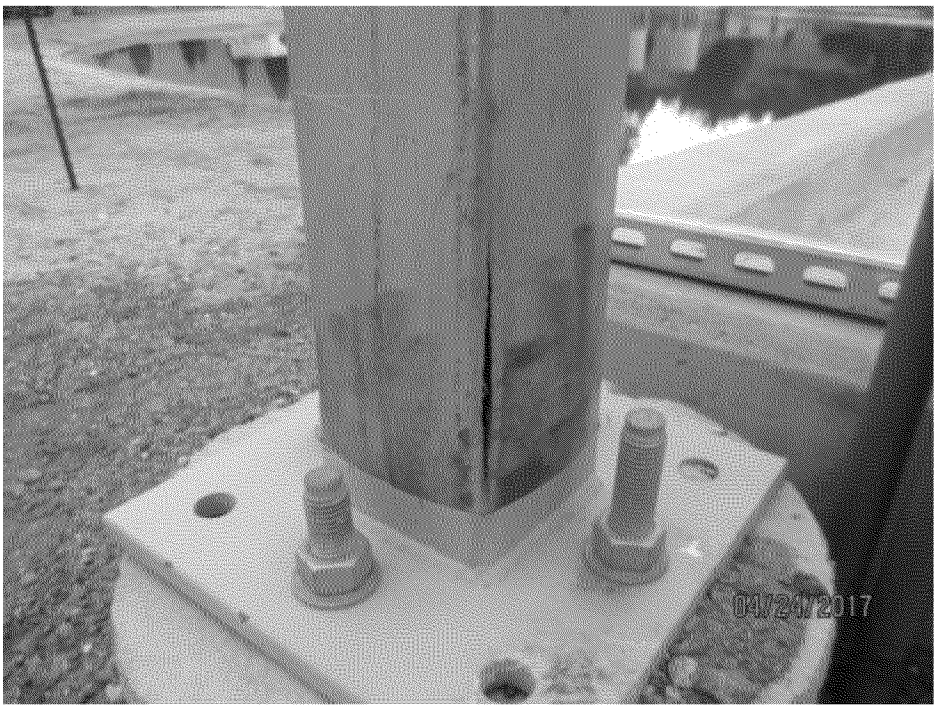
- Water has entered the interior of the control panel steel support pedestals, froze, expanded, and caused swelling of the steel supports near the base. The north pedestal at Pond 1 has cracked at the corner of the pedestal (see photos). Tops of pedestals need to be capped or weepholes added to prevent water from entering the interior. Steel support repair need to be determined by control panel vendor.

Pond 1 control panel steel support pedestal (cracked north pedestal).

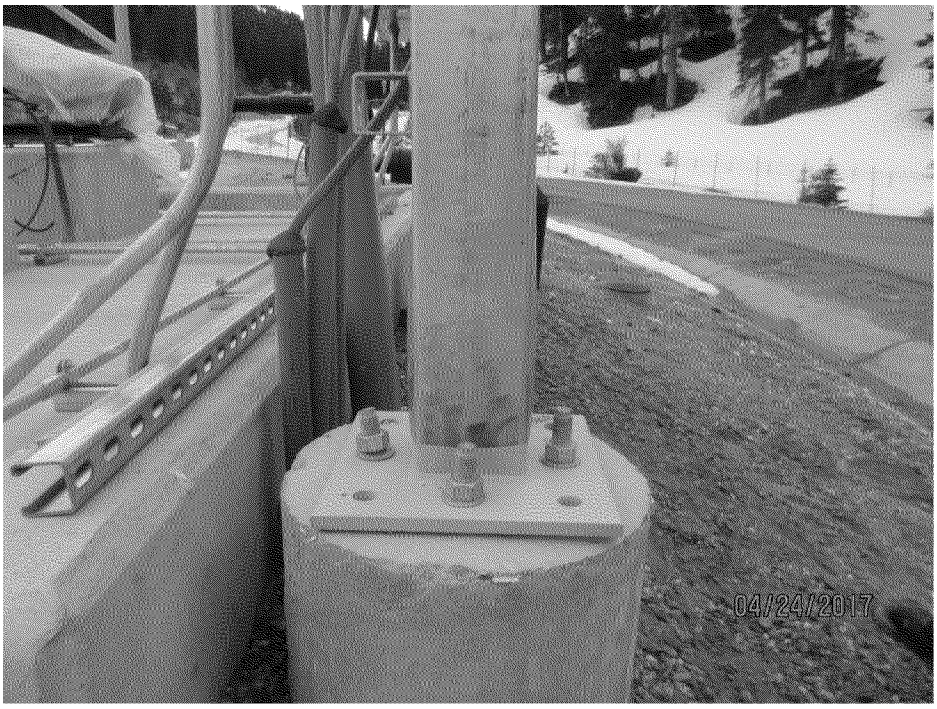
Swelled control panel steel support pedestal (at base).

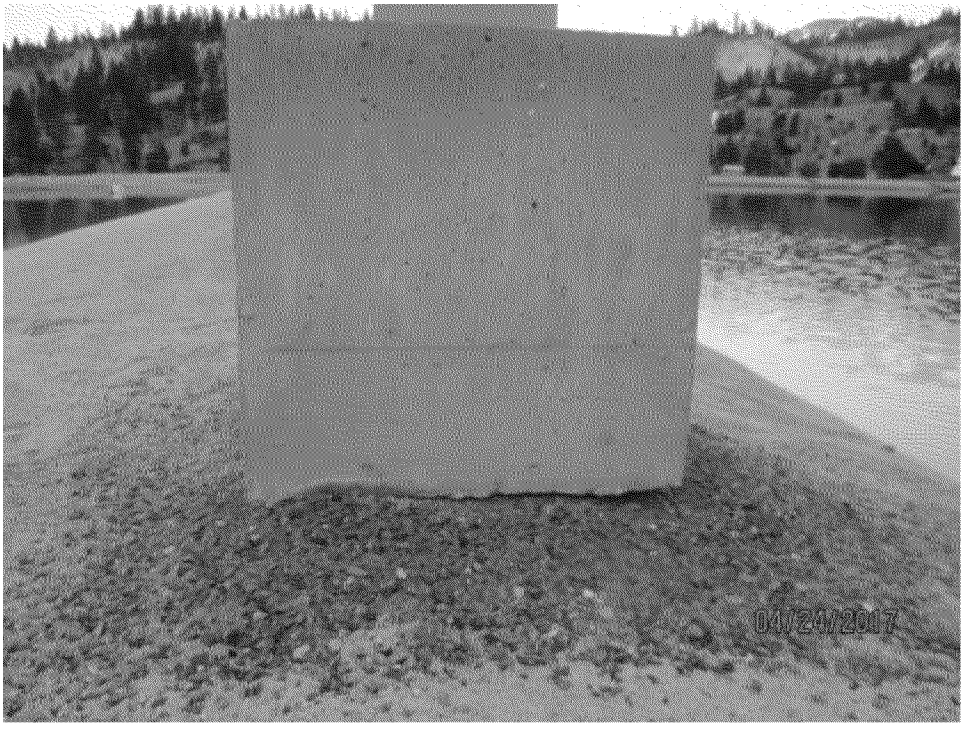
- Winter shutdown issues:
  - Base material under winch concrete pedestals has eroded/settled at the pond-side corners (see photos). South pedestal at Pond 1 appears to have tilted approximately 3 degrees toward pond. Other 3 pedestals at ponds do not appear to show signs of movement.

Eroded/settled foundation material at winch support (Pond 1 south).

Eroded/settled foundation material at winch support (Pond 2S west).

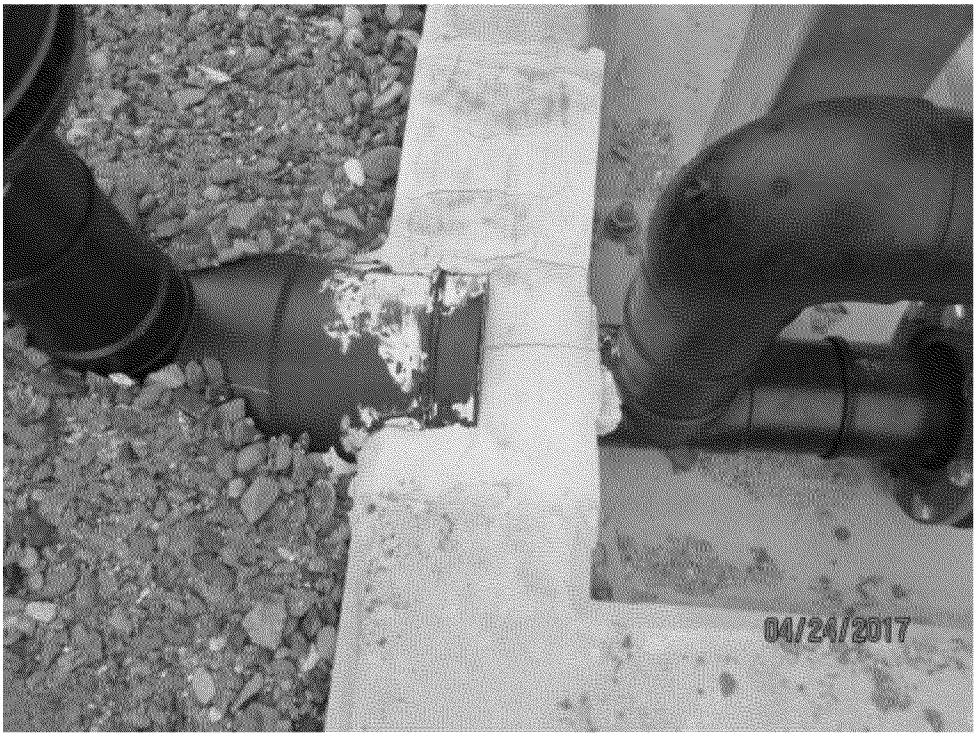
- Grout around discharge pipe at Pond 2S is cracking (see photos). Will need to be replaced/repaired.
  - Earthen pipe anchors along west side of Pond 4 are eroding and allowing minor pipe movement (see photos). Earth anchors need to be repaired or re-built with additional or potentially less erodable material.

South winch pedestal at Pond 1 is tilted ~3 degrees toward pond.

Cracked grout around Pond 2S pump station discharge pipe.

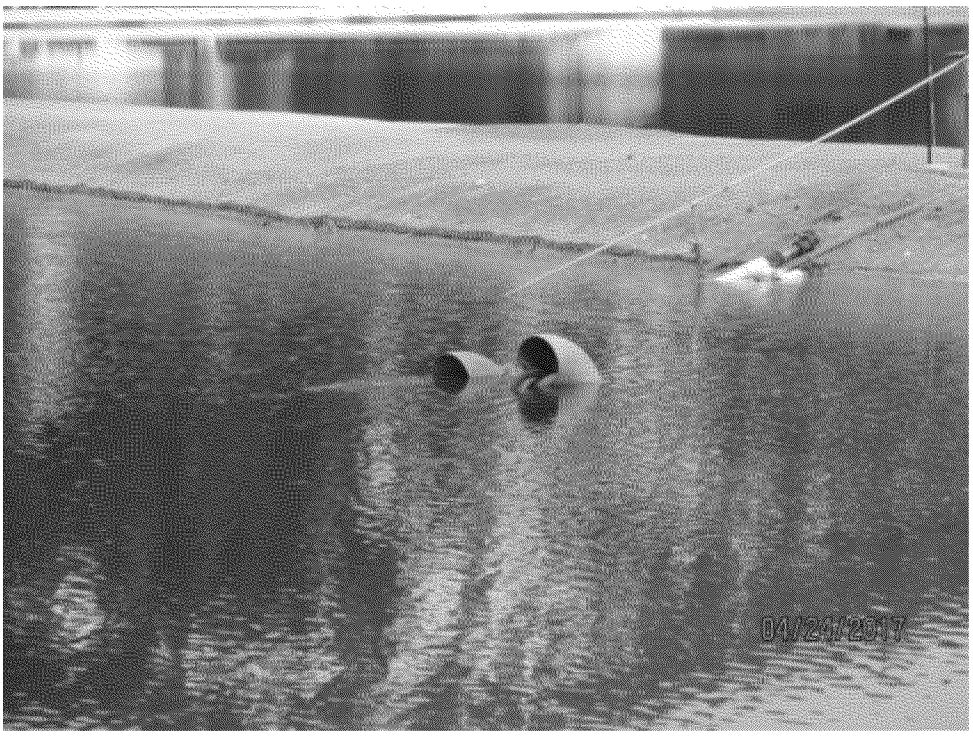
Pond 2S discharging through overflow pipe.

Eroded earthen pipe anchor west of Pond 4.
