Subject: **Hazardous Conditions Response Plan – Crusher Road Slope Instability**

CRUSHER ROAD SLOPE INSTABILITY
Leviathan Mine Site
Alpine County, California

ATTACHMENT A
CRUSHER ROAD SLOPE INSTABILITY PHOTOGRAPHS
Leviathan Mine Site
Alpine County, California

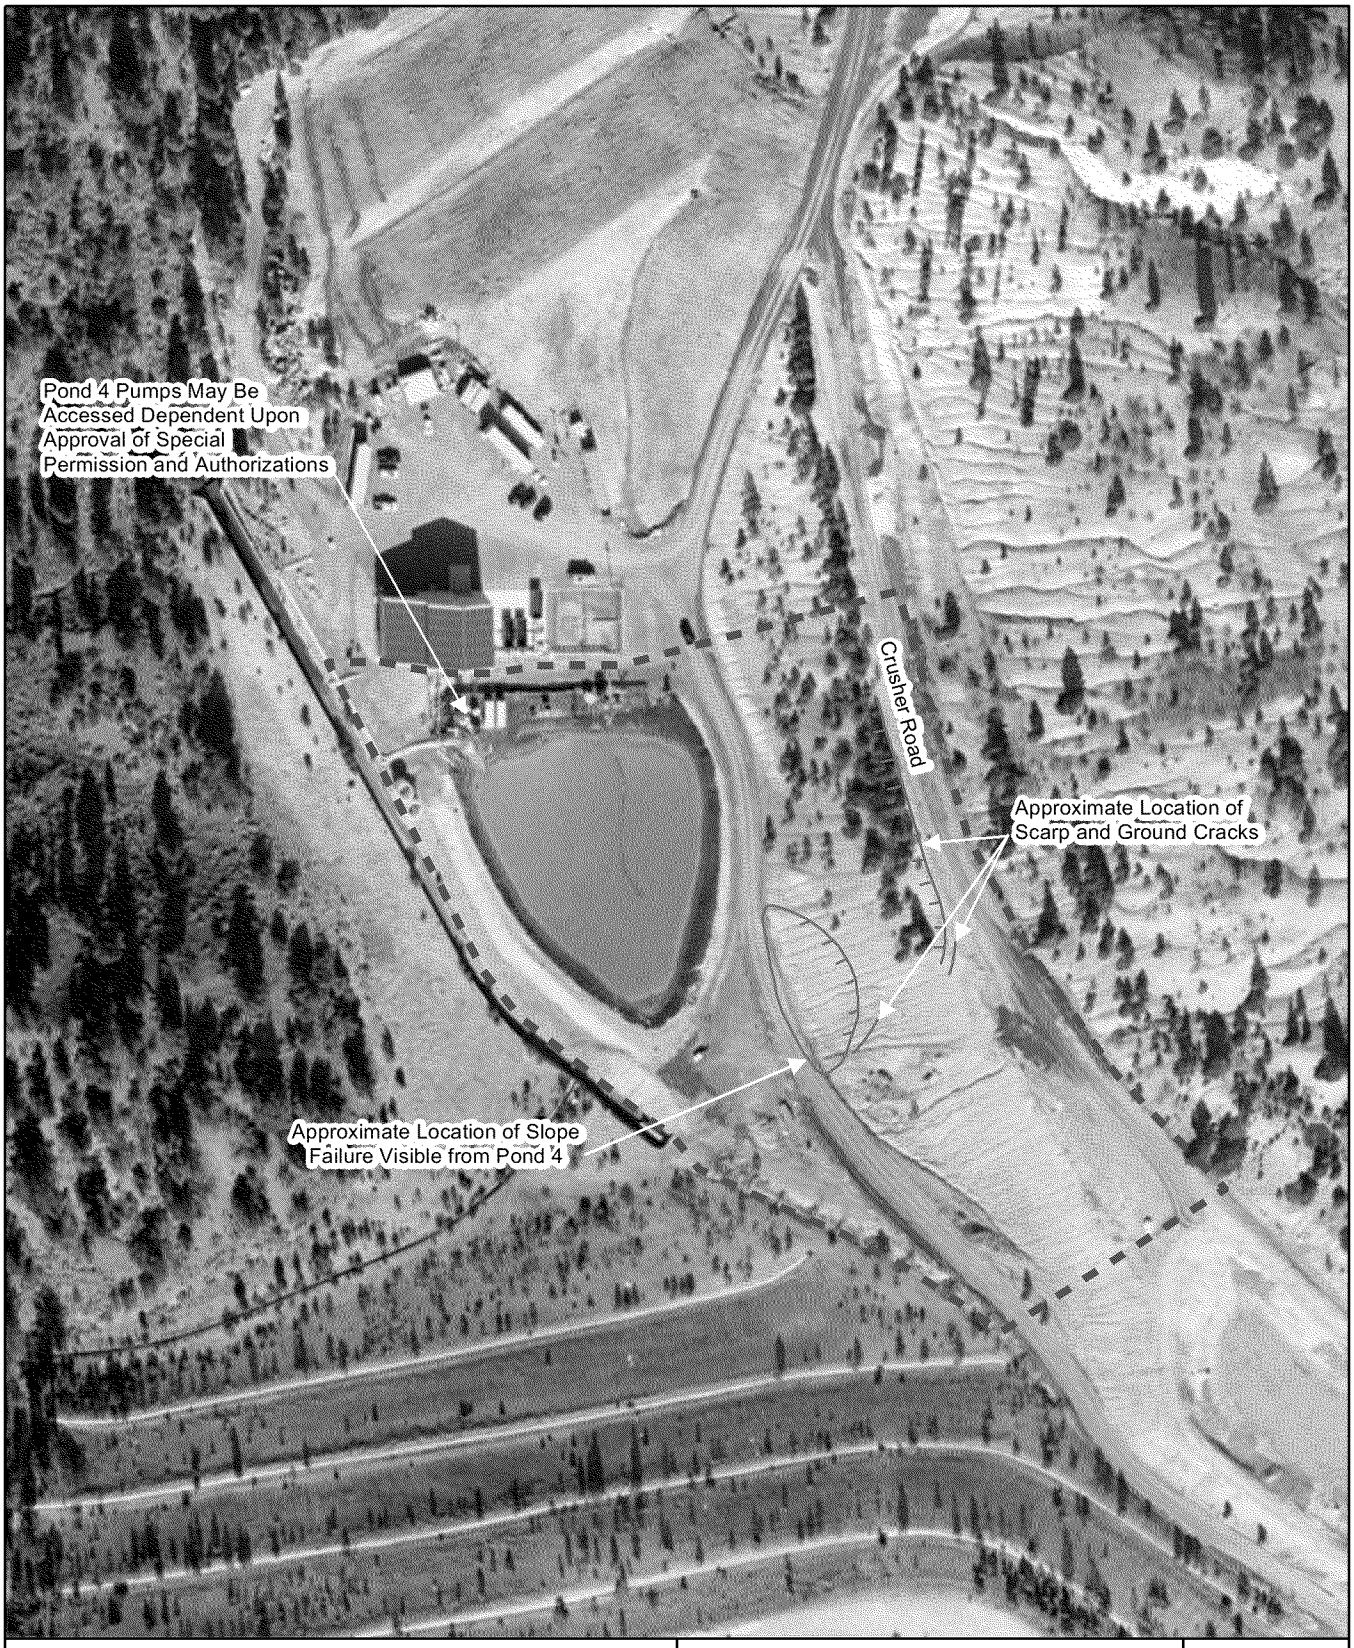
Figure 1

The area of the slope movement is located east of Pond 4, on the uphill slope immediately below the "Crusher Road" and is referred to herein as the Crusher Road Slope Instability. The upper limit (head) is defined by an approximately 200-foot-long zone of tension cracks and scarps located along the west edge of the Crusher Road. The lower limit (toe) is at the base of the slope east of the main site road adjacent to Pond 4, and extends out into the main access road near the southern end of Pond 4. The northern extent of the visible ground cracking is east of the approximate northern end of Pond 4. The southern extent of visible deformation features is approximately 50 feet south of southern edge of Pond 4. The approximate location of the tension cracks, scarps, and slump area of the Crusher Road Slope Instability are shown in Figure 1. Photographs that show site conditions April 28, 2017 and May 2, 2017 are provided in Appendix A.

- Tension cracks (ground cracks with no vertical offset) and scarps (ground cracks with vertical offset) along the west side of the Crusher Road.

- A subordinate slope deformation defined by scarps in an arcuate feature in the lower portion of the slope immediately east of the main site road adjacent to the south end of Pond 4.
- A toe bulge in the main site road adjacent to the southern portion of Pond 4.

Continued slope deformation has occurred in the days following discovery of the Crusher Road Slope Instability. Based on current information, it is reasonable to assume that unstable material within the observed extent of the slide will continue to move. There is uncertainty with regards to the velocity, total travel distance, and extent of future slope movements.

This memorandum establishes an exclusion zone in the vicinity of the Crusher Road Slope Instability. The purpose of this exclusion zone is to minimize the potential hazard exposure to personnel. It is not intended to control possible damage to infrastructure.

Barriers have been placed on the road adjacent to Pond 4 to demarcate the north and south ends of the exclusion zone. Similar barriers were installed on the Crusher Road north of the northern extent of the Crusher Road Slope Instability.

The exclusion zone is shown on Figure 1.

- **The Atlantic Richfield workforce, with the exception noted below, are prohibited from entering the exclusion zone until further notice. This includes entering the exclusion zone on foot, via a vehicle, and via equipment.**
  - The exception is that trained and competent personnel who are evaluating geotechnical conditions and/or conditions that affect safety are allowed to enter the exclusion zone as needed to conduct these evaluations.
  - Permission for entering the exclusion zone to conduct geotechnical evaluations or other work must be requested from site Health, Safety, Security, and Environment (HSSE) personnel prior to entry. Entry will be allowed only if proper HSSE protocols are in place and permission is granted.

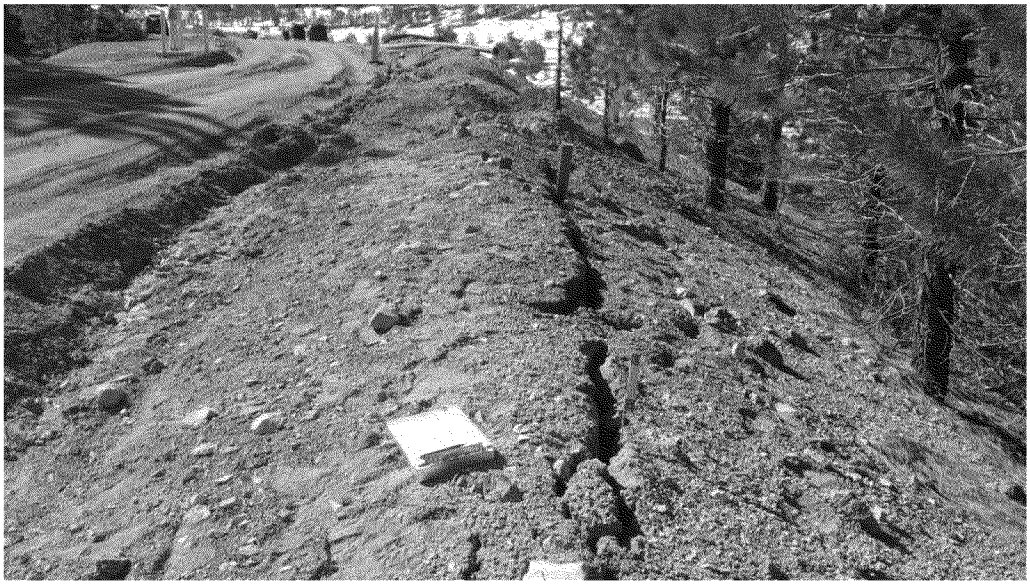
Photograph A3: Scarp forming at top of Crusher Road slope. View looking south. Photo taken April 28, 2017.

Photograph A4: Scarp forming at top of Crusher Road slope. View looking East. Photo taken May 2, 2017.
