TECHNICAL MEMORANDUM

TO: Lynda Deschambault, U.S. EPA
FROM: Mike Johnson, P.E.
SUBJECT: February 1, 2017 – Field Observations
DATE: February 3, 2017

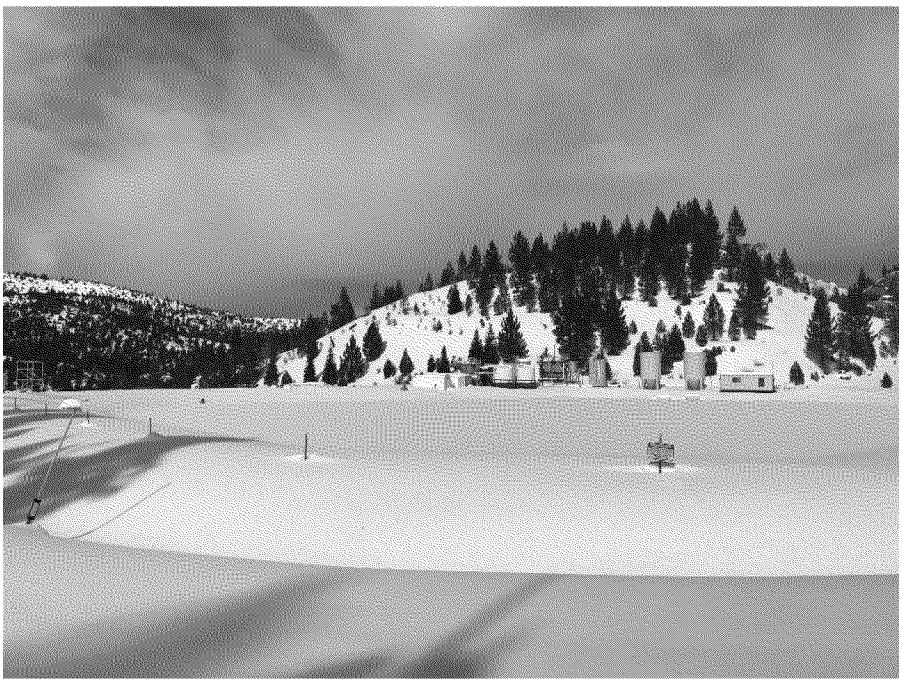
Photograph 1: Pond 1

The pond water (snow) levels in Pond 1, Pond 2S, Pond 2N, Pond 3, and Pond 4 were all below the overflow structures as seen in the Photographs 1 through 5.
