Atlantic Richfield Company

April 18, 2017

RE: Leviathan Mine Site: Update on Limited Access Season Site Conditions April 5 - 12, 2017

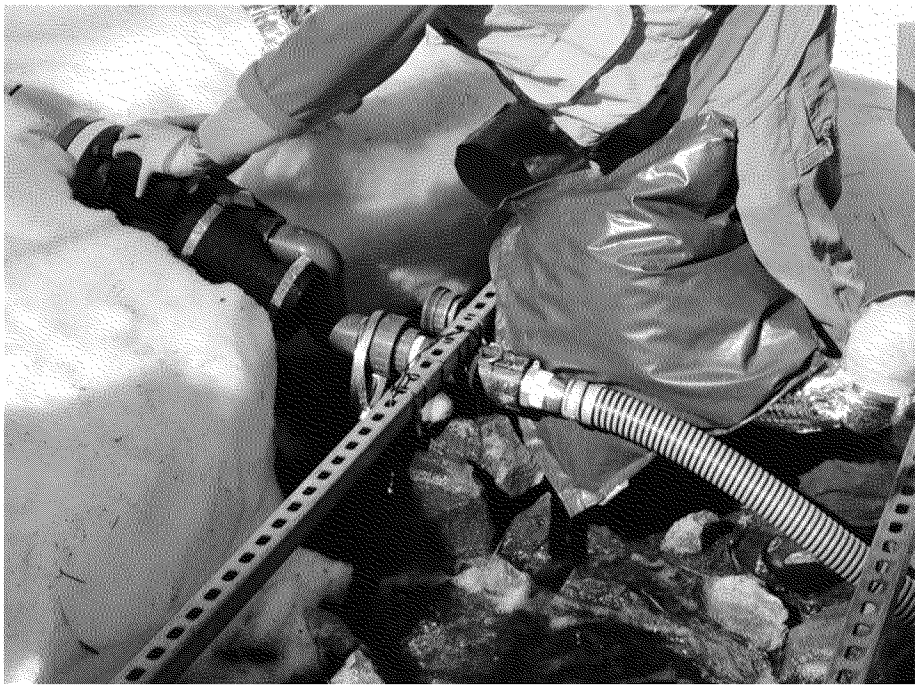
April 6, 2017: ASB-Pond 4 before piping modificat ions and siphoning.

April 6, 2017: ASB-Pond 4 after piping modifica tions and siphoning.

Copper Environmental personnel accessed the ASB on April 6, 2017. Personnel cleared debris from the Pond 4 effluent launder, increased the diameter of the outlet piping from 1-inch to 2-inch, and disconnected the 1-inch in-line flow meter. They also pumped approximately 21,000 gallons of treated water out of ASB-Pond 4 to the aeration channel to lower the pond water level. Treated effluent continued to discharge from ASB-Pond 4 to the aeration channel following these modifications.

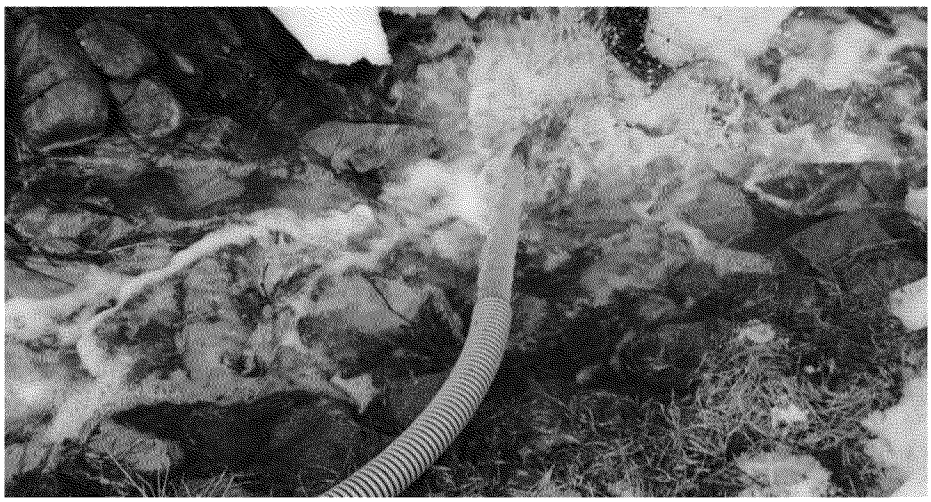
April 6, 2016: Replacement 2-inch effluent line d ischarging to aeration channel.

April 6, 2017: ASB-Pond 4 treated effluent discharged through 2" pipe to aeration channel.

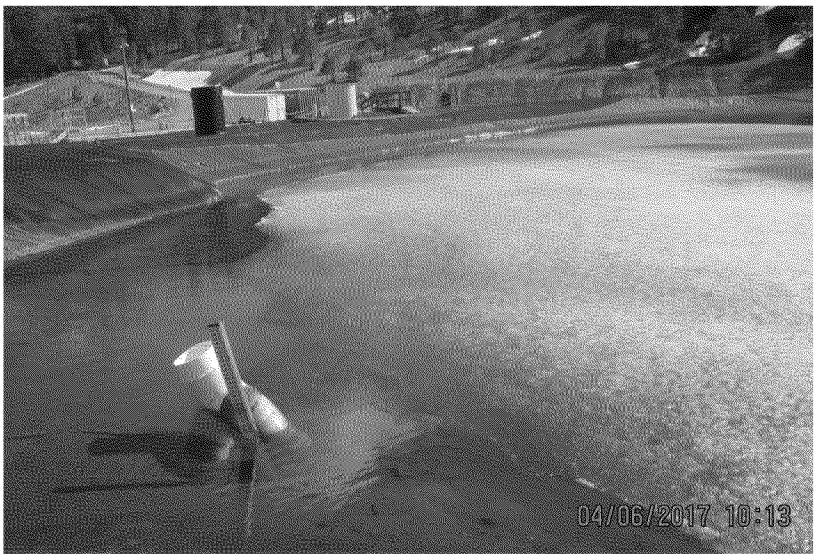
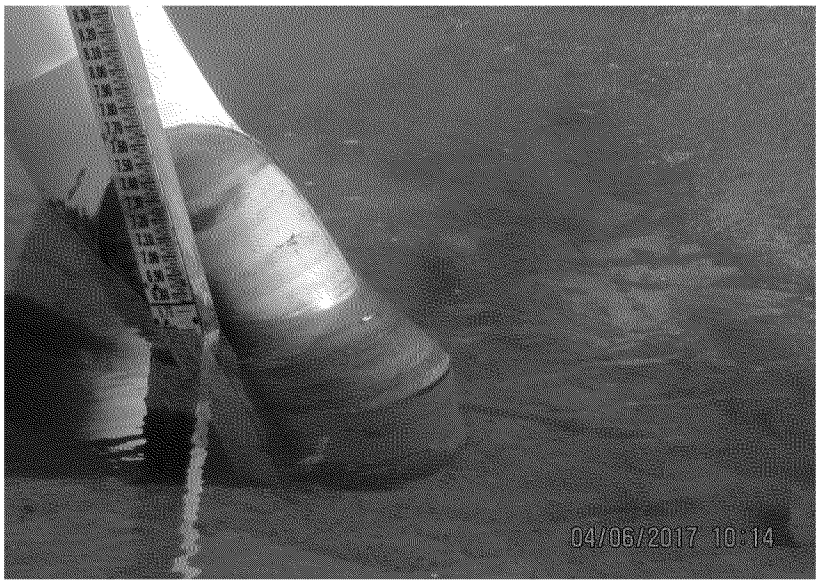
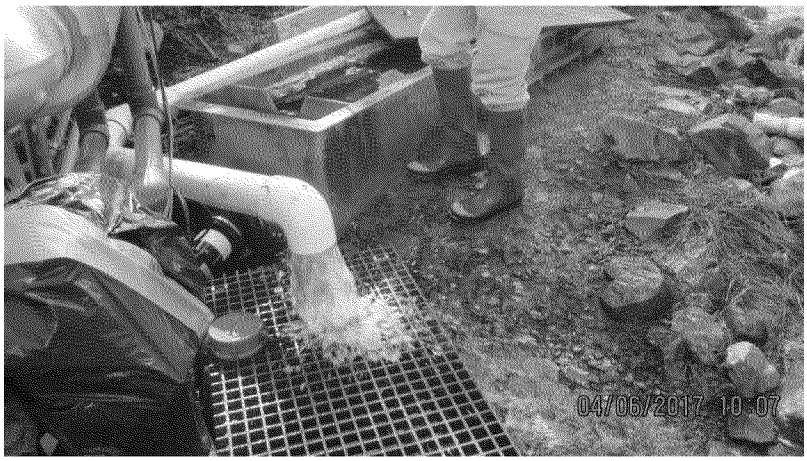
On April 6, 2017, at approximately 3:30 PM PDT, Atlantic Richfield received word from the LRWQCB that a connection on the overflow riser pipe assembly in Pond 4 (near the HDS

treatment building) had separated a few inches below the water line, and as a result, water was discharging through the overflow pipe to Leviathan Creek. Photographs sent by the LRWQCB are shown below:

It appeared from the photos that the separation may have resulted from ice pushing against the riser pipe asasembly. Atlantic Richfield does not normally have personnel at the site at this time of year, and the pipe separation was not the result of any human-caused activity. It also appeared that there were only a few inches of standing water in Pond 4 above the pipe separation, and the section of pipe below the separation was intact. According to Doug Carey, LRWQCB Board crews who were at the site earlier in the week did not observe any discharge from the Pond 4 overflow pipe, so we assume the separation occurred sometime between April 4 and April 6, 2017. pH measurements from EPA's data sonde in Leviathan Creek at 4L did not suggest that the resulting discharge from Pond 4 was having any significant effect on surface water quality during this time:

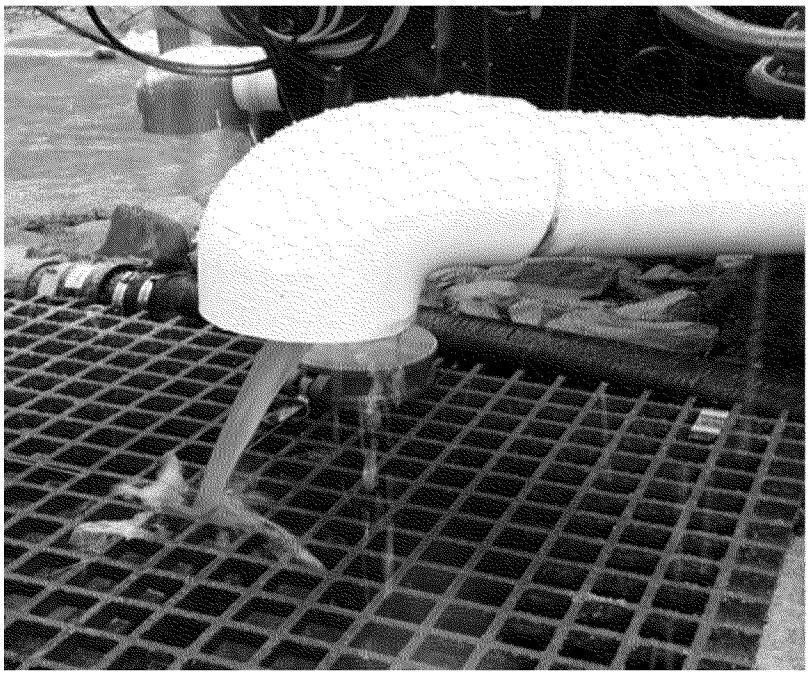
April 7, 2017: Overflow pipe discharge while Pond 4 pipe riser assembly was being removed and re-set.

April 7, 2017: Overflow pipe discharge after re-setting of the Pond 4 pipe riser assembly.

On April 7, 2017, Copper Environmental field personnel entered the site, despite poor weather conditions (sleet and snow). Personnel waded into Pond 4 and re-set the overflow pipe riser assembly into the lower pipe receiver as best they could. Personnel also placed temporary sandbags around the pipe riser assembly in an attempt to stabilize the piping. Discharge from Pond 4 through the discharge pipe increased briefly while the piper rise assembly was being removed and then reset. After resetting the assembly, the discharge rate decreased, but flow was not completely stopped. As a result, Copper began formulating plans for additional, more permanent repairs to the pipe riser assembly to be made the following week.

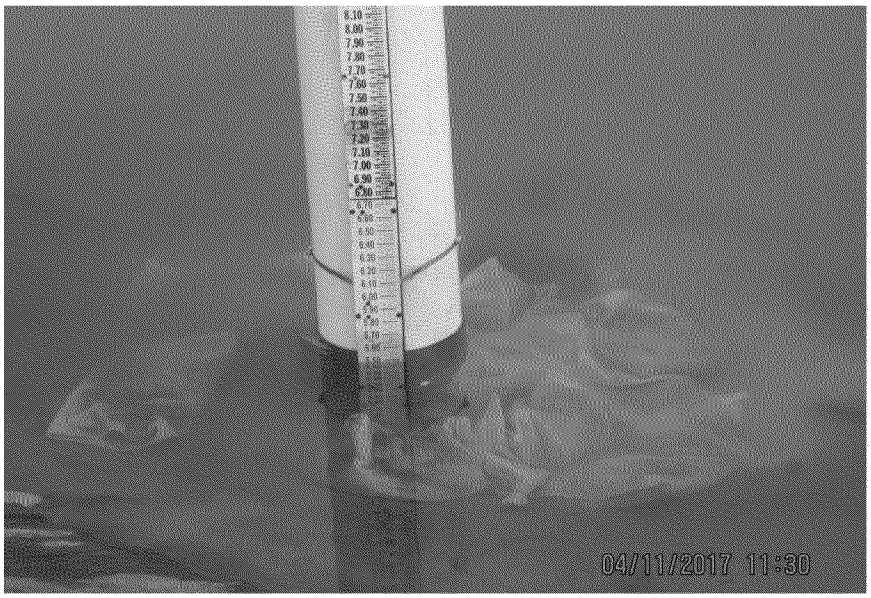
April 11, 2017: Repaired pipe riser assembly. Pond water level at 5.50'.

On April 11, 2017, crews returned to the site to complete more permanent repairs to the Pond 4 pipe riser assembly. A new stand pipe was inserted into the lower pipe receiver and better stabilized with appropriate fittings and clamps. The pond water level staff gage was also re-set, and some of the sand bags were removed. Following these additional repairs, no flow was observed from the discharge pipe outlet. Photographs showing conditions following these additional repairs are provided below:

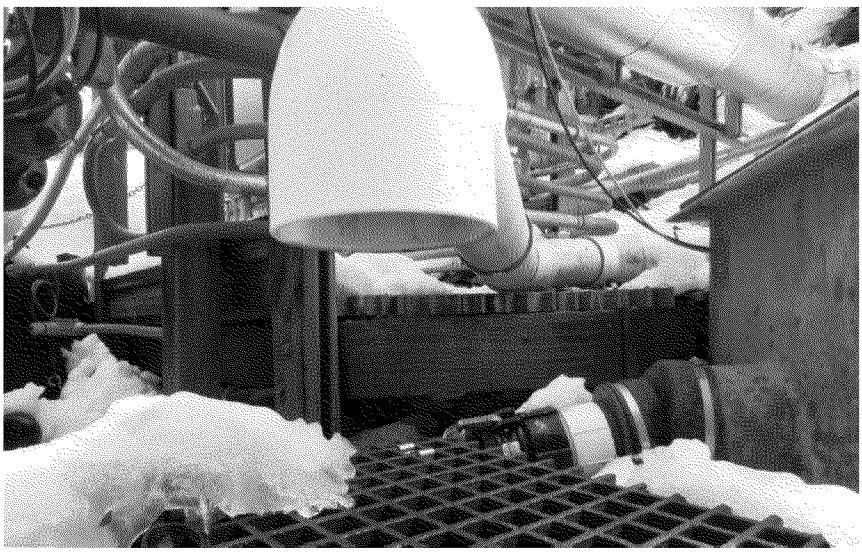
April 11, 2017: Discharge pipe outlet following re pairs to pipe riser assembly.
