To: anthony.brown@bp.com[anthony.brown@bp.com]
Cc: gr@burlesonconsulting.com[gr@burlesonconsulting.com]; Mike Johnson[mike.johnson@copperenv.com]; Doug Carey[douglas.carey@waterboards.ca.gov]; Cory Koger[Cory.S.Koger@usace.army.mil]; lily tavassoli (tavassoli.lily@epa.gov)[tavassoli.lily@epa.gov]
From: Deschambault, Lynda
Sent: Wed 4/12/2017 5:16:46 PM
Subject: RE: Leviathan Mine Aspen Seep Bioreactor update

From: Mike Johnson [mailto:mike.johnson@copperenv.com]
Sent: Friday, April 07, 2017 12:00 PM
To: Deschambault, Lynda <Deschambault.Lynda@epa.gov>; anthony.brown@bp.com
Cc: gr@burlesonconsulting.com
Subject: FW: Leviathan Mine Aspen Seep Bioreactor update

From: Mike Johnson [mailto:mike.johnson@copperenv.com]
Sent: Wednesday, April 05, 2017 6:07 PM
To: Deschambault, Lynda <Deschambault.Lynda@epa.gov>
Cc: gr@burlesonconsulting.com; Dave McCarthy <dave.mccarthy@copperenv.com>; Cohen, Adam <Adam.Cohen@dgslaw.com>
Subject: Leviathan Mine Aspen Seep Bioreactor update

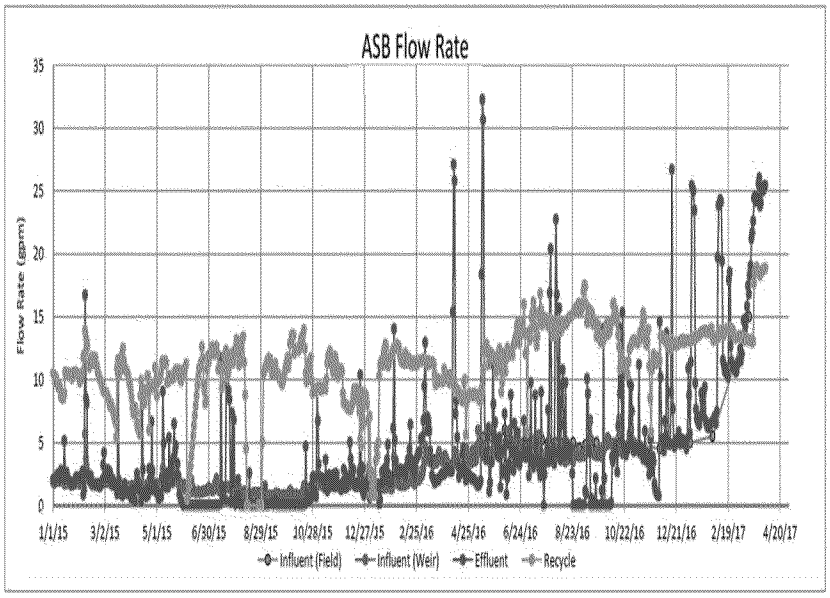
1) **Flow Rates**: Could you please provide some additional updates on charts and figures regarding flow, freeboard etc? For instance this one:

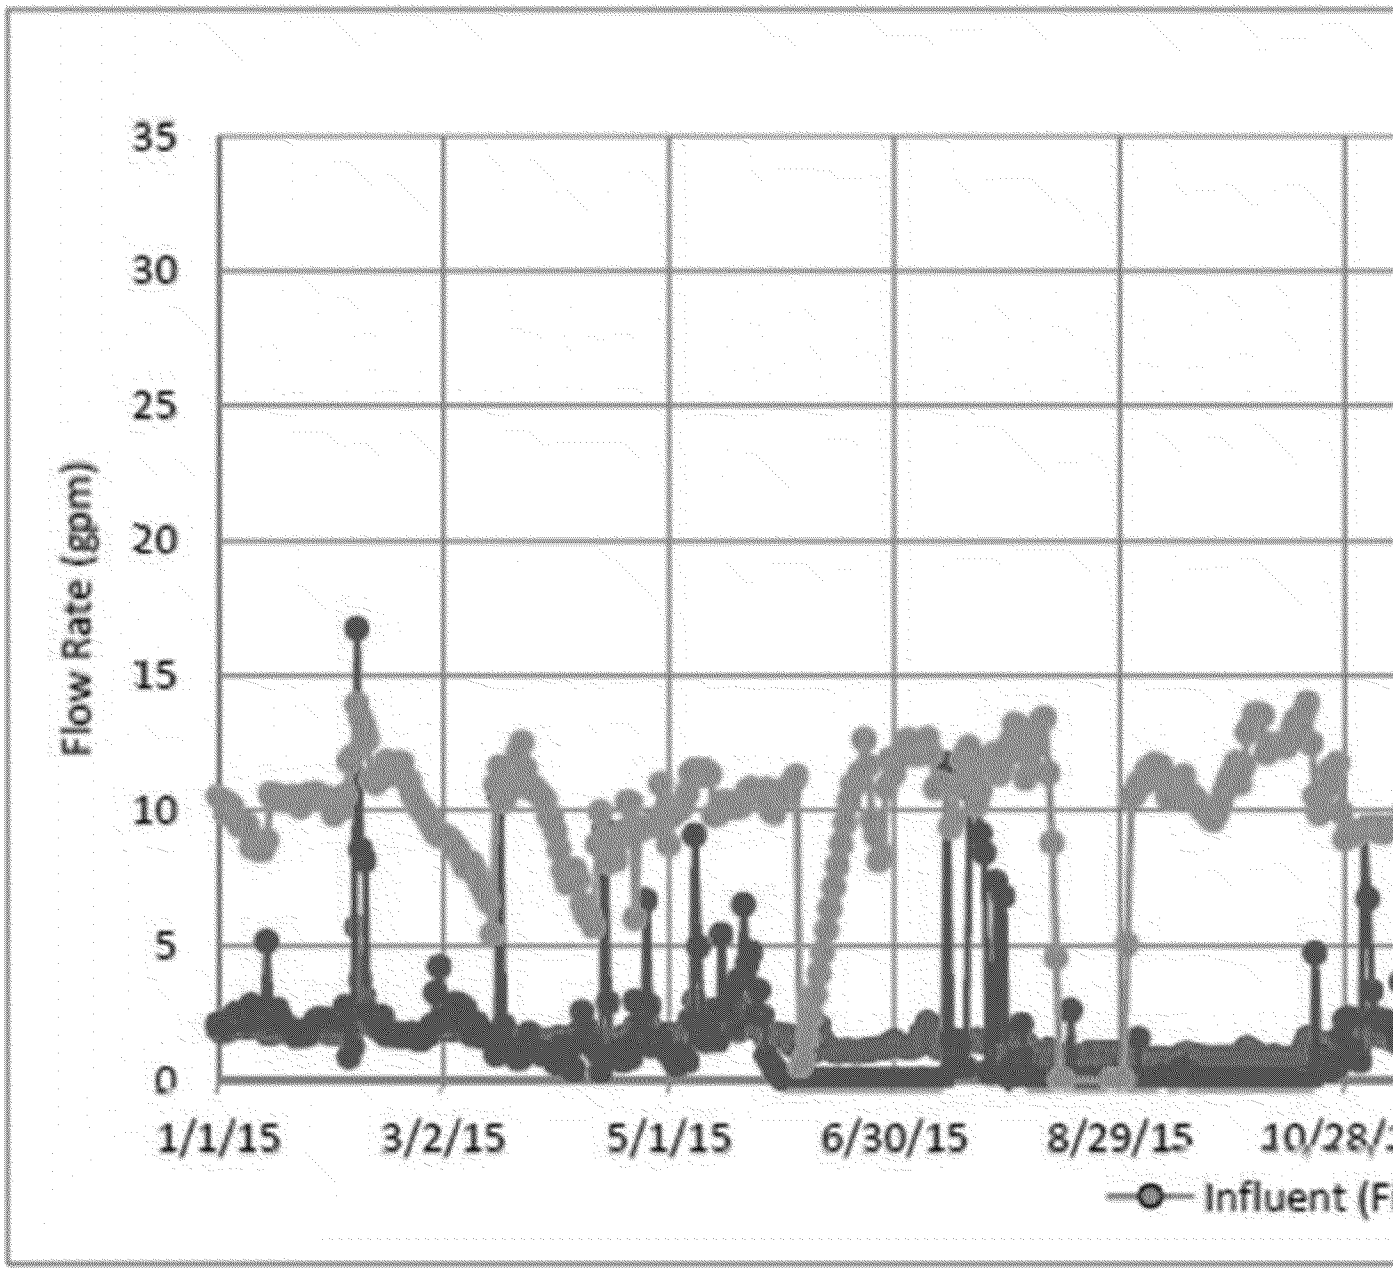
Please see the chart below which illustrates the recent influent flow rate (field measurements) and effluent flow rate data from the Aspen Seep Bioreactor (ASB) Treatment System. We have not received the downloaded influent flow rate data since 12/31/16; however, our approximately monthly field measurements are shown on the chart. In addition, the influent flow rate was manually measured at approximately 25 gpm during the 4/6/17 field visit. As we have had to temporarily remove the 1" effluent flow meter, we will not have effluent flow rate data until it (or a larger 2" flowmeter) can be re-installed. During the 4/6/17 visit, the debris at the launder was removed, and the Pond 4 water elevation was lowered through the use of a siphon. The 1" section of discharge piping and the 1" flowmeter was replaced with 2" flexible piping. The new 2" piping was flowing at approximately 100 gpm while the Pond 4 elevation was lowering (see attached photo). At the time that the maintenance crew left the site, the effluent flow rate had still not yet reached equilibrium.

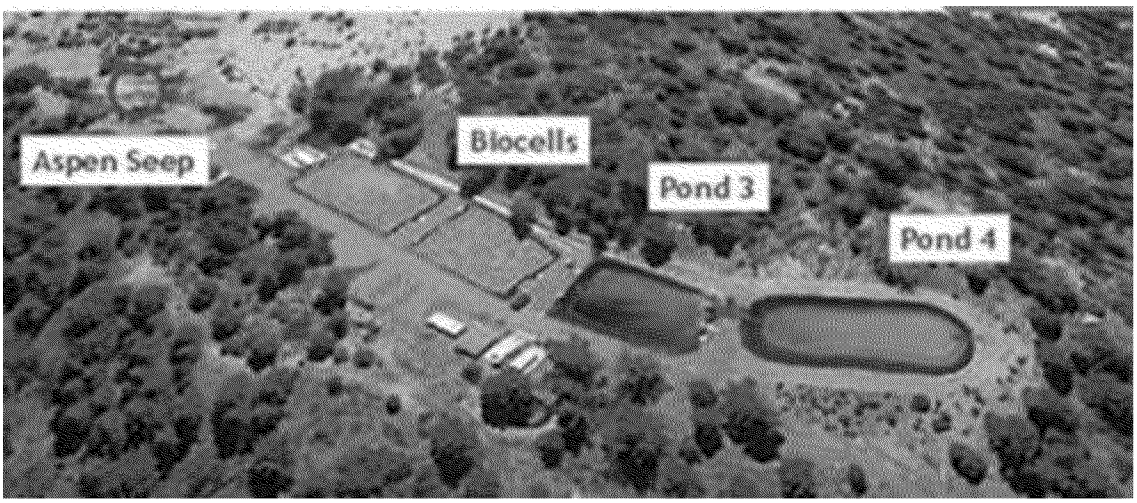
In addition, here are some before and after photos from the 4/6/17 site visit. As you can see, we gained approximately 2 “stairs” of freeboard which provides approximately 100,000 gallons of storage in Pond 4. As a result of the maintenance activities on 4/6/17, we believe there is adequate capacity to get through the forecasted storm this weekend.

Figure 2: Pond 4 Launder at 1545 on 4/6/17

The modification of the Pond 4 discharge that was completed on 4/6/17 increased the effluent flow from 25 gpm to over 100 gpm. Once the pond level drops, this flow will reduce to match the influent flow plus precipitation and runon. The modification increased the flow enough that we do not anticipate the potential for a pond overflow. Again, as we gain regular access to the Aspen Seep Bioreactor we would be able to reinstall the effluent flow meter and gain more remote monitoring capabilities.
