Subject: July and August 2017 Cultural Resource Monitoring Report for Expanded Area of Potential Effects
Leviathan Mine Site
Alpine County, California

Attachment 1 Draft Site Record for JDH_1702/Camp Isabell

***Resource Name or #:** Temporary # JDH_1702

P1. Other Identifier: Camp Isbell

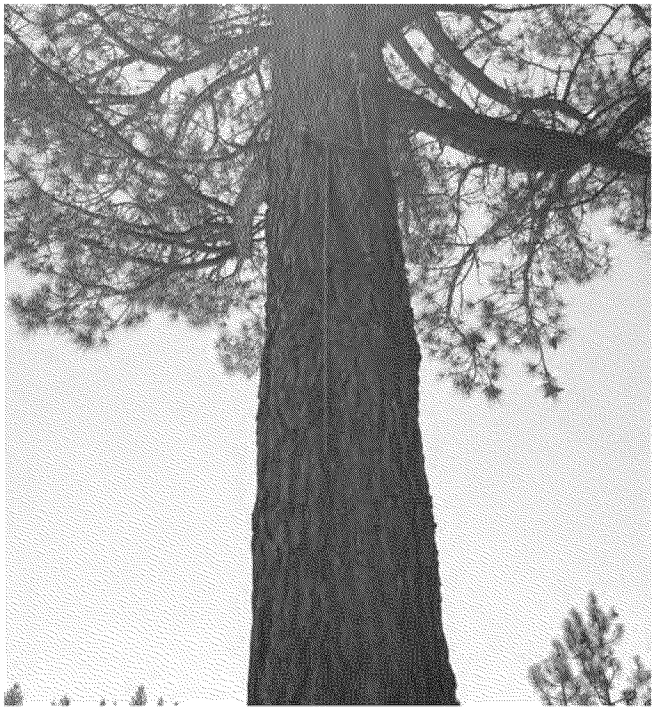
JDH_1702/Camp Isbell, Overview of Feature F-25, tree-mounted lighting fixture, facing southeast-south, 20170717_115754.jpg

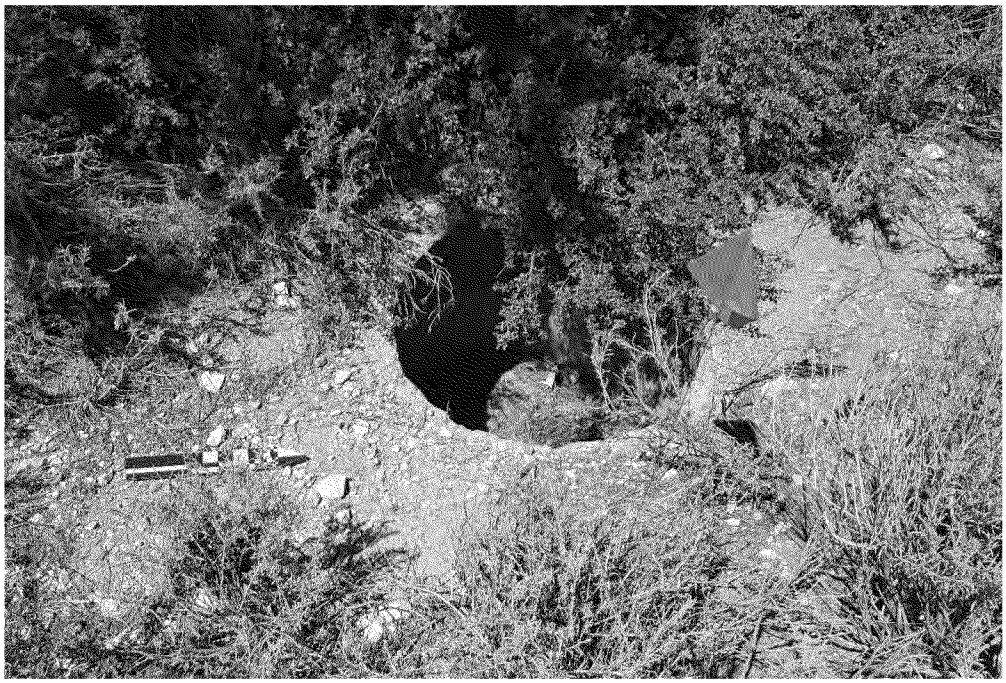
JDH_1702/Camp Isbell, Overview of Feature F-26, concrete cistern, plan view, 20170717_120016.jpg

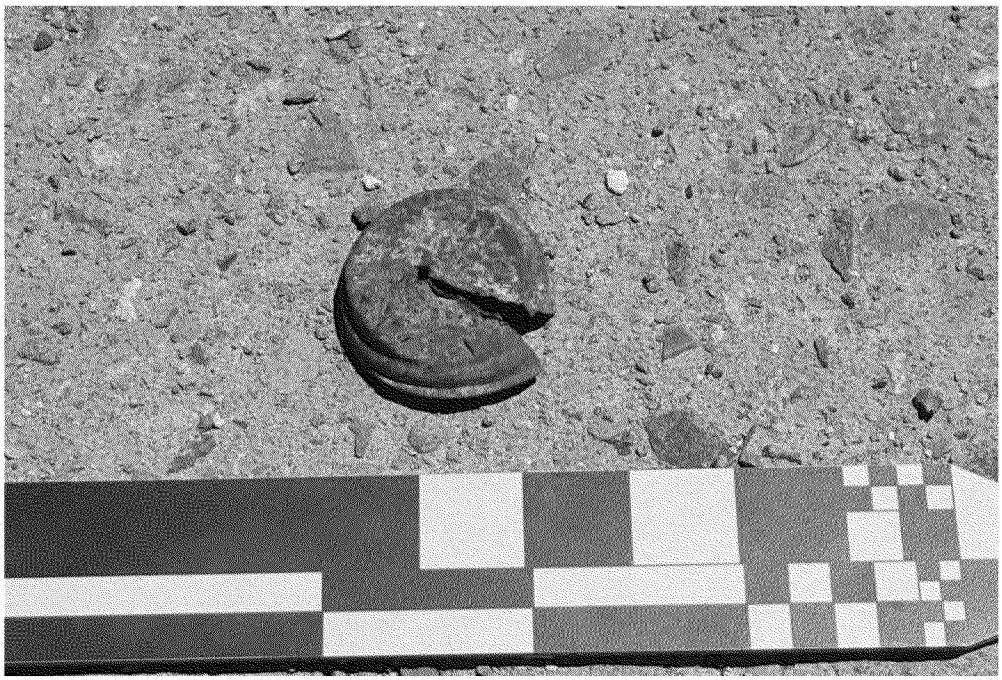
JDH_1702/Camp Isbell, Artifact A-06, internally threaded 'TEXACO' barrel lid, plan view, 20170717_135006.jpg
