ENVIRON

March 20, 2015

Re: Notification of Additional Locations at Malibu High School and Juan Cabrillo Elementary School to be Addressed in Accordance with October 2014 USEPA Approved Plan

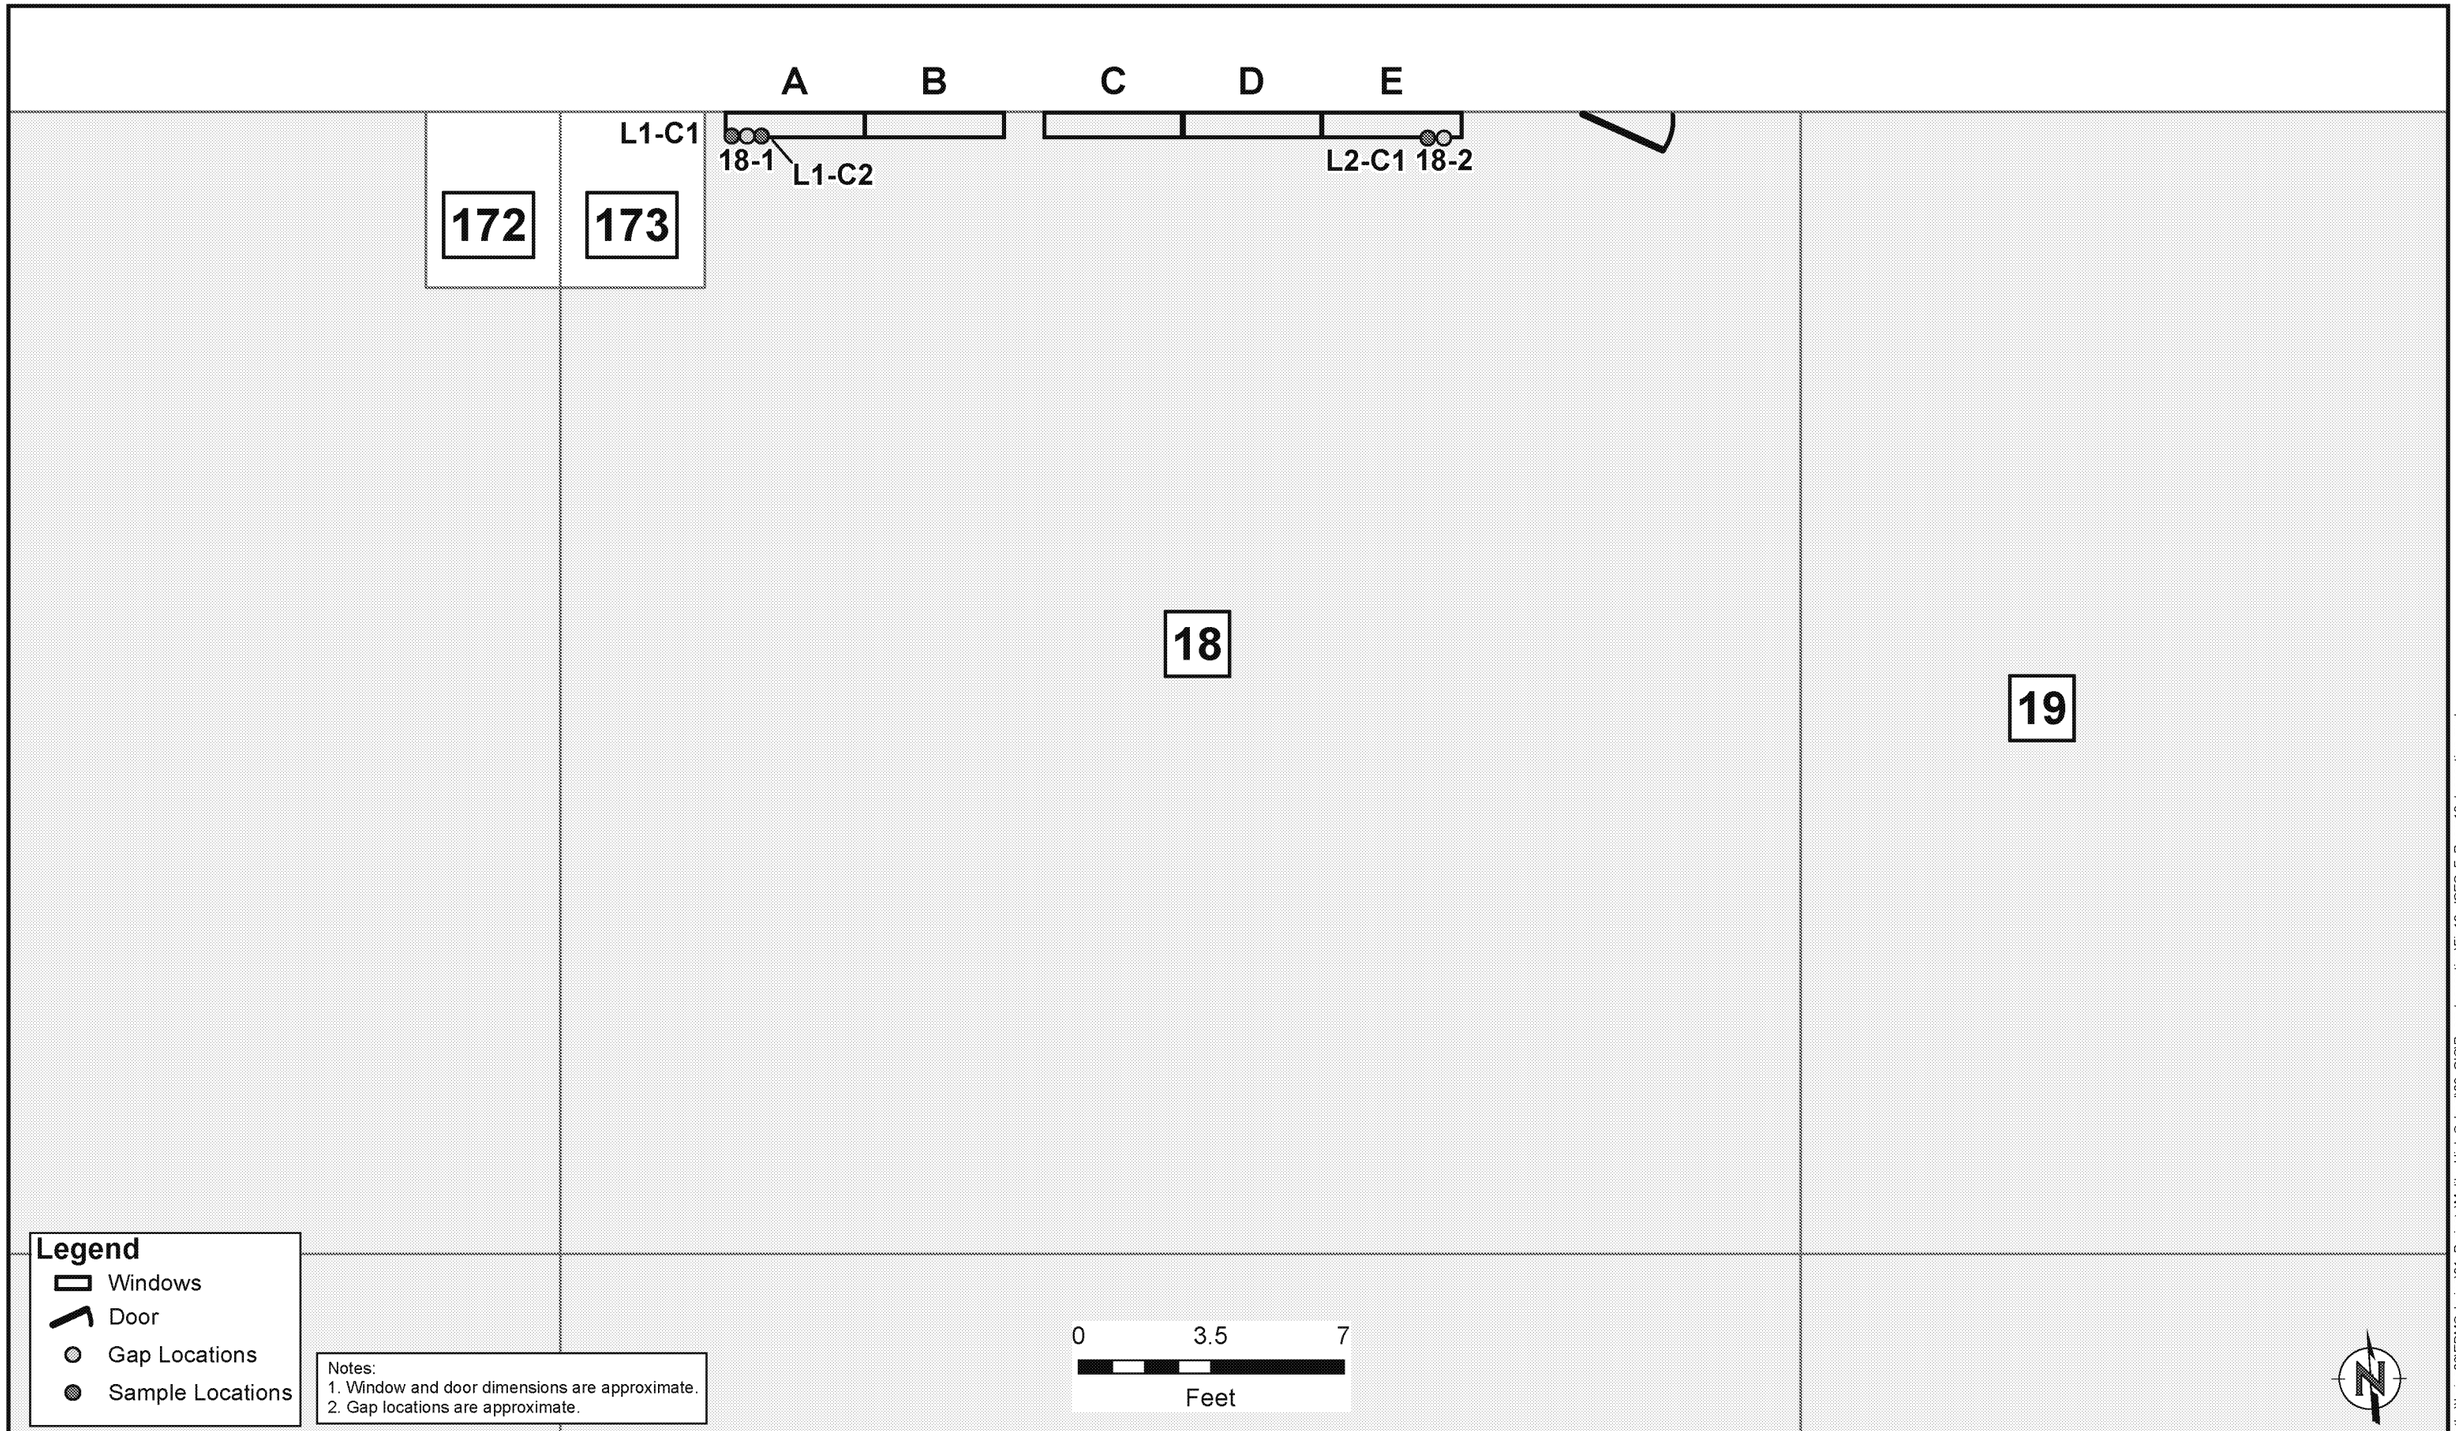
Figure
10

Building	Placard Room ID	Floor Plan Room ID	Room Description	Number of Windows	Number of Doors	Number of Sinks	Sample Description as Provided by AU	Gap ID	Gap Location	Gap Length (cm)	Notes	Figure
JCES												
A	100J	Principal's Office	Principal's Office	9	NA	NA	JCES office: interior window caulk	NI	NI	NI	No apparent gaps from tool removal; some repair caulk. Possible gaps likely due to incomplete repair caulk in the Nurse's Office and Teachers' workroom.	9
	100L,100E	Main Office	Main Office	7	NA	NA		NI	NI	NI		
	100F	Community Liaison	Nurse's Office/ community liaison	6	NA	NA		Office-1	Window C	10		
	100B	100B	Teachers' workroom	3	NA	NA		Office-2	Window B	35		
F	R18	18	PTA room	5	NA	NA	JCES room 18: interior window caulk	18-1	Window A	37	Bottom window sill covered in masking tape. Bottom window panes recaulked except Window C and part of Window D. Middle and upper panes do not appear to be recaulked. Window A: One gap of missing masking tape and potentially grey caulk. Window B: No apparent gaps. Window C: Some areas of apparent deteriorated caulk on lower window pane. Window D: No apparent gaps. Window E: One gap of potentially missing grey caulk.	10

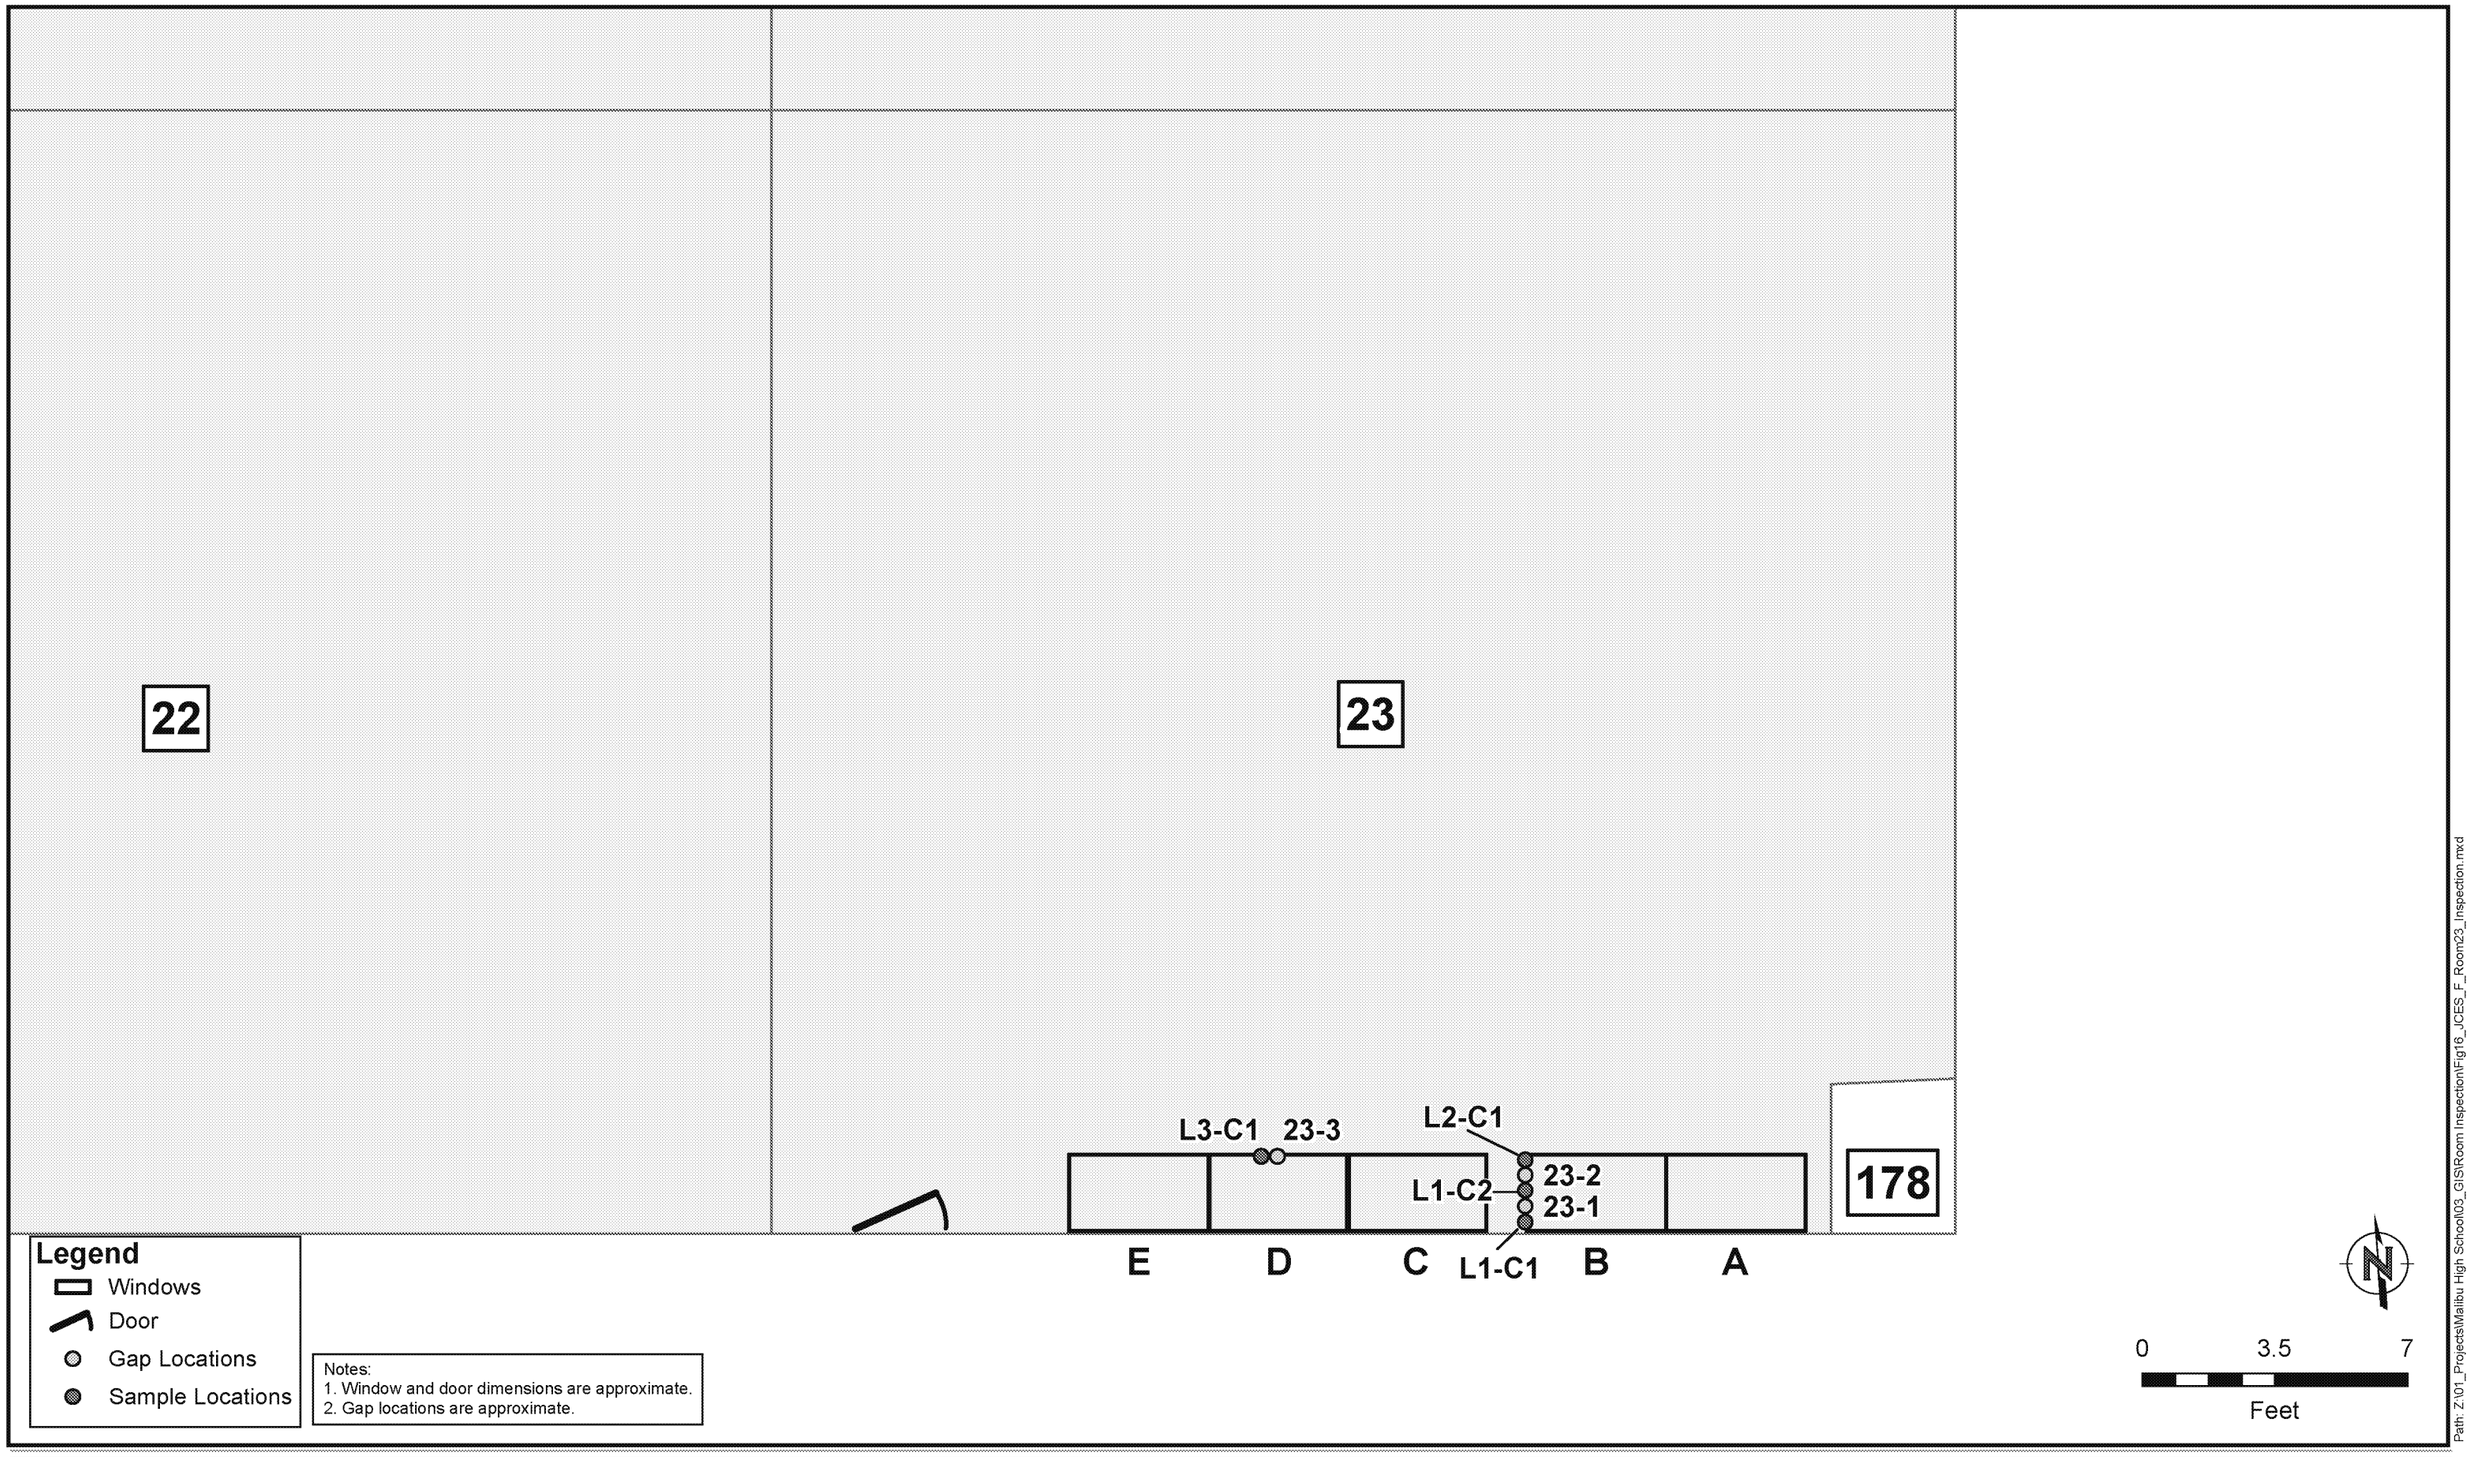
22-2		24		
								22-3	Window B	19		
								22-4	Window C	25		
								22-5		5		
								22-6	Window D	22		
								22-7	Window E	17		
	R23	23	Overflow room/music room	5	NA	NA	JCES room 23: interior window caulk	23-1	Window B	7	Caulk between frame and wall generally painted over, some separations noted but no apparent missing gaps. Window A: No apparent tool-removed caulk, some repair caulk and some missing patches possible due to deterioration. Window B: Some repair caulk on lower window pane, two gaps on right side of window. Window C: Some repair caulk, no apparent gaps. Window D: Some repair caulk, one gap on sill in gray caulk. Window E: Some repair caulking, no apparent gaps.	13
								23-2		23		
								23-3	Window D	52
