MGP Ingredients
Chlorine Release
10/21/2016
Aitchison, KS
* kshb.com – picture by Dunn Heating and Cooling

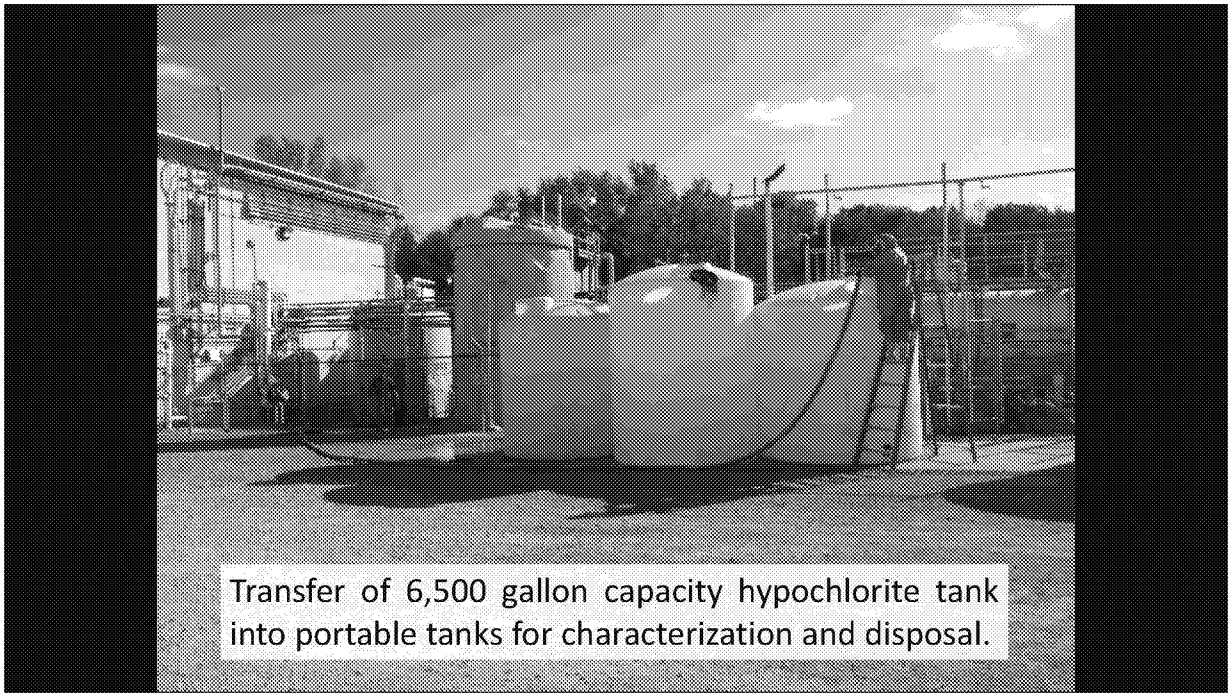
Transfer of 6,500 gallon capacity hypochlorite tank into portable tanks for characterization and disposal.

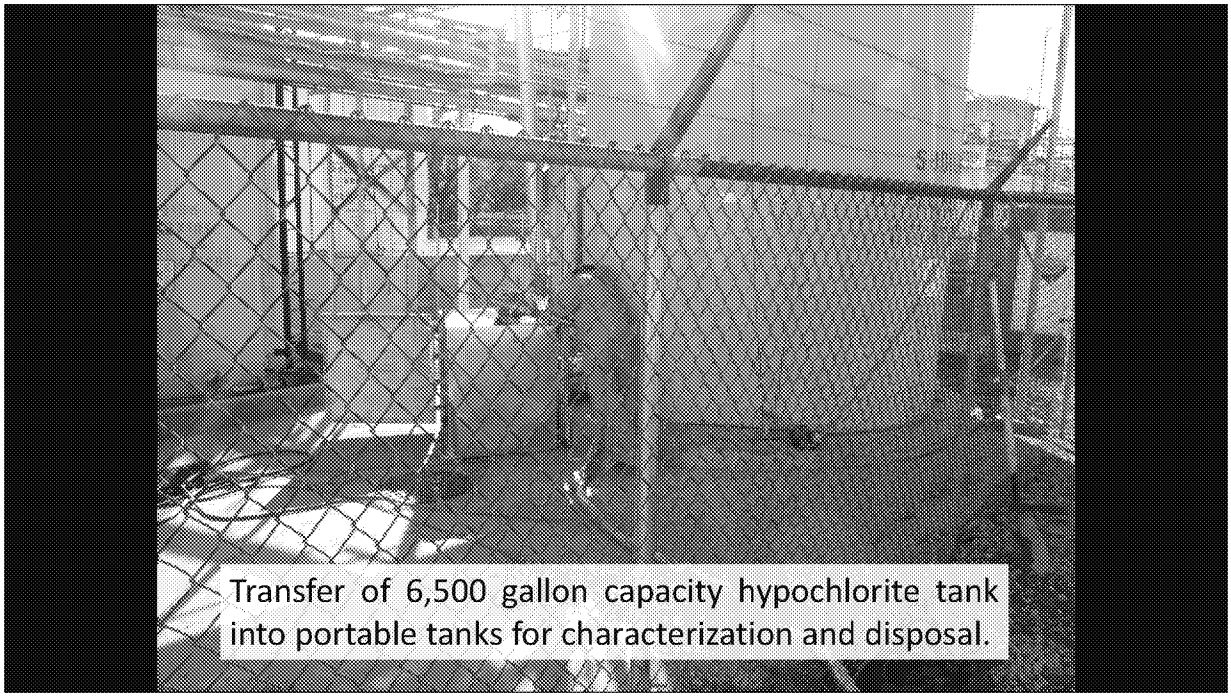
Transfer of 6,500 gallon capacity hypochlorite tank into portable tanks for characterization and disposal.

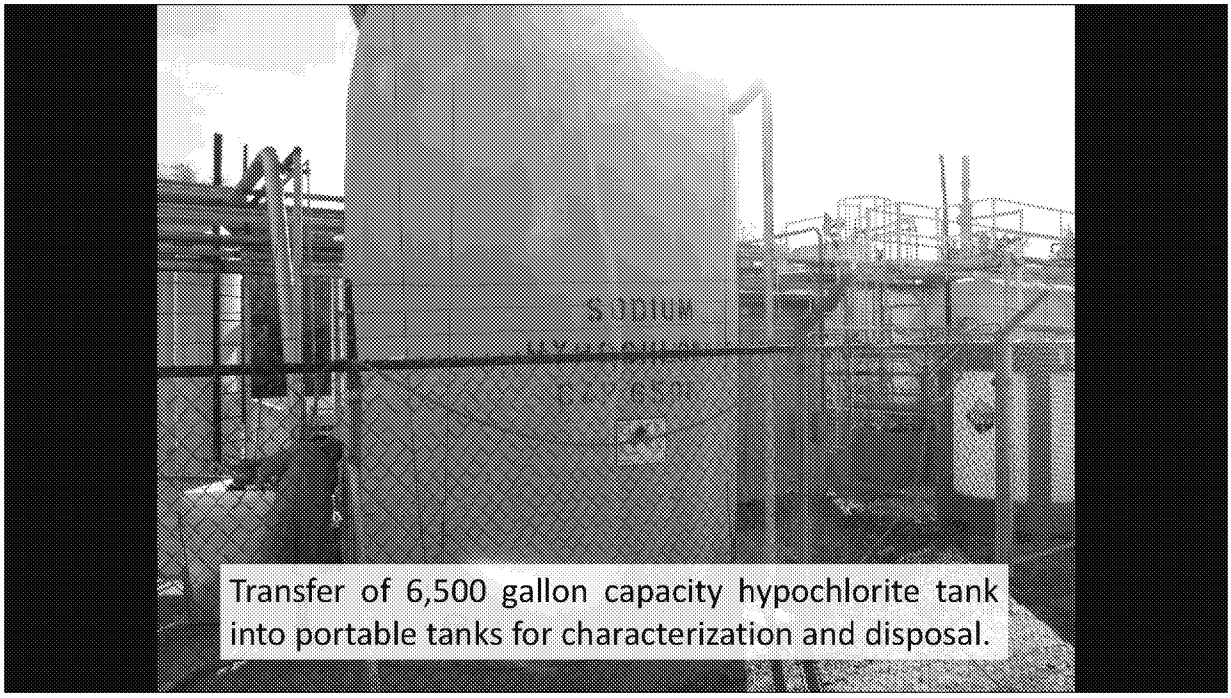
Transfer of 6,500 gallon capacity hypochlorite tank into portable tanks for characterization and disposal.
