MGP Ingredients
Chlorine Release
10/21/2016
Aitchison, KS
* kshb.com – picture by Dunn Heating and Cooling

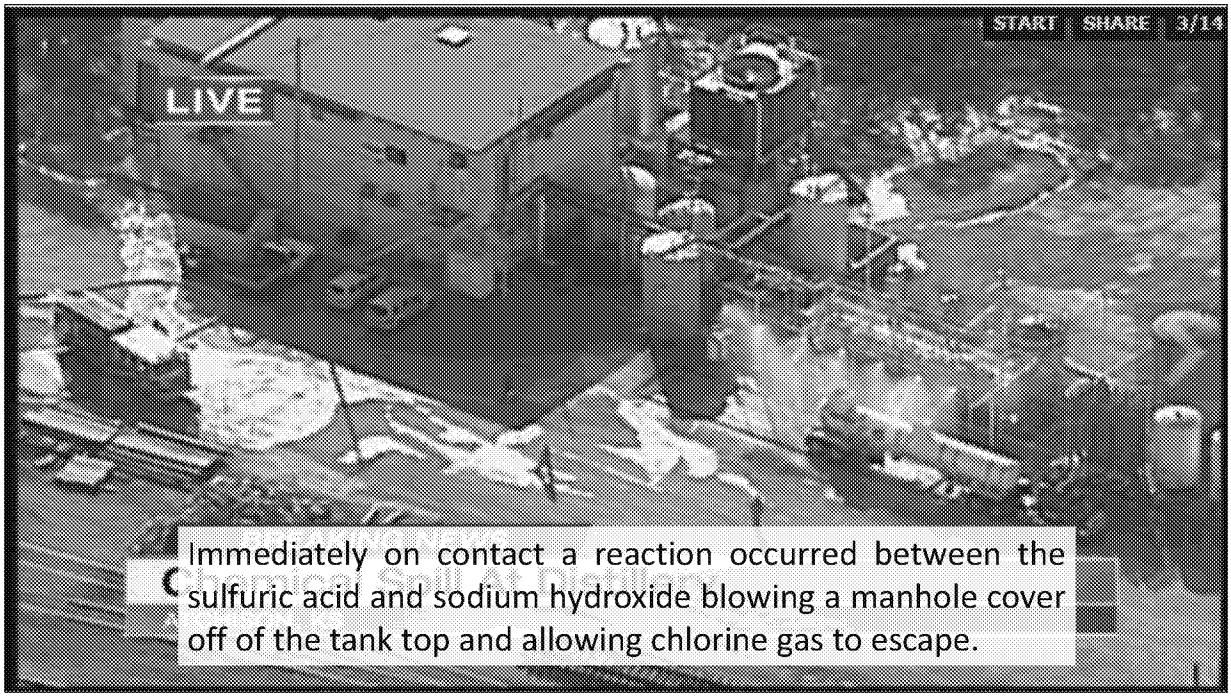
On 10/21/2016 at approximately 0800 hrs an MGP employee working at the industrial pretreatment facility inadvertently connected a hose from a tanker truck delivering sulfuric acid to a tank containing sodium hypochlorite.

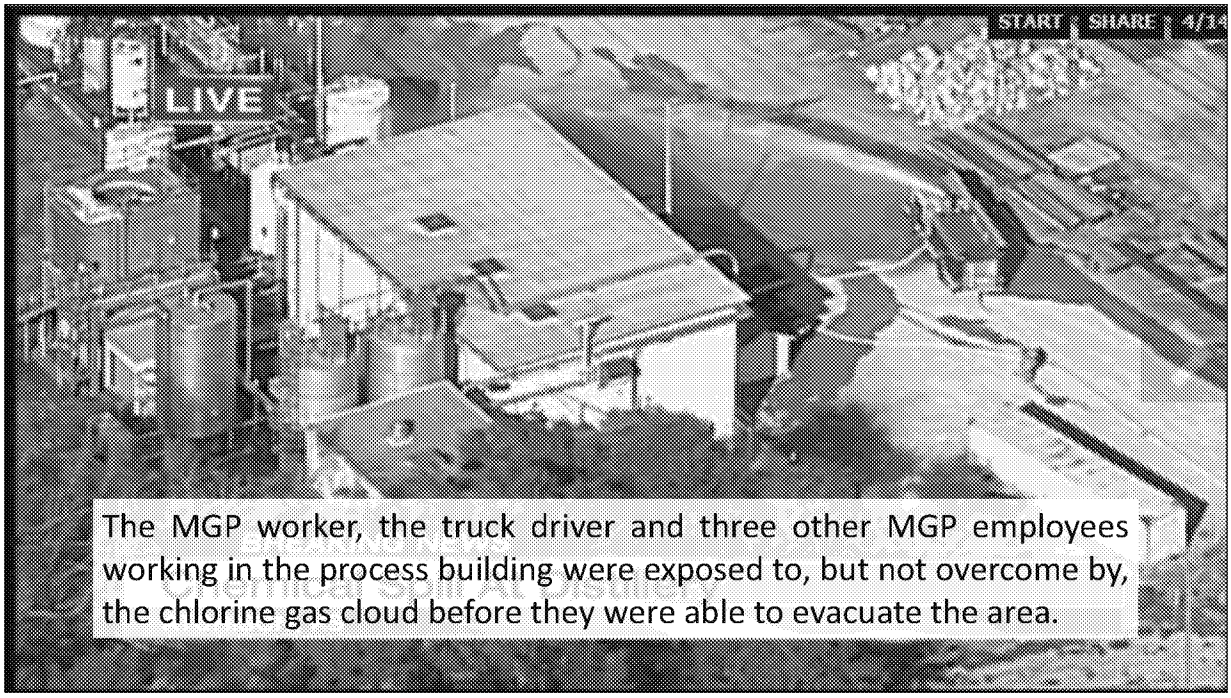
Immediately on contact a reaction occurred between the sulfuric acid and sodium hydroxide blowing a manhole cover off of the tank top and allowing chlorine gas to escape.

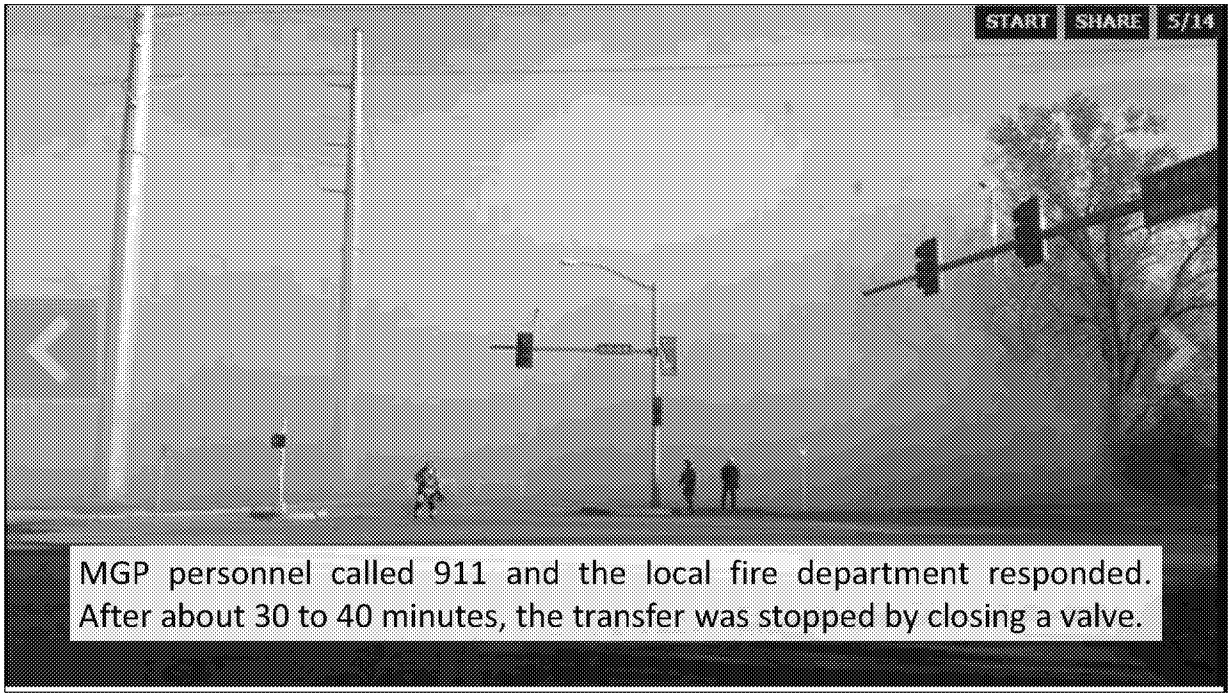
The MGP worker, the truck driver and three other MGP employees working in the process building were exposed to, but not overcome by, the chlorine gas cloud before they were able to evacuate the area.

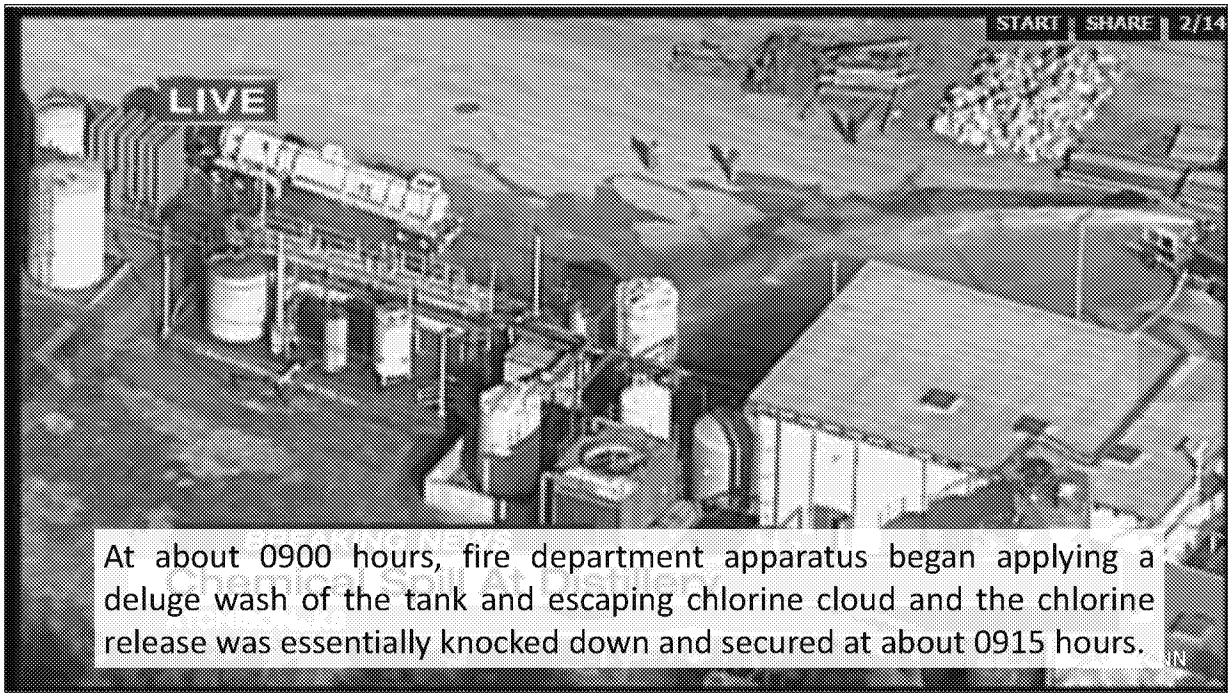
START
SHARE
5/14
MGP personnel called 911 and the local fire department responded. After about 30 to 40 minutes, the transfer was stopped by closing a valve.

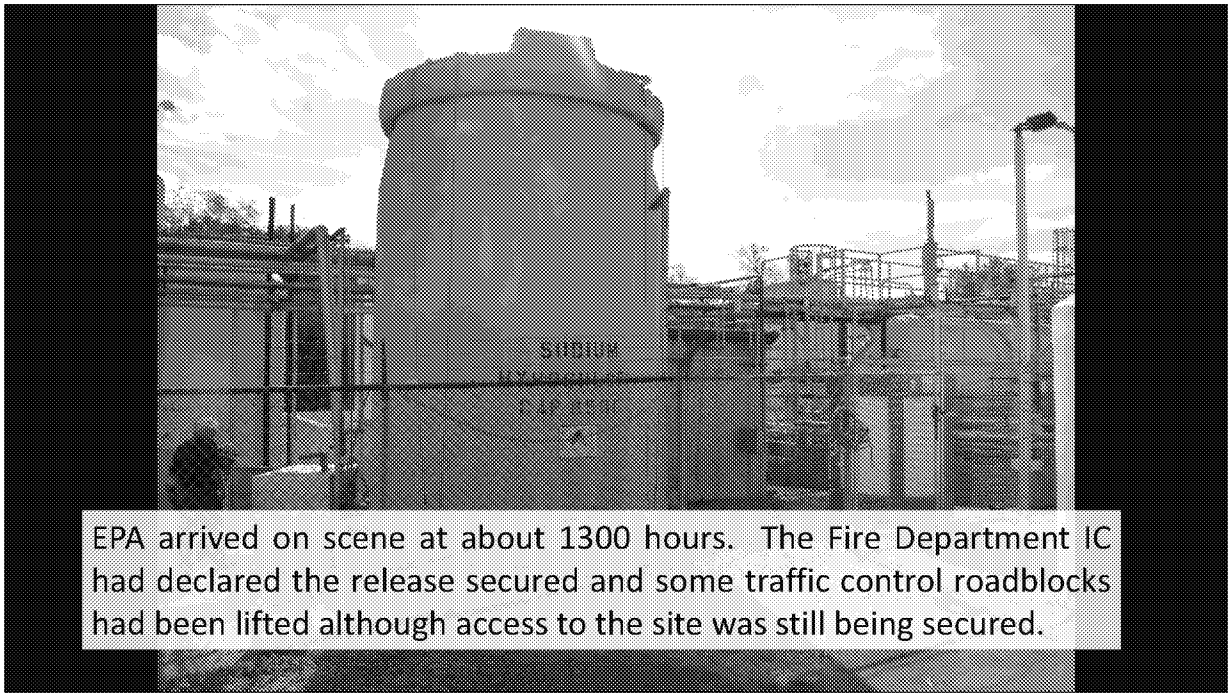
At about 0900 hours, fire department apparatus began applying a deluge wash of the tank and escaping chlorine cloud and the chlorine release was essentially knocked down and secured at about 0915 hours.

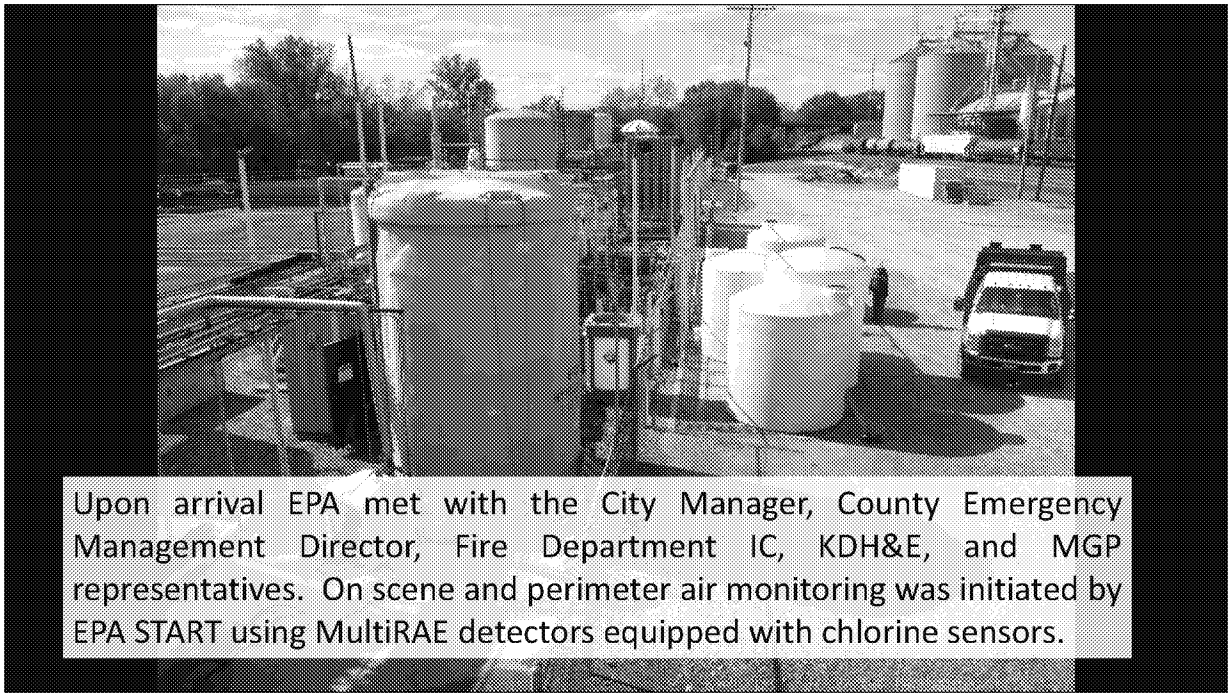
EPA arrived on scene at about 1300 hours. The Fire Department IC had declared the release secured and some traffic control roadblocks had been lifted although access to the site was still being secured.

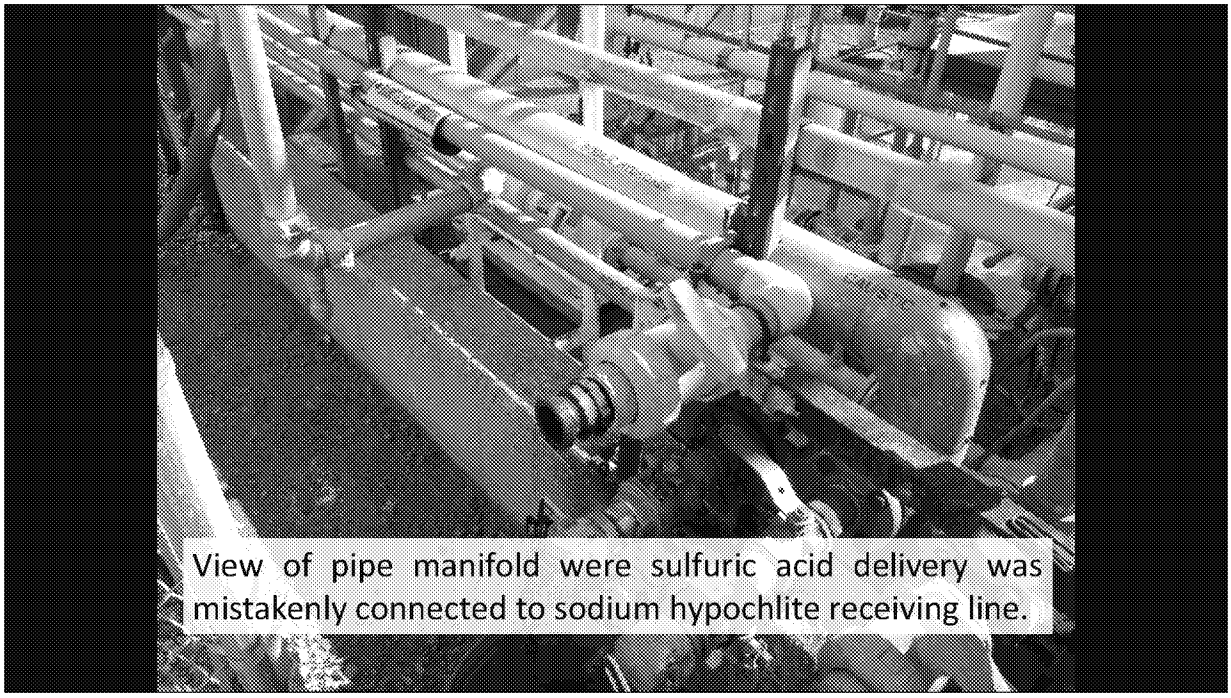
View of pipe manifold were sulfuric acid delivery was mistakenly connected to sodium hypochlite receiving line.

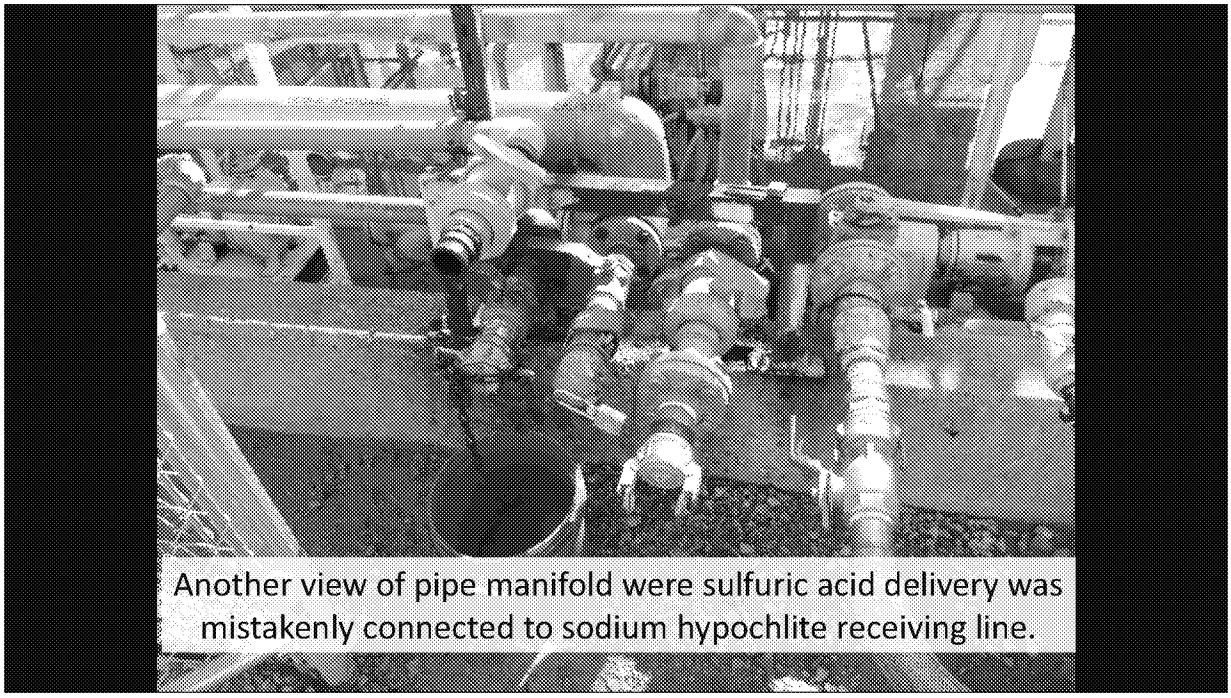
Another view of pipe manifold were sulfuric acid delivery was mistakenly connected to sodium hypochlite receiving line.

Labelled pipe lines.
