MGP Ingredients
Chlorine Release
10/21/2016
Aitchison, KS
* kshb.com – picture by Dunn Heating and Cooling

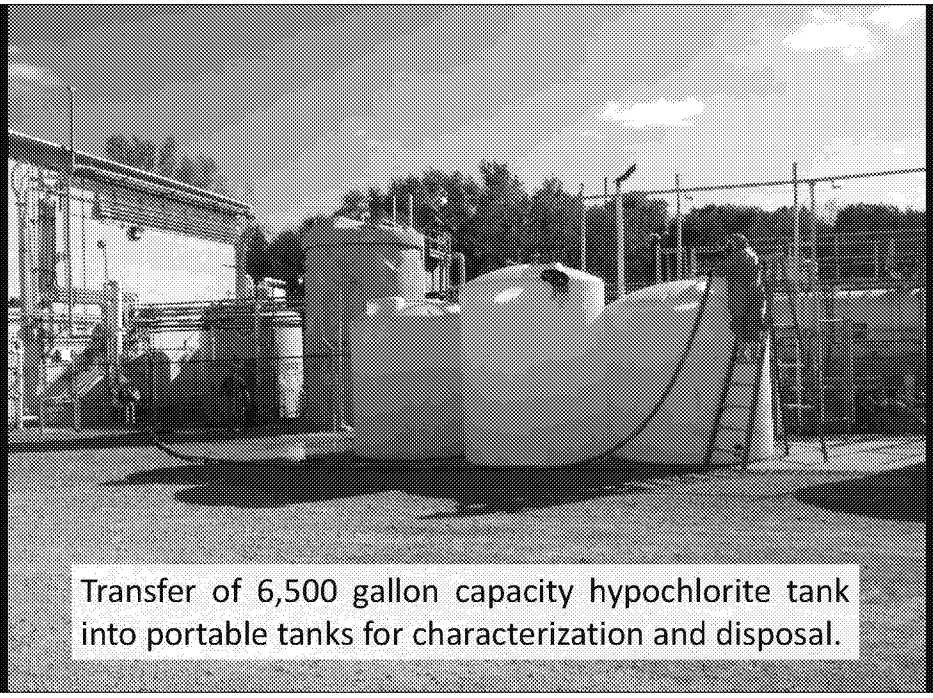
Transfer of 6,500 gallon capacity hypochlorite tank into portable tanks for characterization and disposal.
