Site 12
Field Work Progress
Former Naval Station Treasure Island

August 2014 RAB Meeting
Chris Yantos, Project Manager
Contracted Support for Navy BRAC

8/20/2014

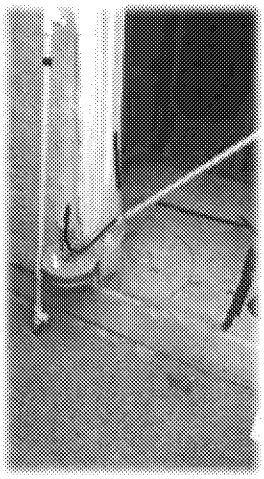
Date	Location
07-30-2014	Exterior storage shed

Elevated Survey Results July 30, 2014

- **Dose calculation: 1.7 mrem/yr**
- Reading at 12" inches: 4.8 uR/hr
- Reading on contact: 12 uR/hr
- Background: 3.2 uR/hr

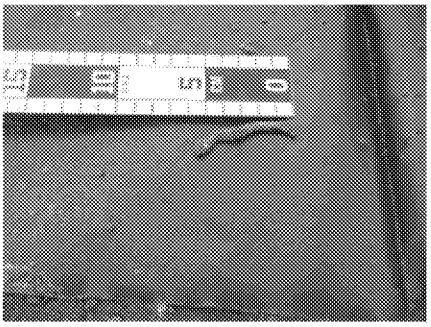
SWDA Bigelow Court Object Removal

July 21 (copper pipe segment) – origin Excavation Area E.
Dose reading with NaI detector was 26 uR/hr at 12 inches

July 30 (metal fragment) –origin Excavation Area L2.
Dose reading with NaI detector was 10 uR/hr at 12 inches
