**Hunters Point Naval Shipyard Parcel A-1, Radiation Health and Safety Scanning Survey: Progress Update #8**

*Note: This update includes both the regular update for work during the week of September 3-7 as well as related follow-up information from early this week.*

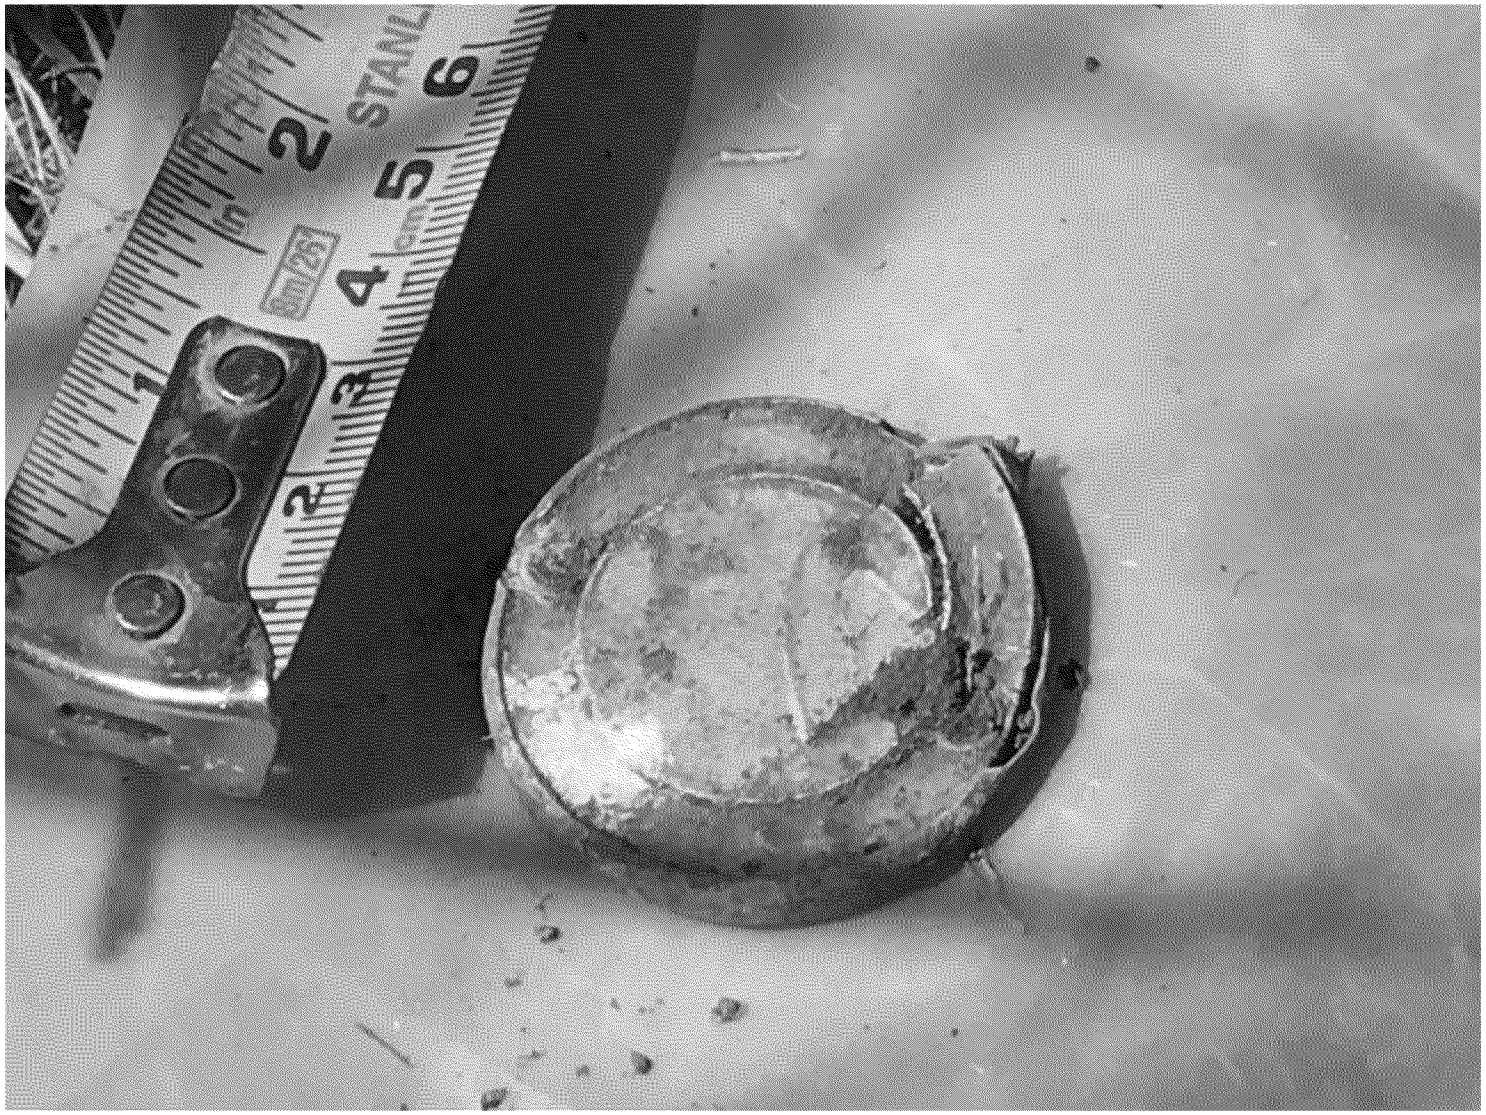
One of these anomalies, which was detected by CDPH's Walkover Scanning Survey on September 7th, was determined early this week to be a naval deck marker 1.5 inches in diameter that contained radium. The deck marker was located just west of the Department of Public Works (DPW) trailer, at the bottom of the hill on the north side of parcel A-1, in an undeveloped area behind a fence. On Tuesday, September 11th, the Navy's contractor, under CDPH observation, removed the deck marker from below about 10" of soil. The hole which contained the deck marker and removed soil were scanned and no radiation above background was found (i.e., all of the detected radiation was only in the deck marker itself).

Deck Marker (Ra-226)
Found buried at 10.5"
90 µR/hr at soil surface
Galvez Ave
Hudson Ave
Innes Ave
Hill Dr
The Storehouse
Acrylic Diva
Fisher St
The San Francisco Shipyard
Innes Ct
Hunters Point Shipyard Artists
Kirkwood Ave
Eclectic Cookery
D St
Spear Ave
Blandy
Crisp Rd
Spear Ave
200 ft
100 m
N
