FIGURE 3

WIPE SAMPLING STATUS
MAY 22, 2015

FORMER WESTINGHOUSE EQUIPMENT REPAIR FACILITY
RANCHO DOMINGUEZ, CALIFORNIA

PREPARED FOR
CBS CORPORATION
PITTSBURGH, PENNSYLVANIA

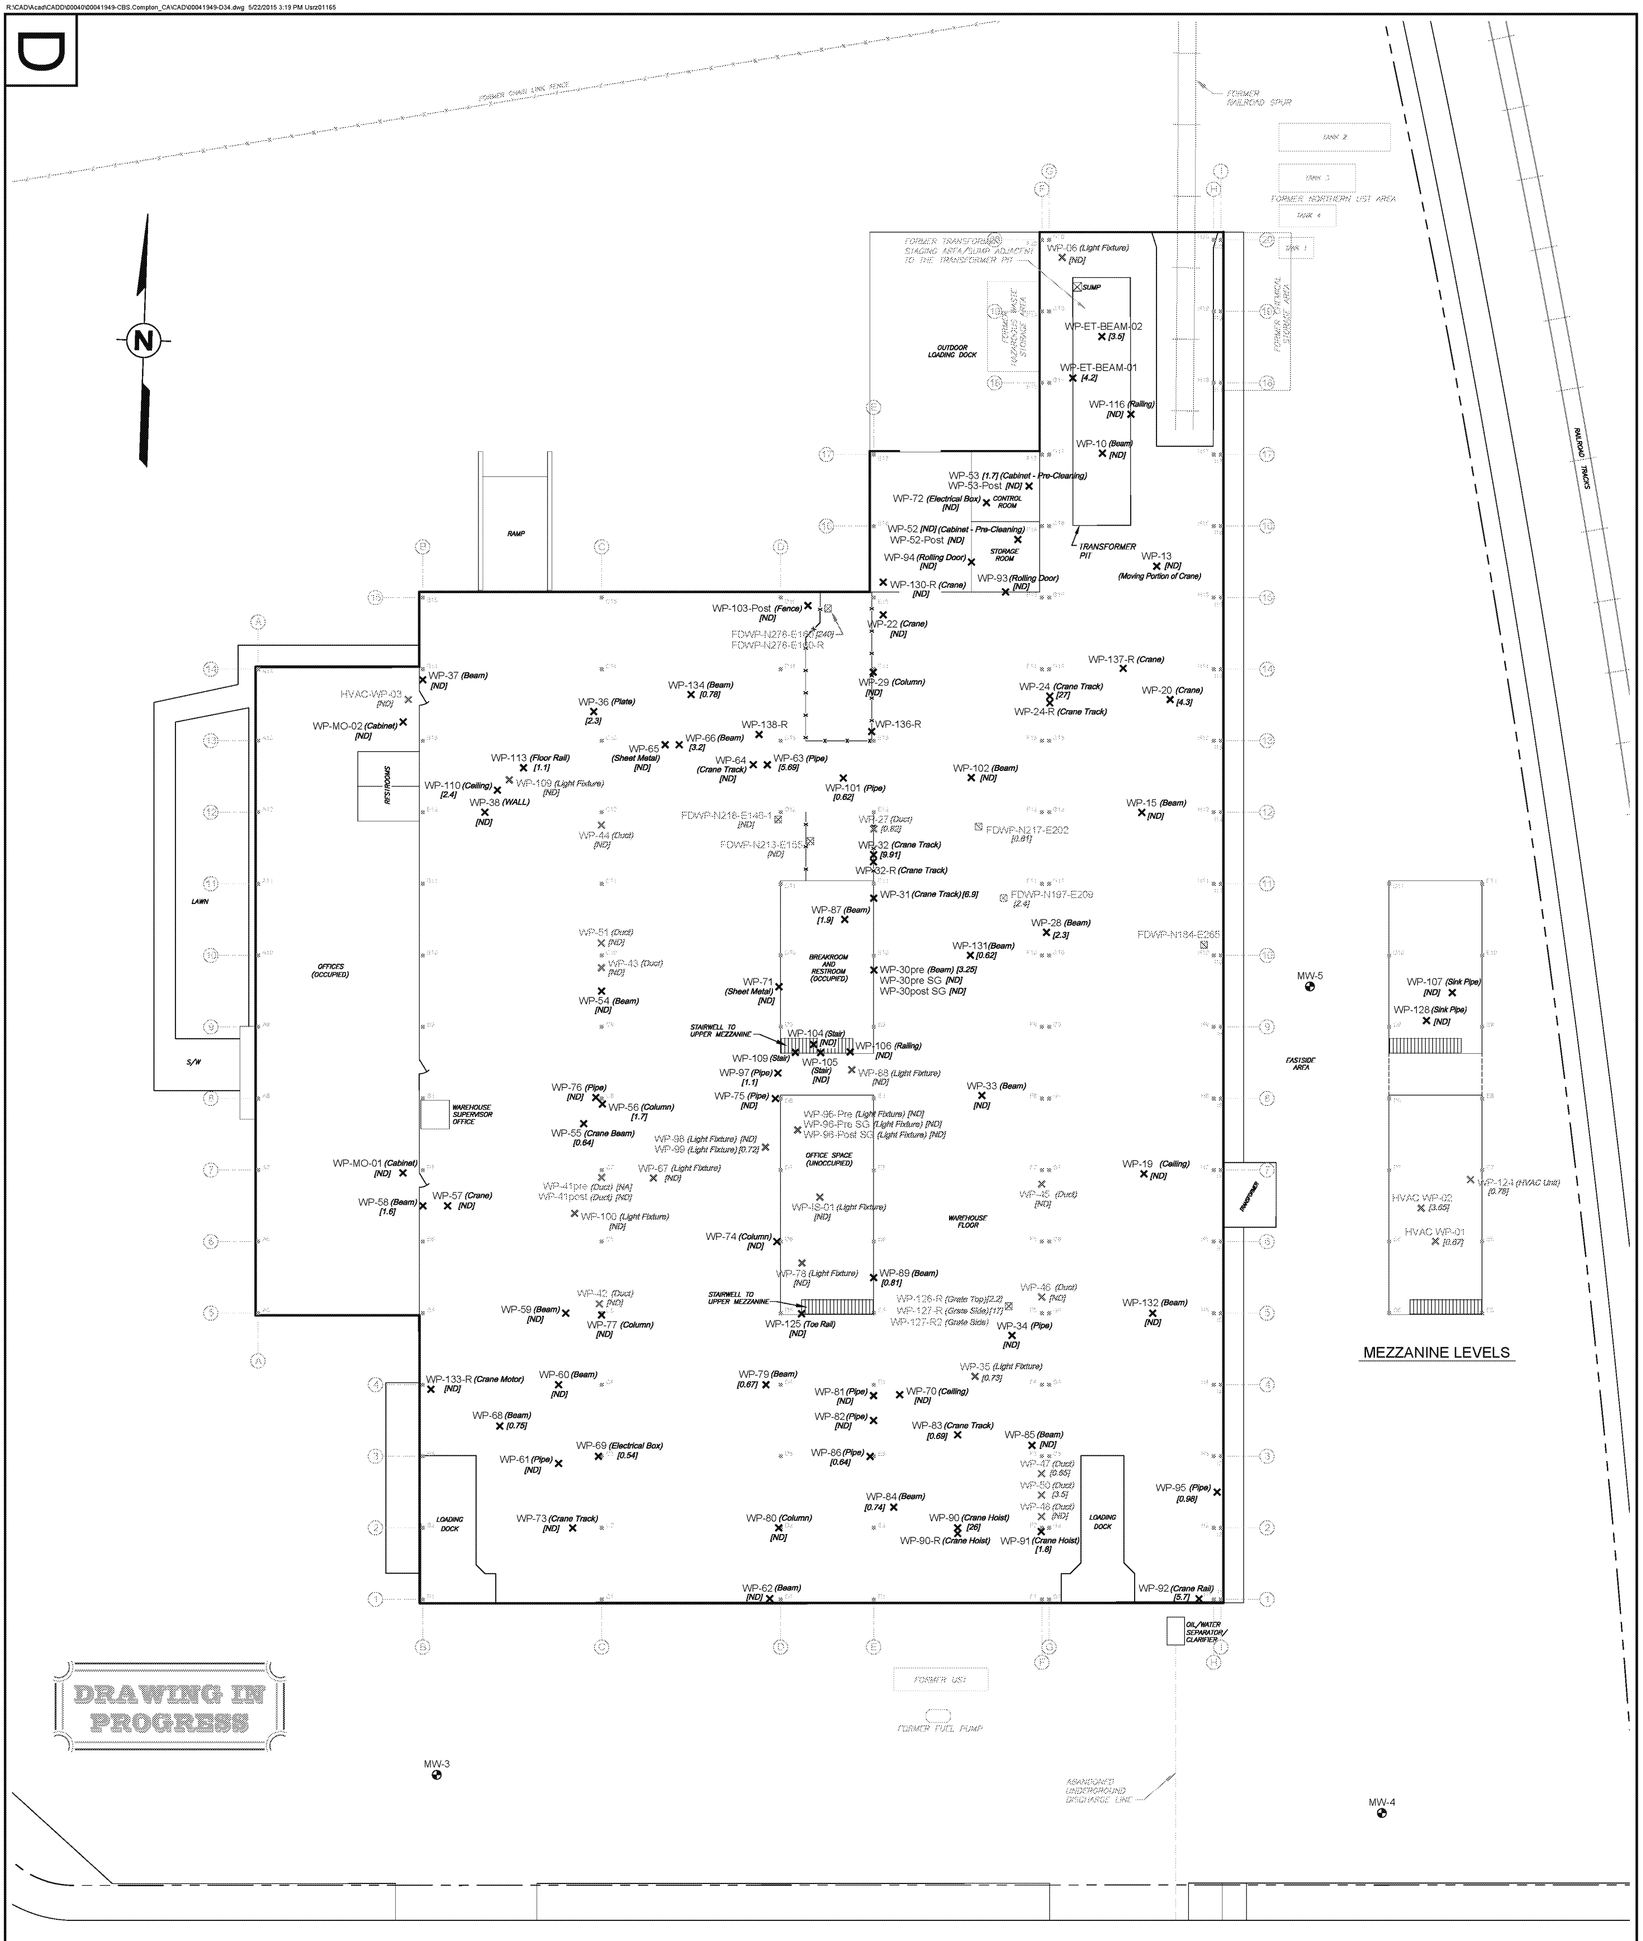
1. SAMPLE LOCATIONS ARE APPROXIMATE.
2. PRE-CLEANING AND POST-CLEANING SAMPLES WERE COLLECTED AT CERTAIN LOCATIONS TO EVALUATE THE EFFECTIVENESS OF THE CLEANING PROCEDURE.
