FIGURE 3

WIPE SAMPLING LOCATIONS AND RESULTS

FORMER WESTINGHOUSE EQUIPMENT REPAIR FACILITY
RANCHO DOMINGUEZ, CALIFORNIA

PREPARED FOR
CBS CORPORATION
PITTSBURGH, PENNSYLVANIA

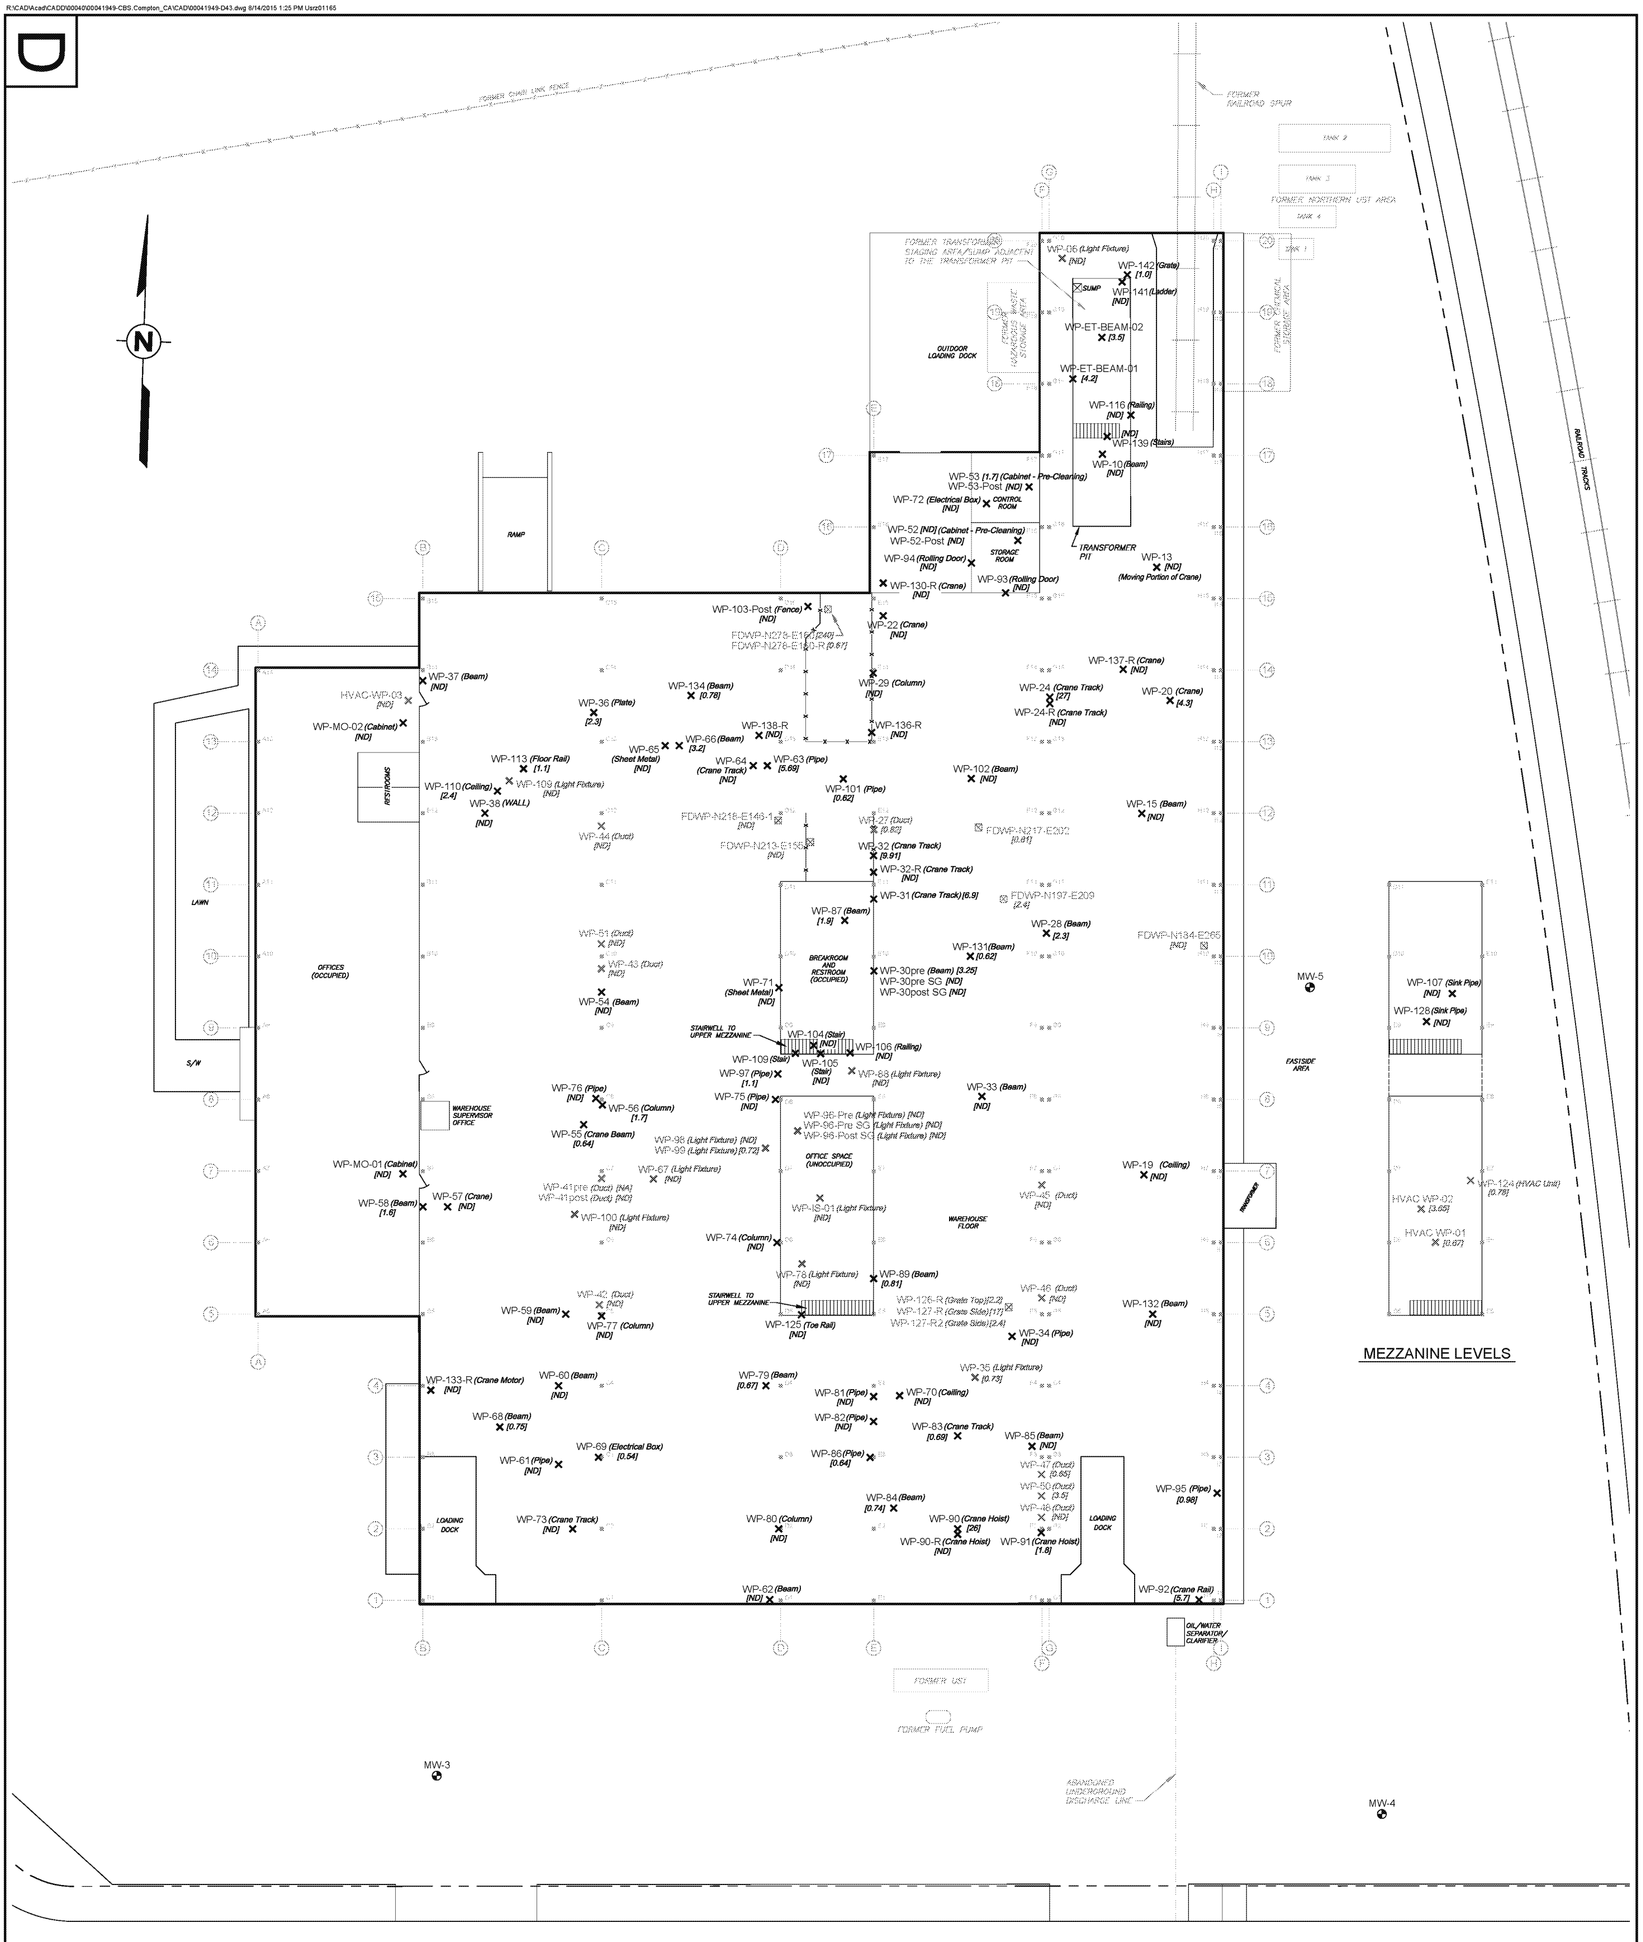
1. SAMPLE LOCATIONS ARE APPROXIMATE.
2. PRE-CLEANING AND POST-CLEANING SAMPLES WERE COLLECTED AT CERTAIN LOCATIONS TO EVALUATE THE EFFECTIVENESS OF THE CLEANING PROCEDURE.
