FIGURE 3

WIPE SAMPLING STATUS
MAY 15, 2015

FORMER WESTINGHOUSE EQUIPMENT REPAIR FACILITY
RANCHO DOMINGUEZ, CALIFORNIA

PREPARED FOR
CBS CORPORATION
PITTSBURGH, PENNSYLVANIA

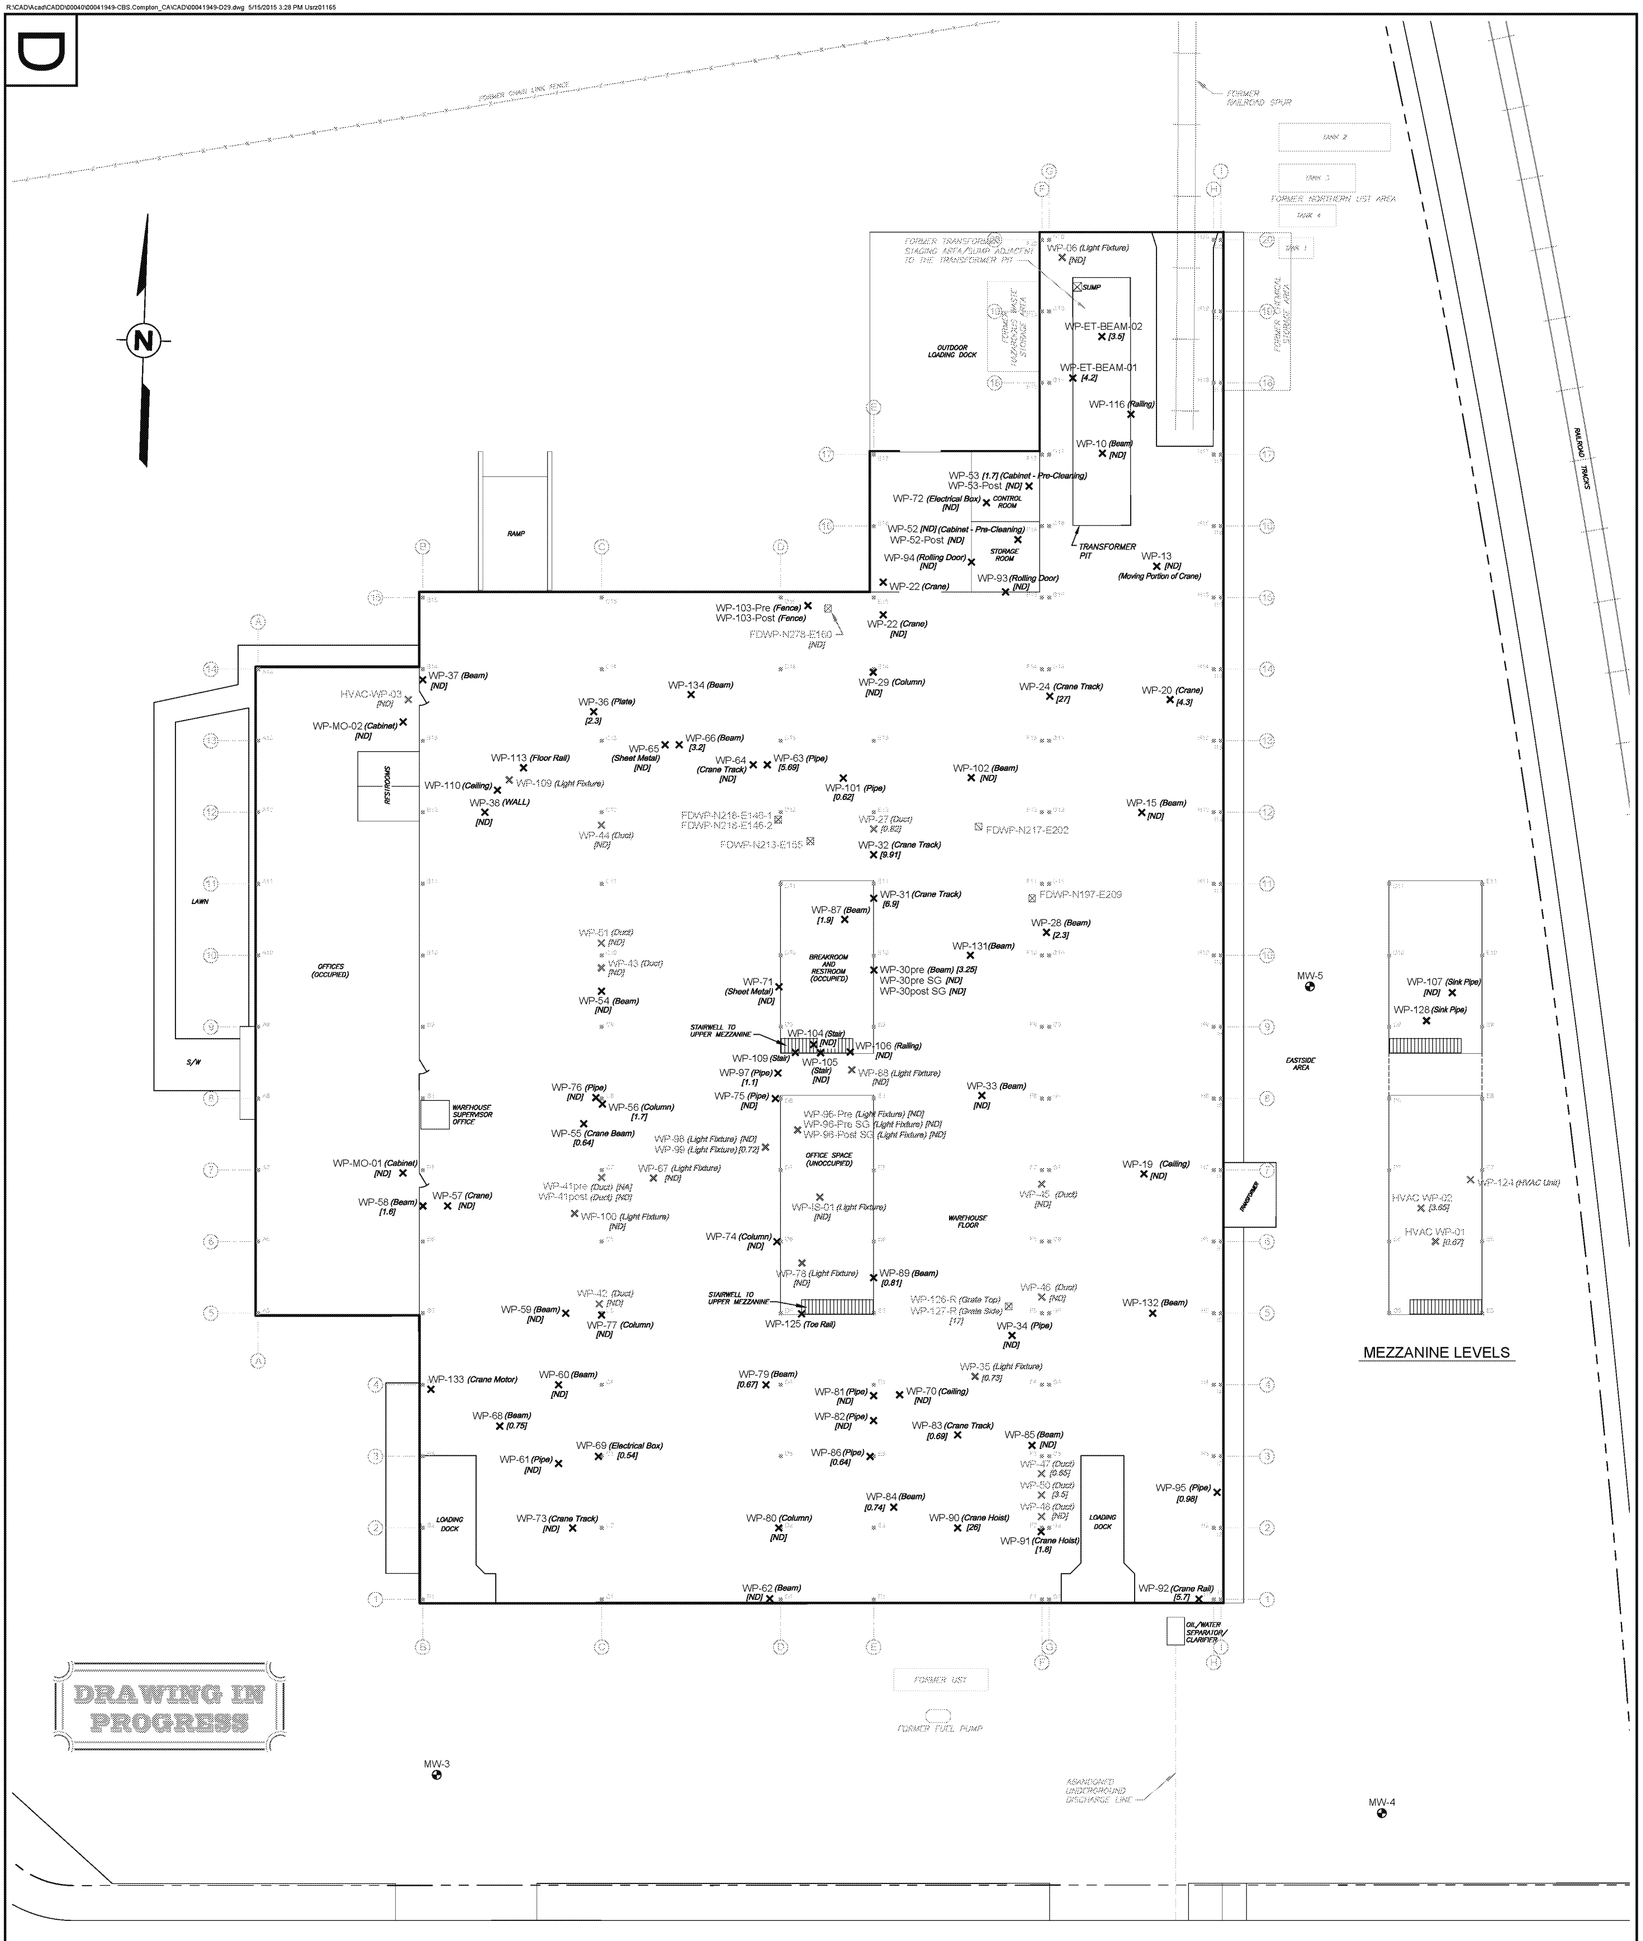
1. SAMPLE LOCATIONS ARE APPROXIMATE.
2. PRE-CLEANING AND POST-CLEANING SAMPLES WERE COLLECTED AT CERTAIN LOCATIONS TO EVALUATE THE EFFECTIVENESS OF THE CLEANING PROCEDURE.
