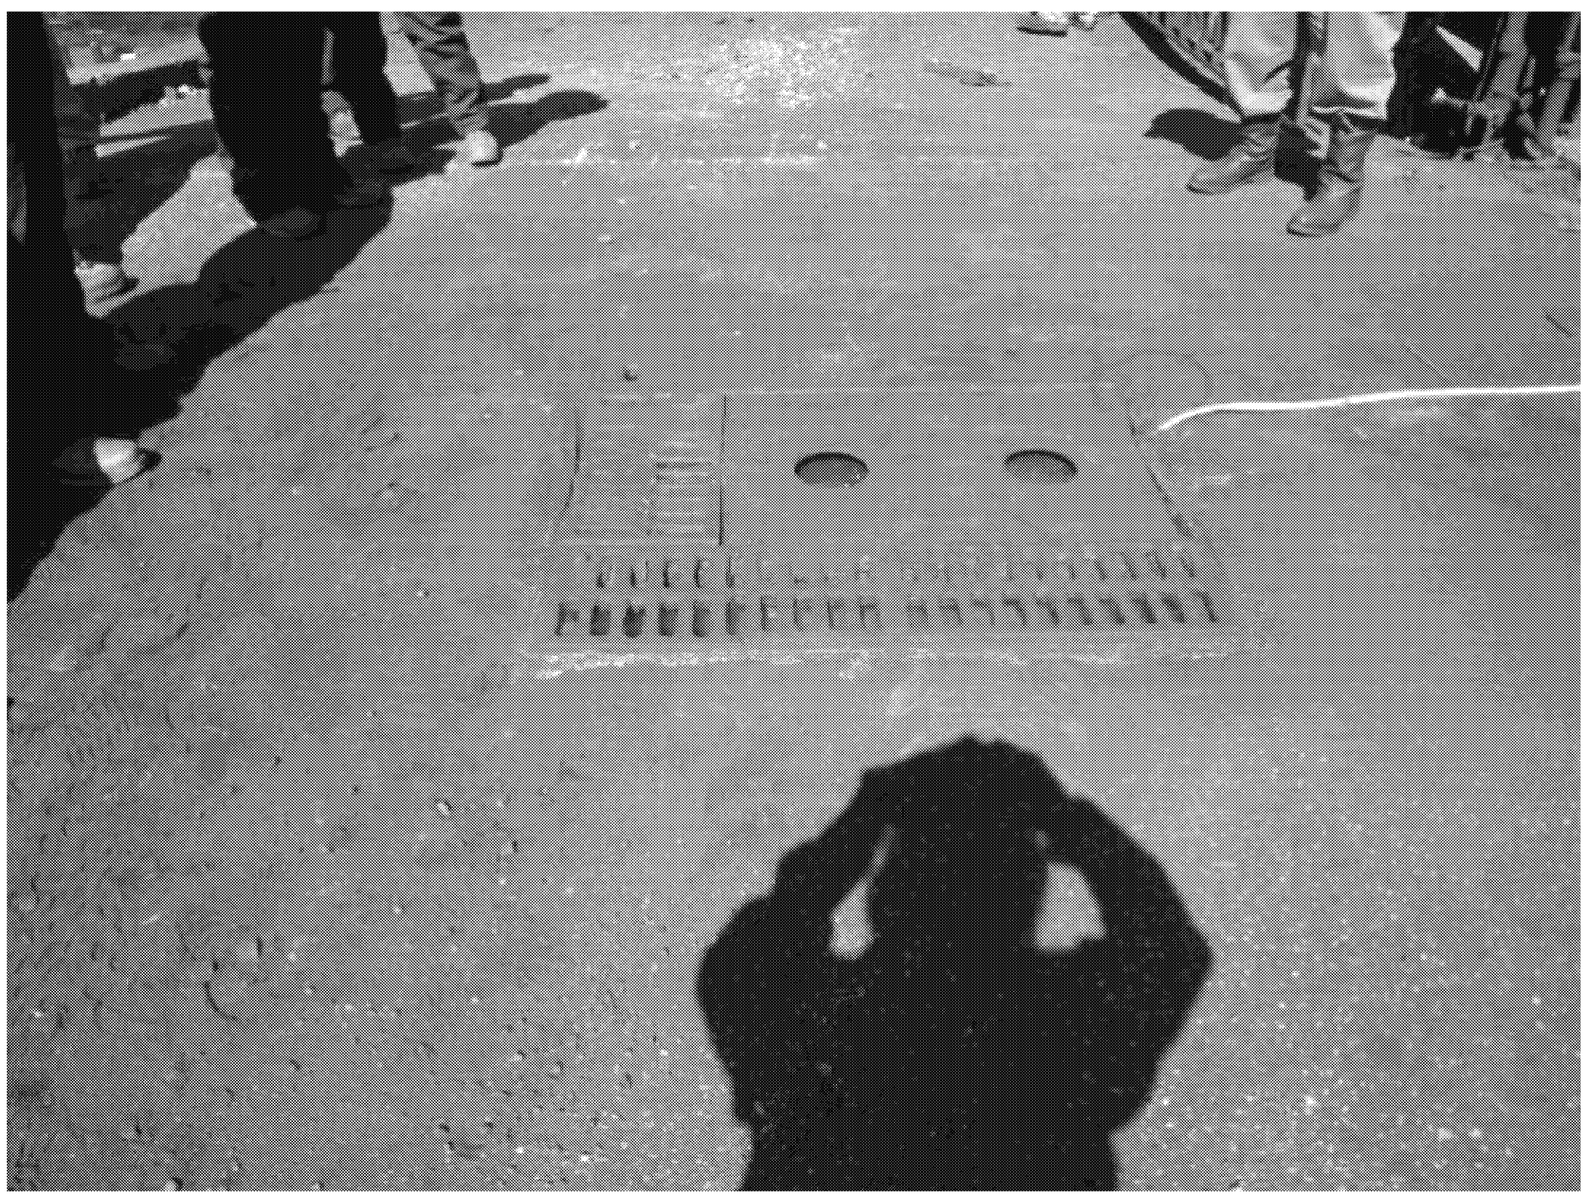
Photo Number: IMGP0007 Photographer: M. Hamre
Date/Time: 5/5/2011 9:39:46 AM
Description: Downcomer near gas distribution system back to battery

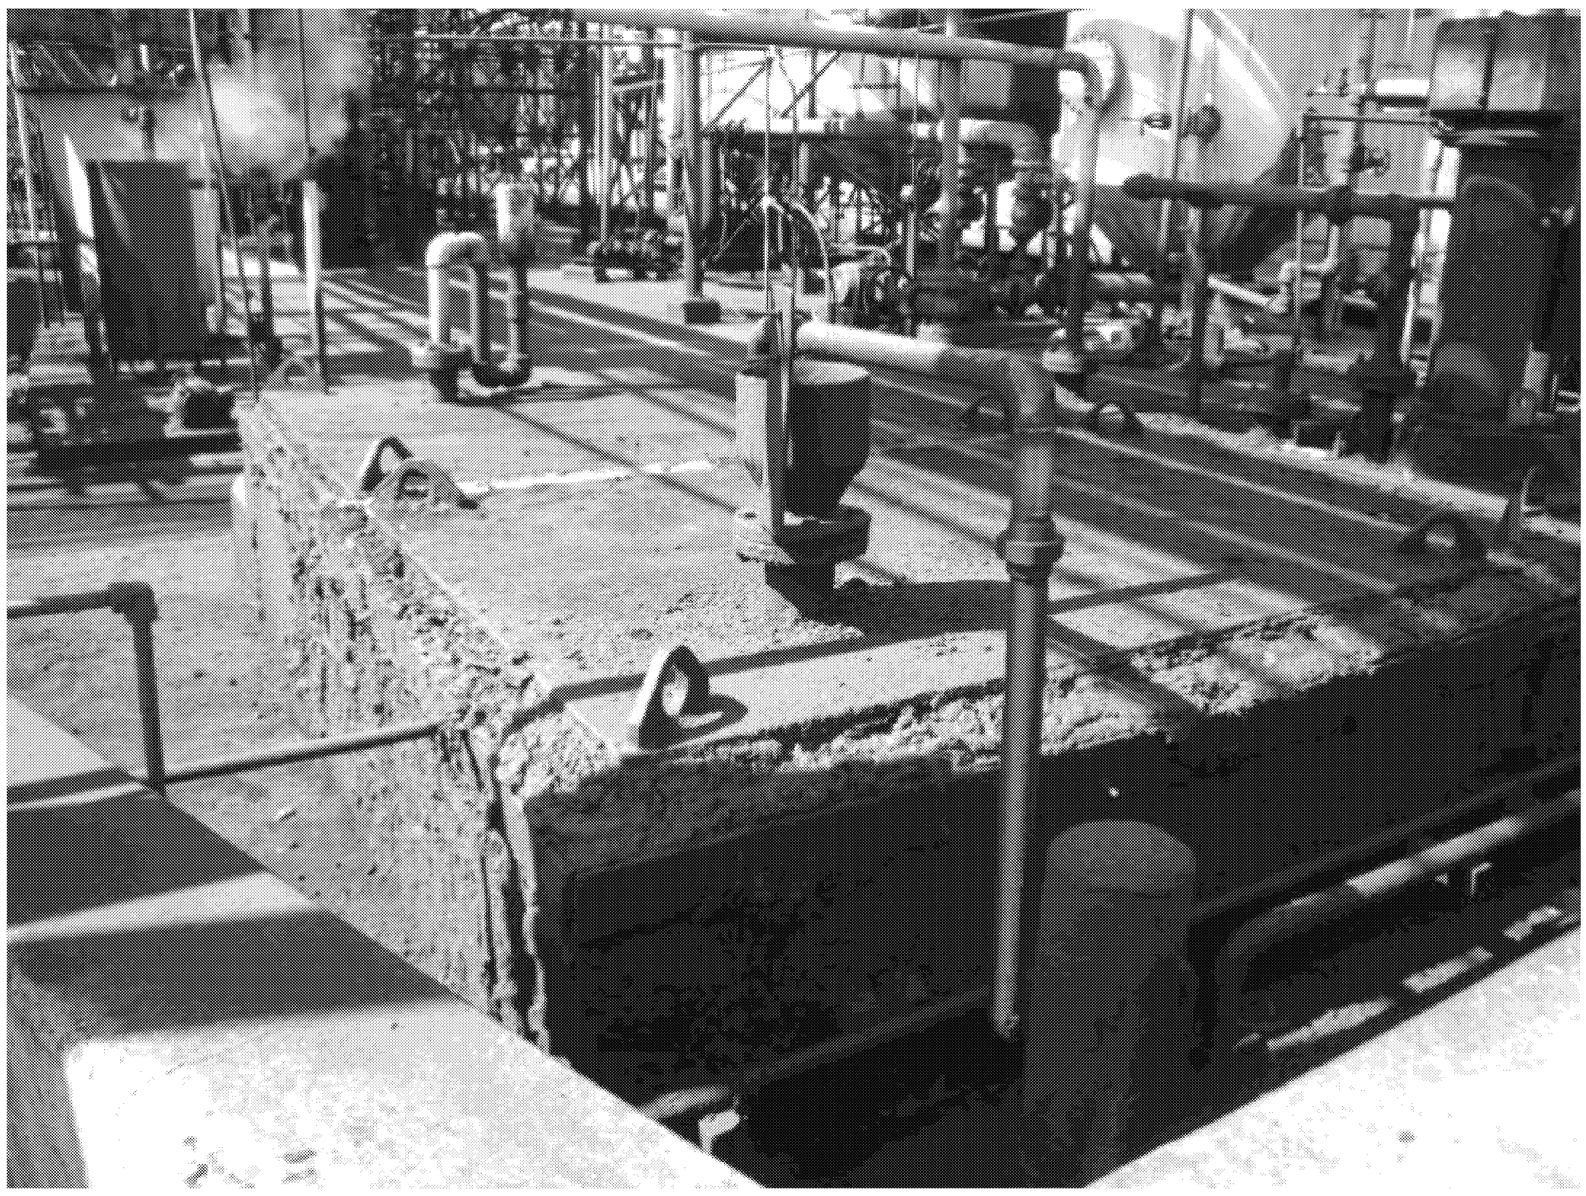
Photo Number: IMGP0009 Photographer: M. Hamre
Date/Time: 5/5/2011 9:56:59 AM
Description: Naphthalene sump (facing east)

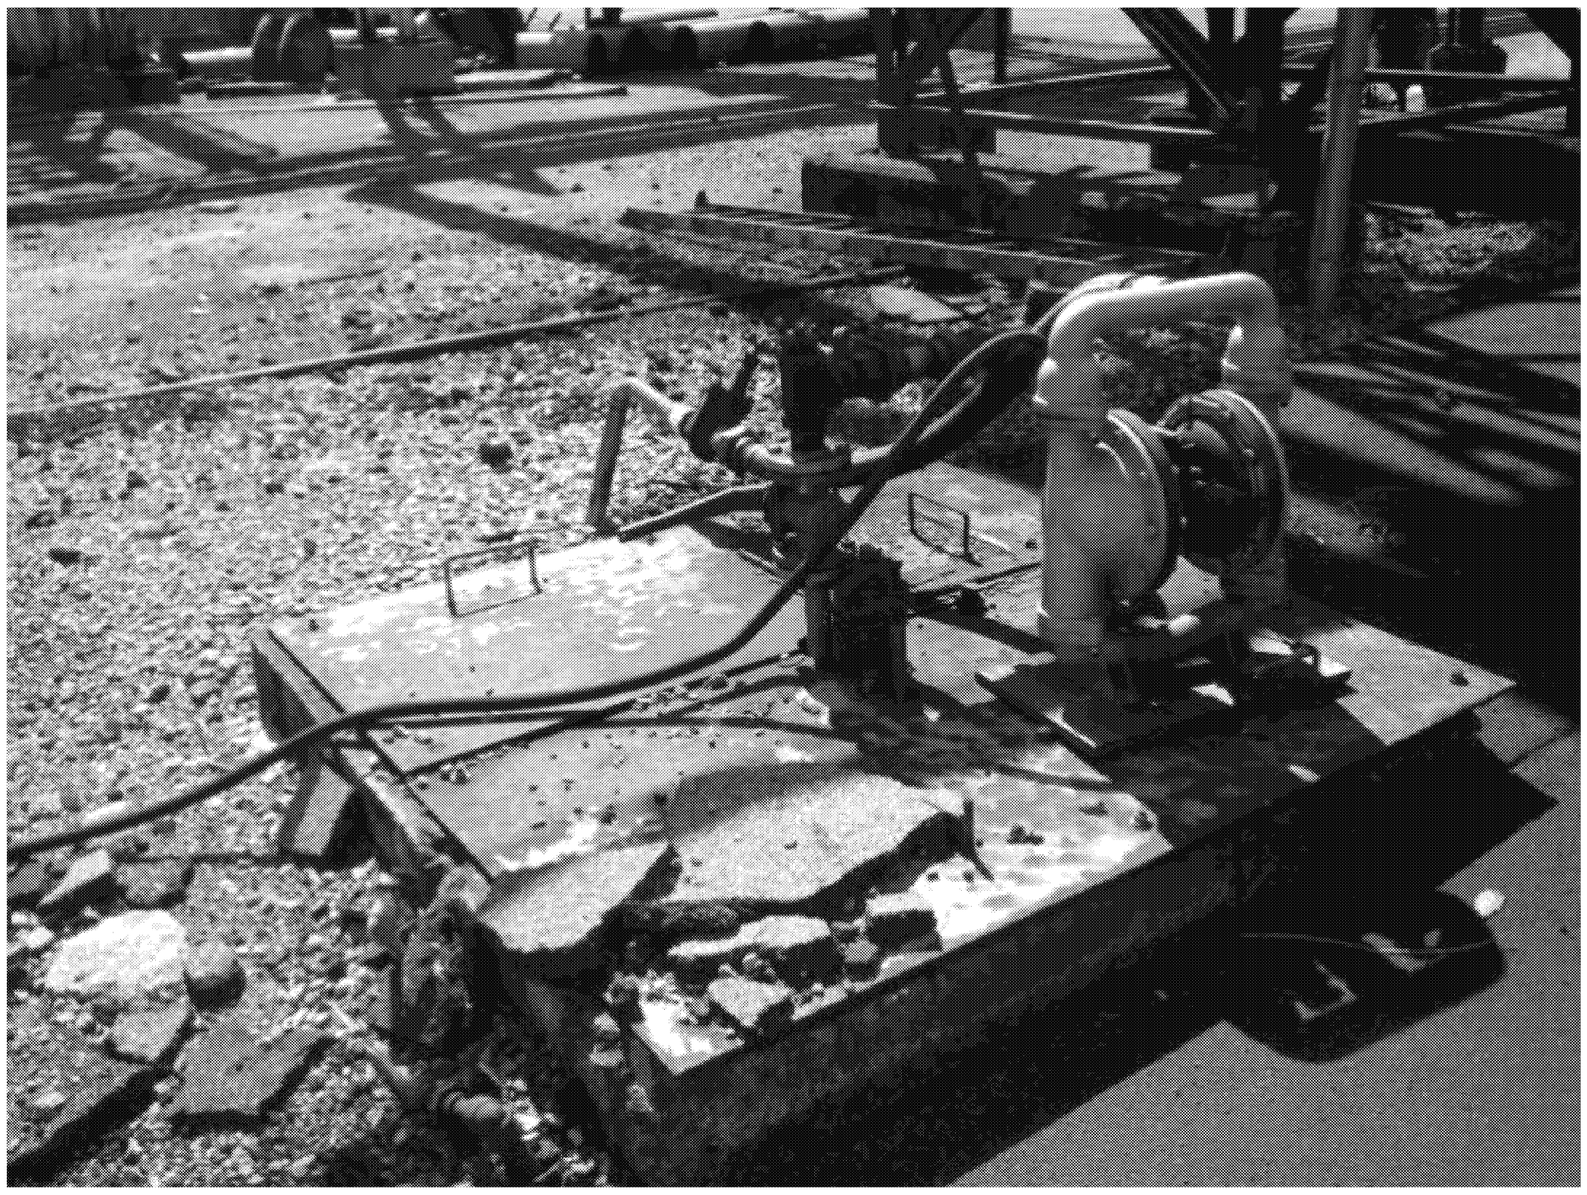
Photo Number: IMGP0011 Photographer: M. Hamre
Date/Time: 5/5/2011 10:02:56 AM
Description: Beckers battery suction line and liquor line (back to batteries)

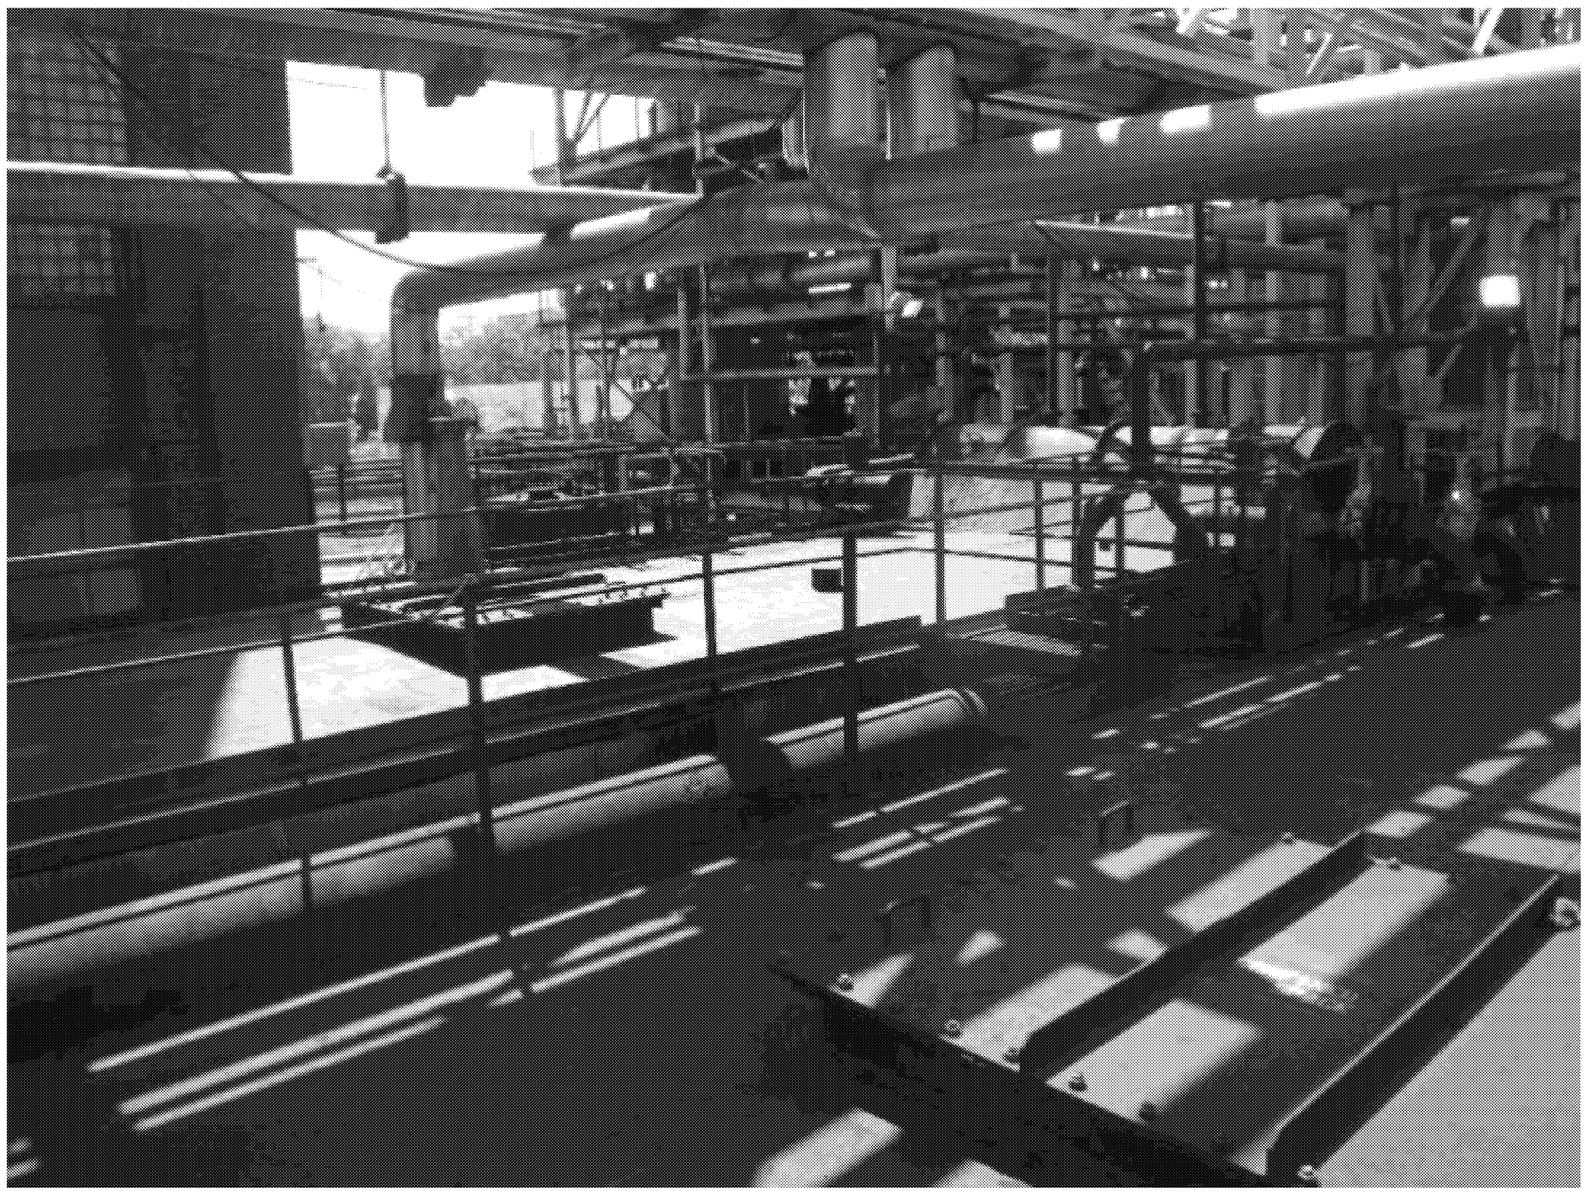
Photo Number: IMGP0012 Photographer: M. Hamre
Date/Time: 5/5/2011 10:06:29 AM
Description: Fuel gas main drip pot

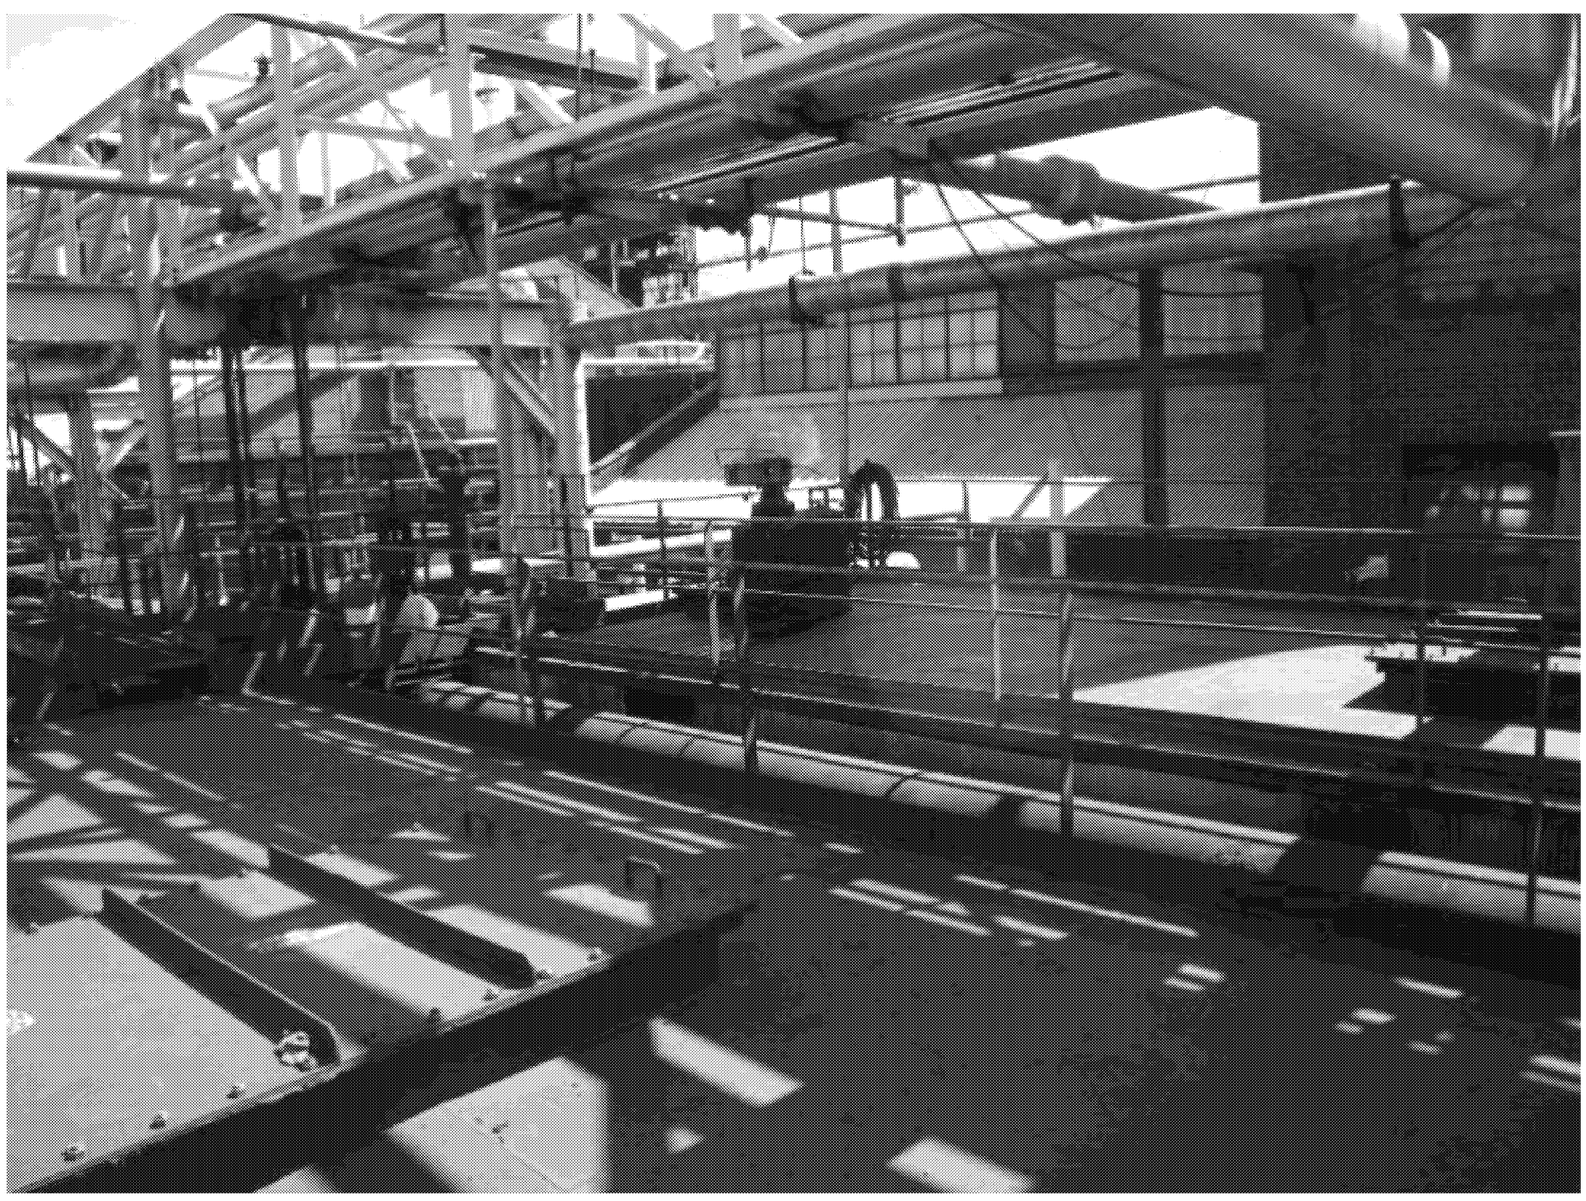
Photo Number: IMGP0013 Photographer: M. Hamre
Date/Time: 5/5/2011 10:30:48 AM
Description: Tar decanter -east

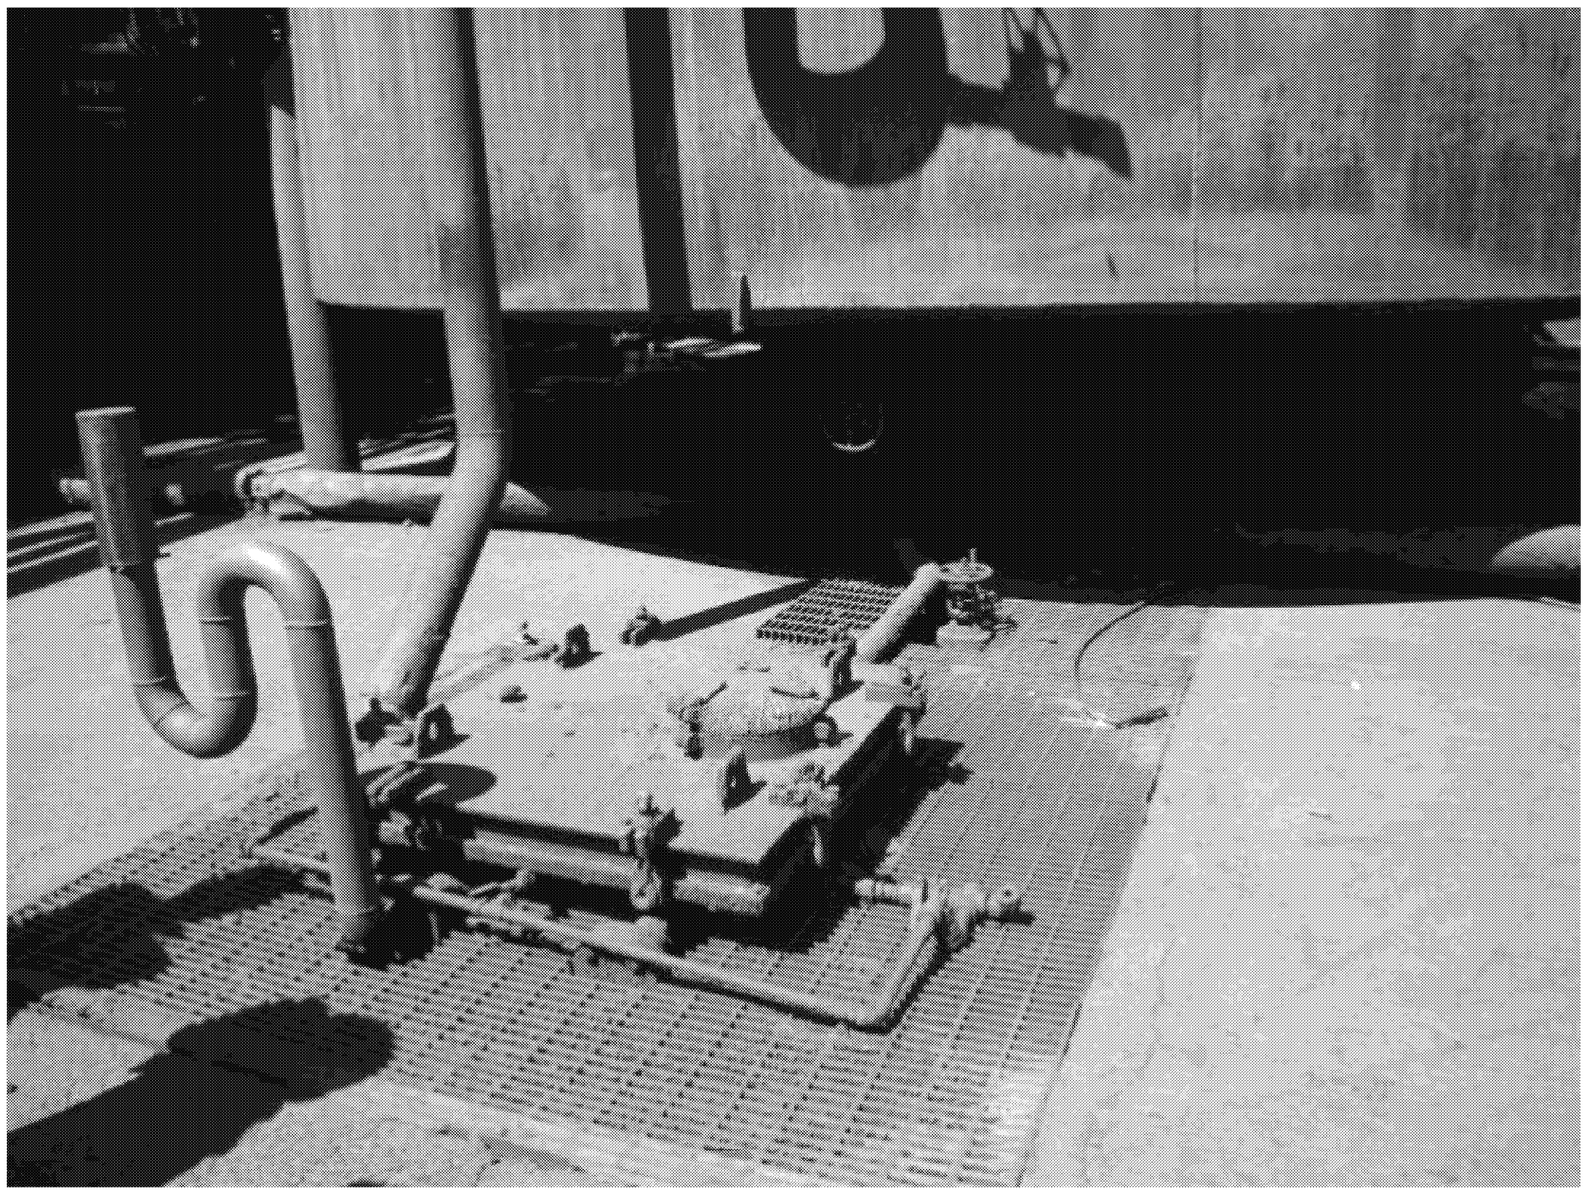
Photo Number: IMGP0015 Photographer: M. Hamre
Date/Time: 5/5/2011 10:31:29 AM
Description: Flushing liquor circulation tank

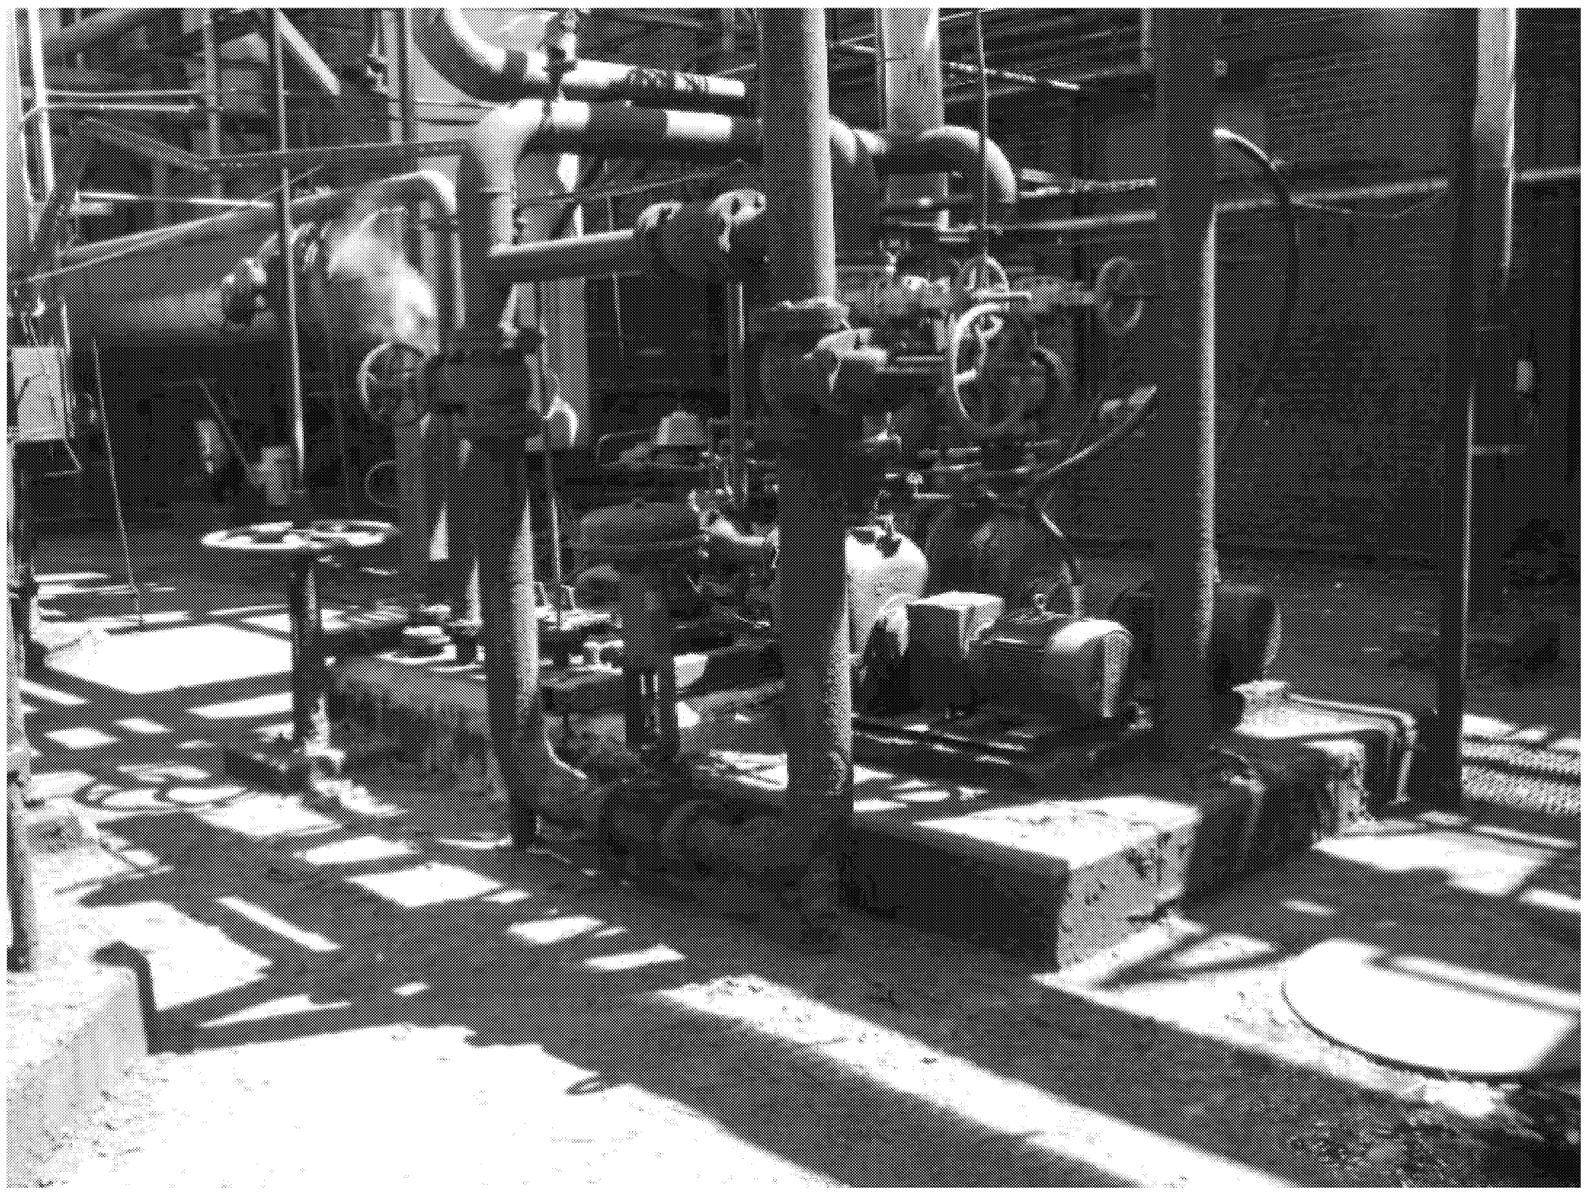
Photo Number: IMGP0016 Photographer: M. Hamre
Date/Time: 5/5/2011 10:47:24 AM
Description: Tar drain pan off flushing liquor circulation tank

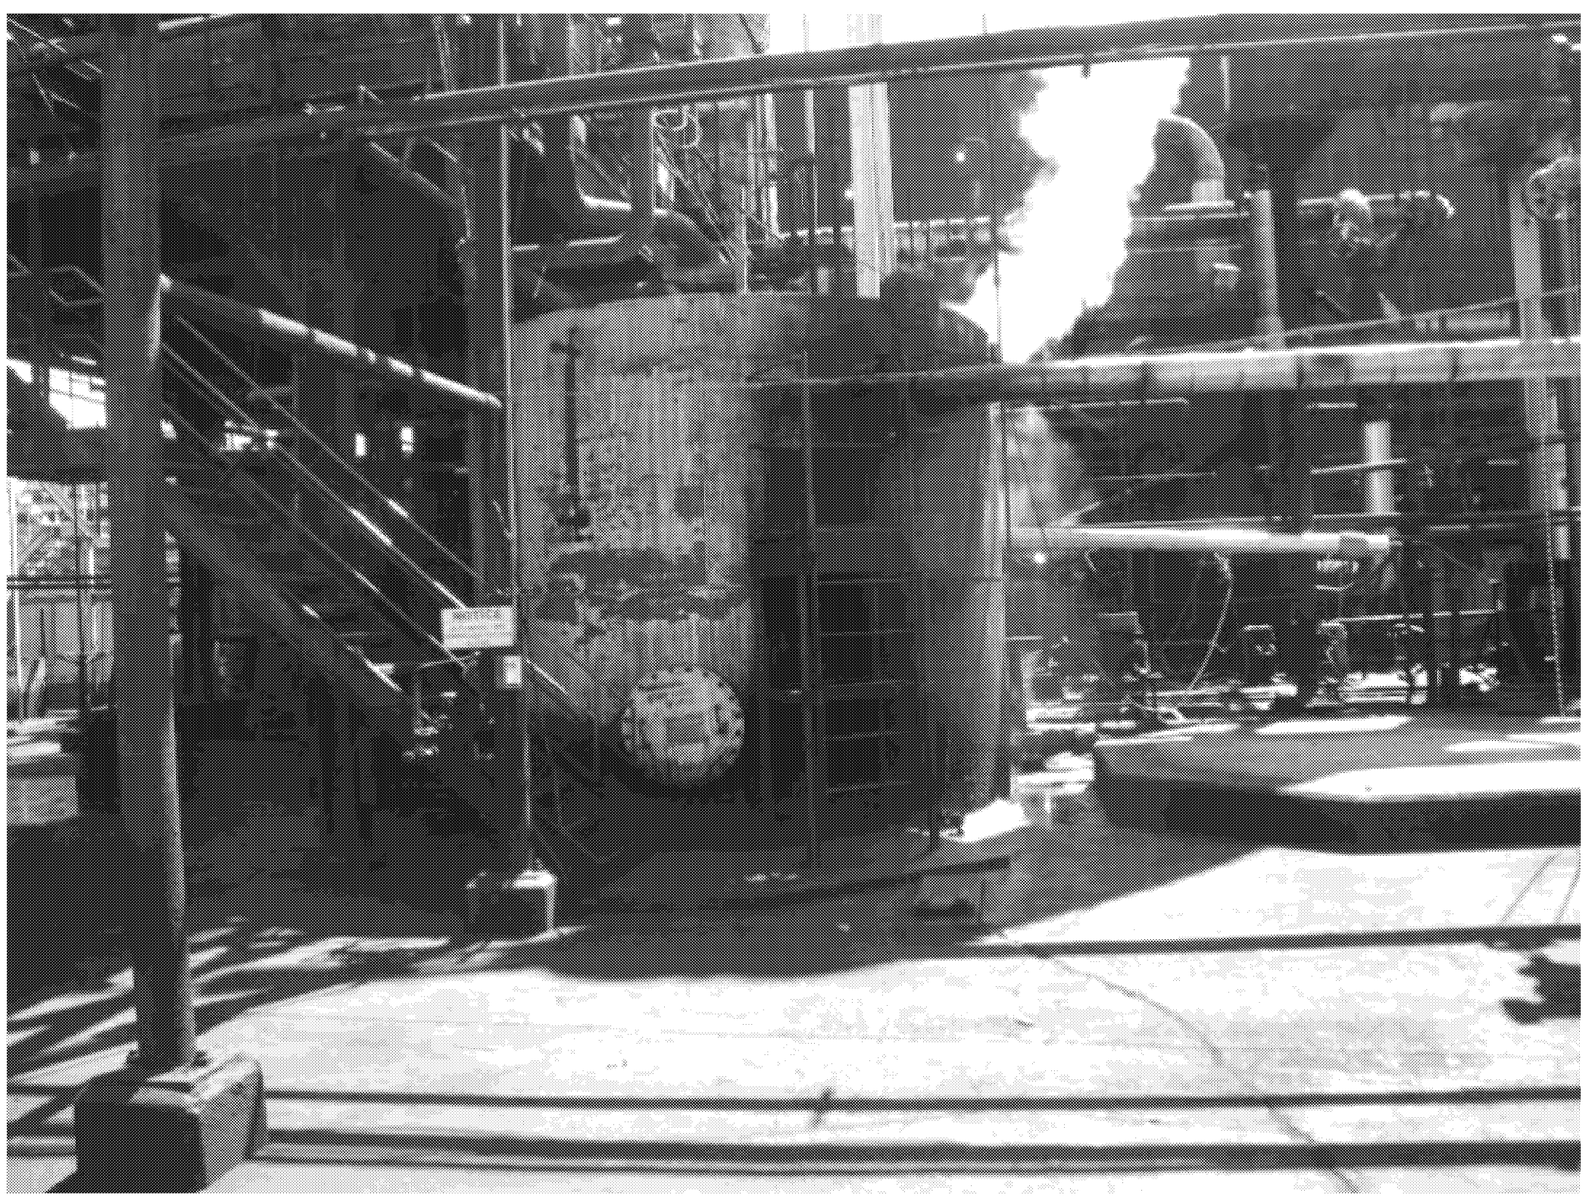
Photo Number: IMGP0017 Photographer: M. Hamre
Date/Time: 5/5/2011 10:53:42 AM
Description: Primary cooler sump

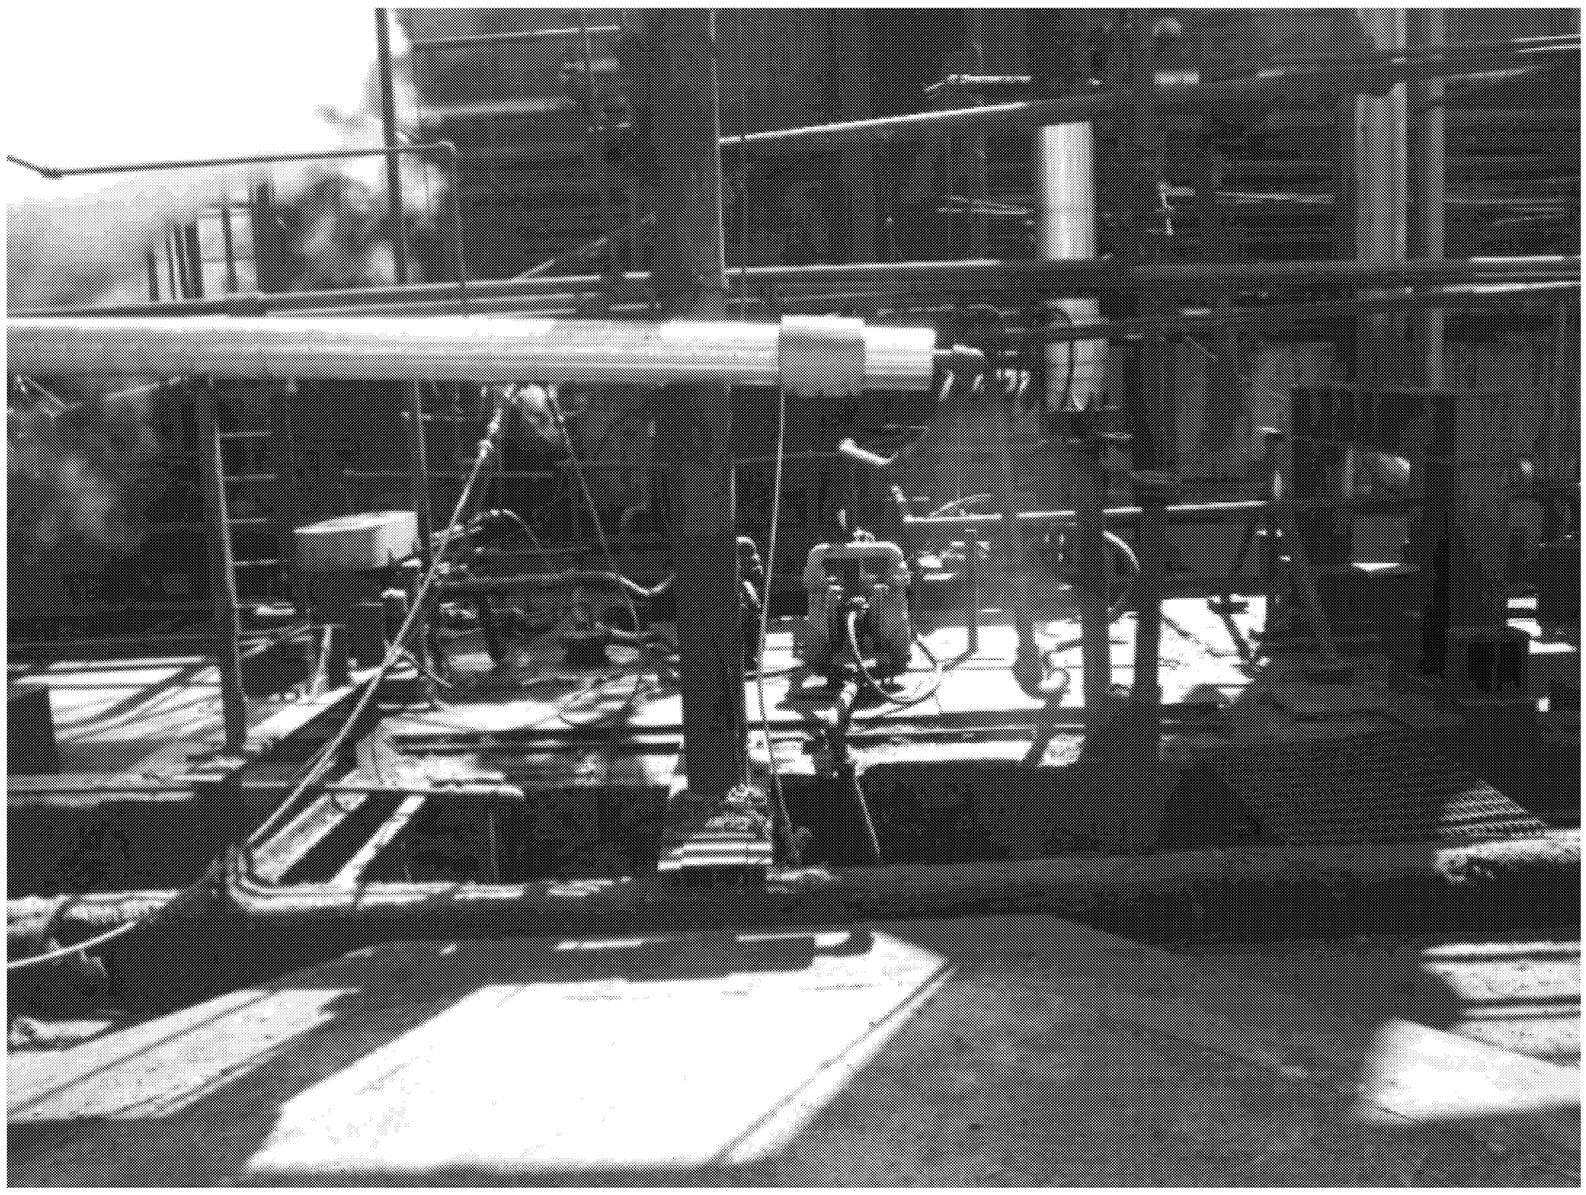
Photo Number: IMGP0018 Photographer: M. Hamre
Date/Time: 5/5/2011 10:59:06 AM
Description: Wilputte decanter

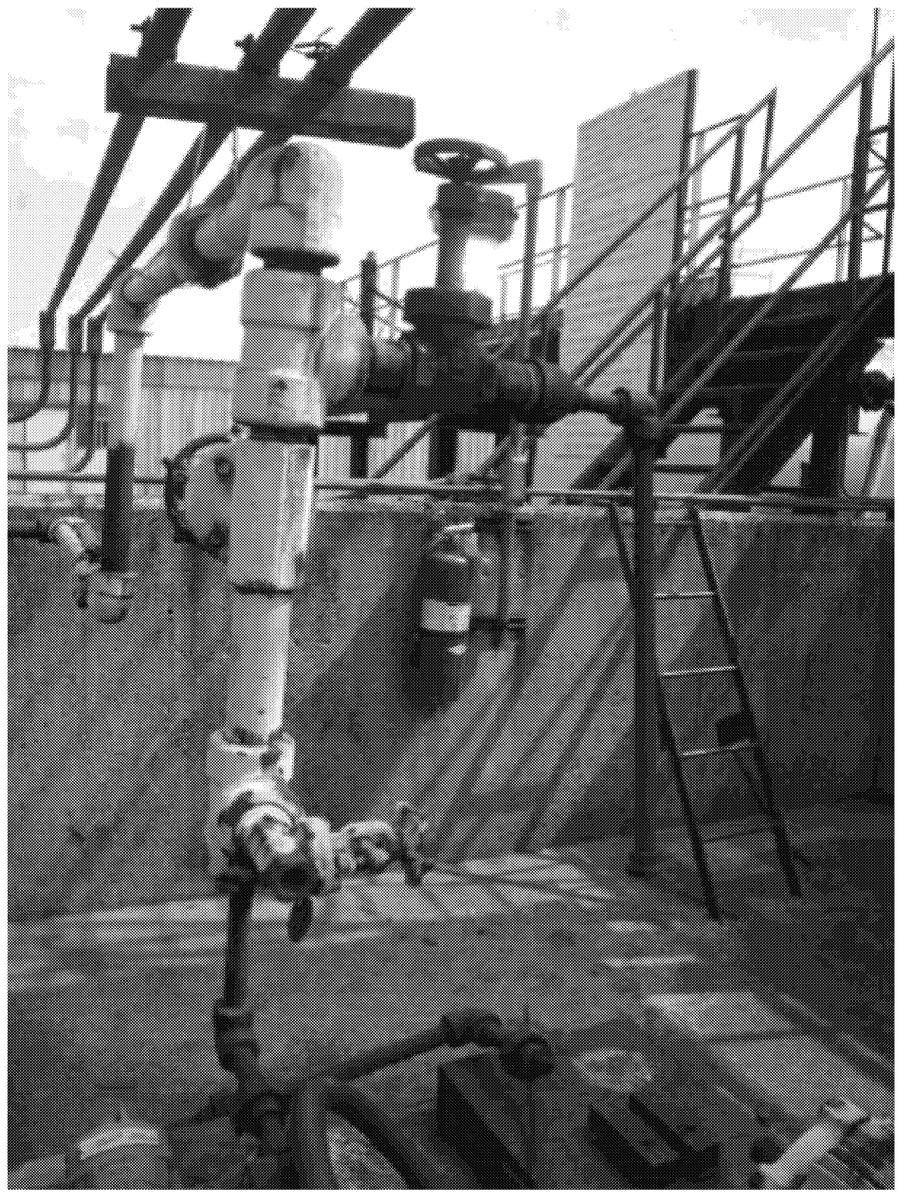
Photo Number: IMGP0036 Photographer: D. Au
Date/Time: 5/6/2011 10:10:55 AM
Description: Open-ended line on BZ 6480

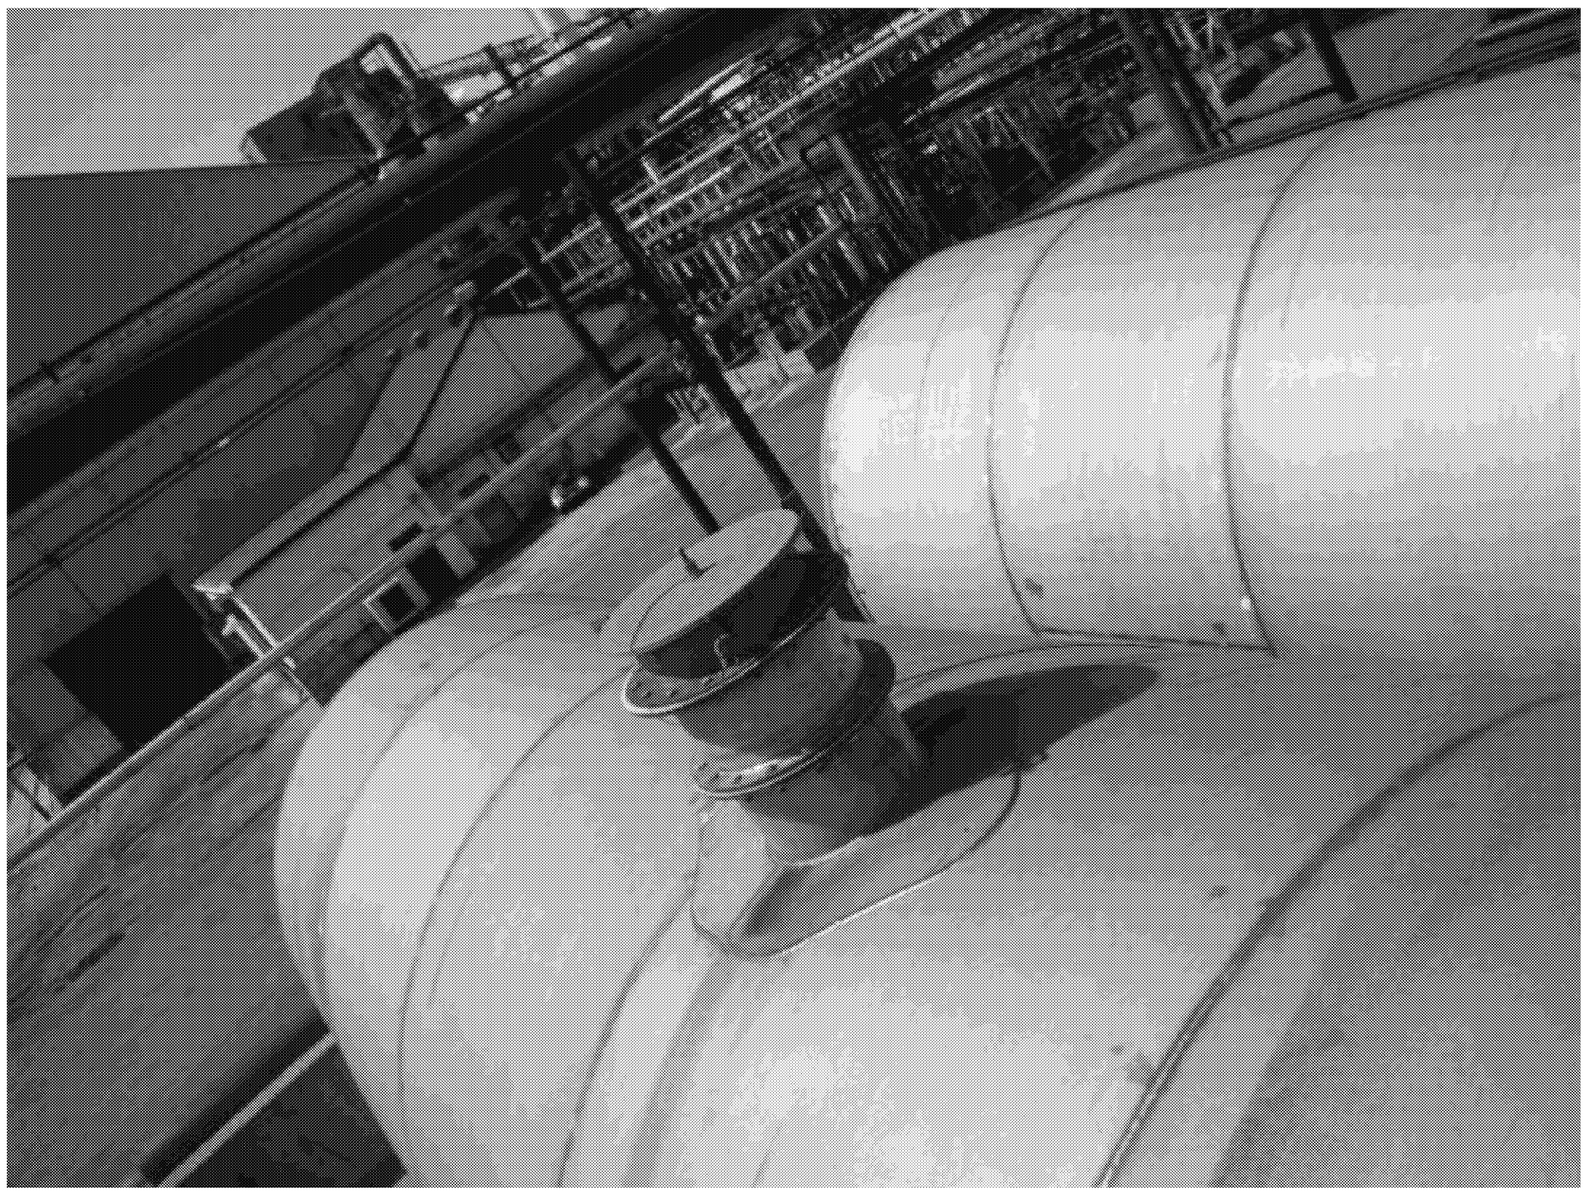
Photo Number: IMGP0038 Photographer: D. Au
Date/Time: 5/6/2011 10:42:20 AM
Description: West light oil tank rupture disk-relief device

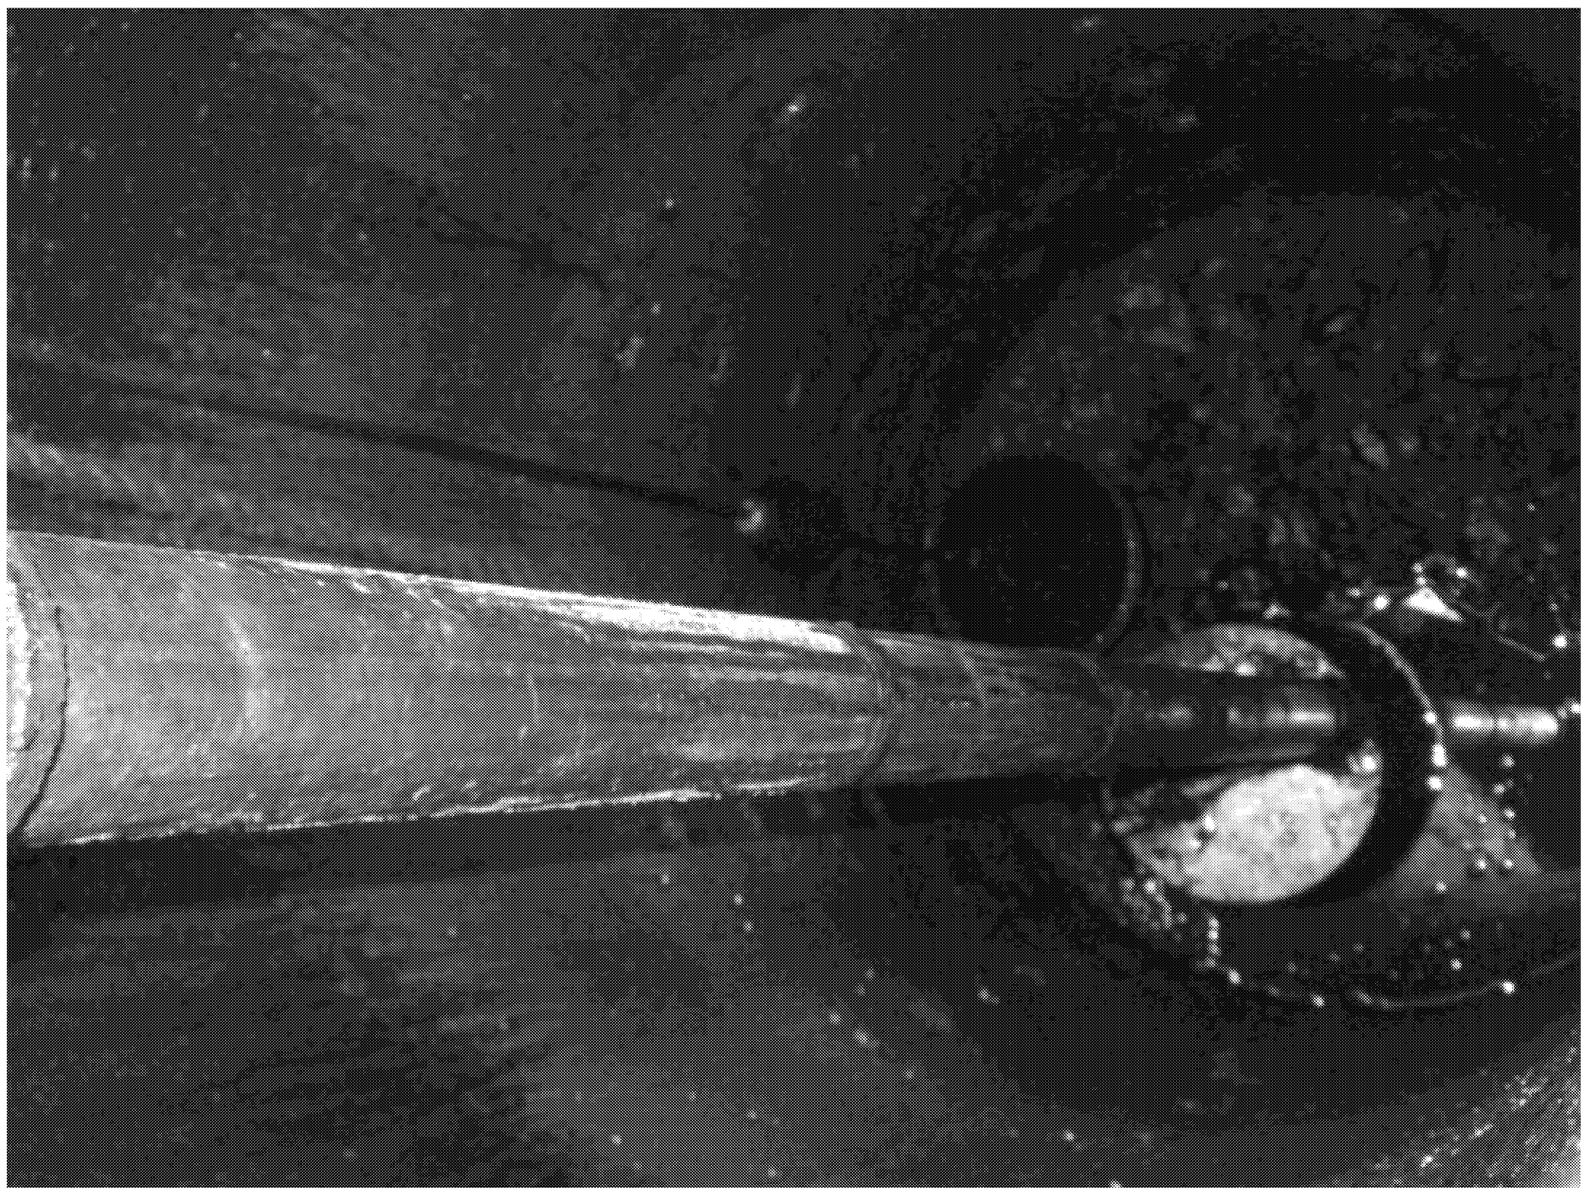
Photo Number: IMGP0048 Photographer: D. Au
Date/Time: 5/6/2011 11:51:11 AM
Description: Visual leak on pipe next to sump uptake near Wilputte decanter
