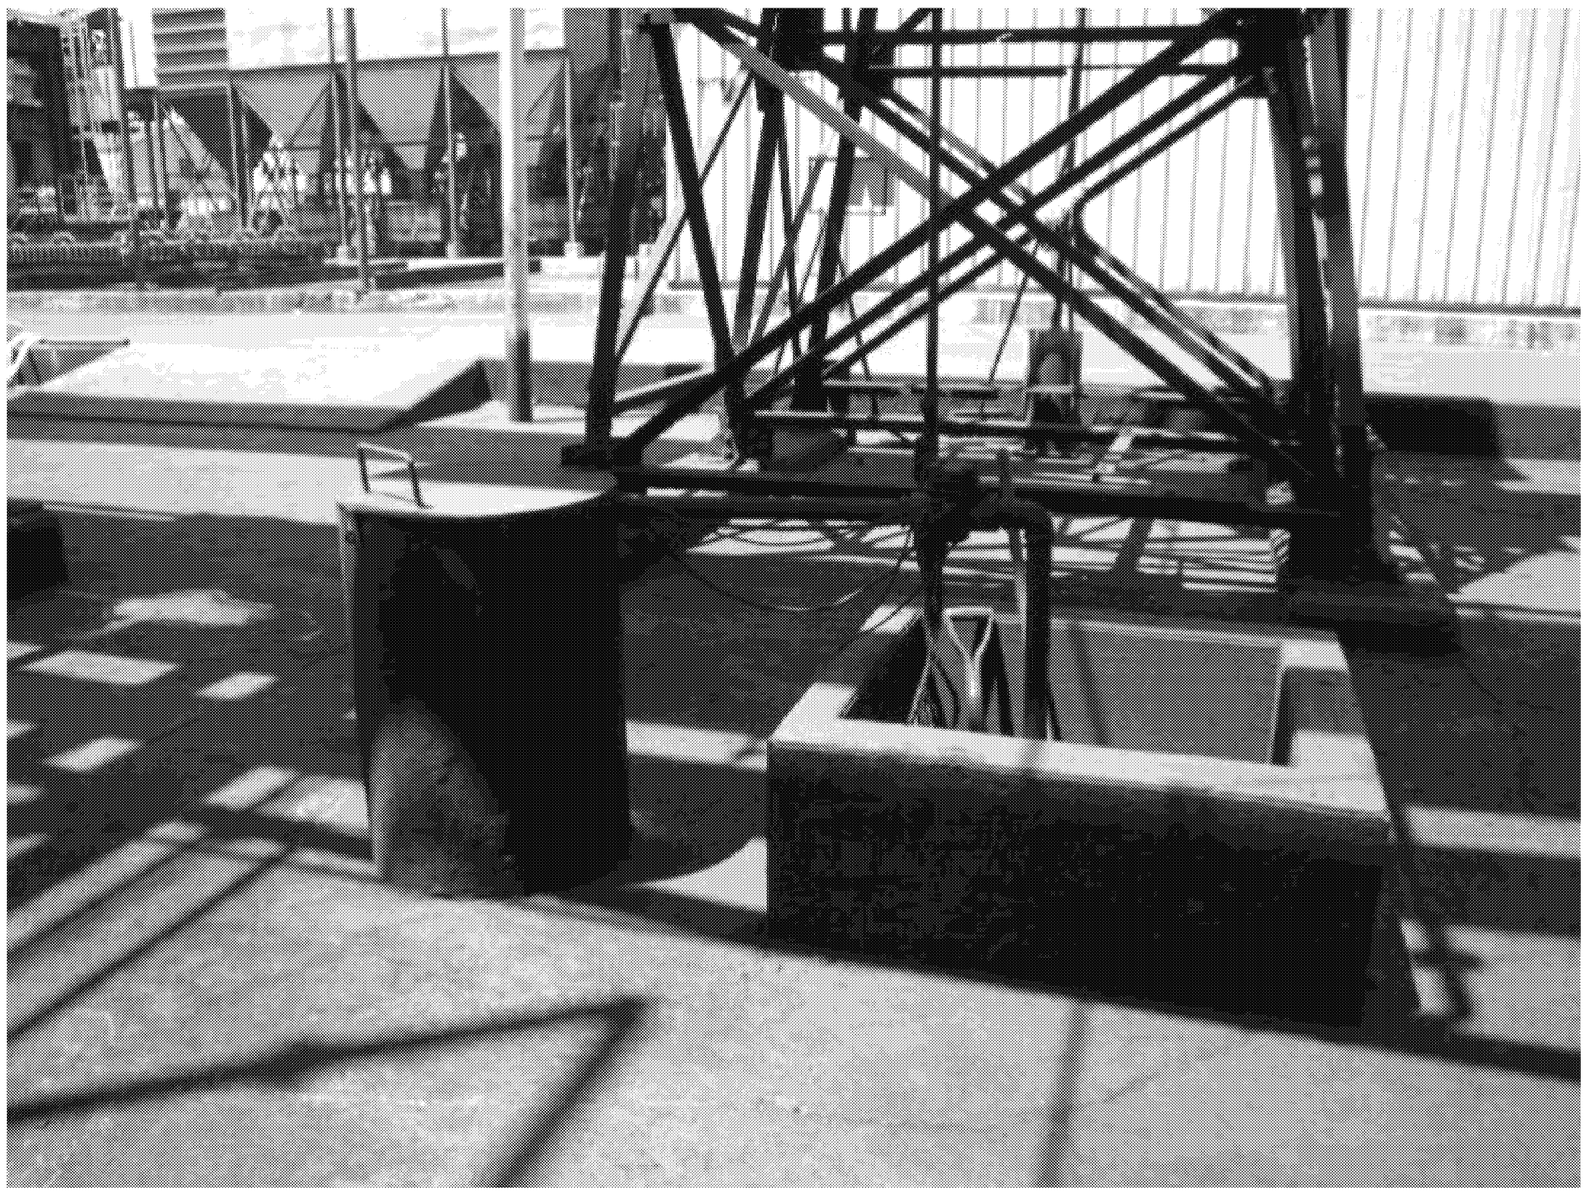
Photo Number: IMGP0050 Photographer: D. Au
Date/Time: 5/6/2011 11:53:39 AM
Description: Open vent on top of BTX tank near valve 6624

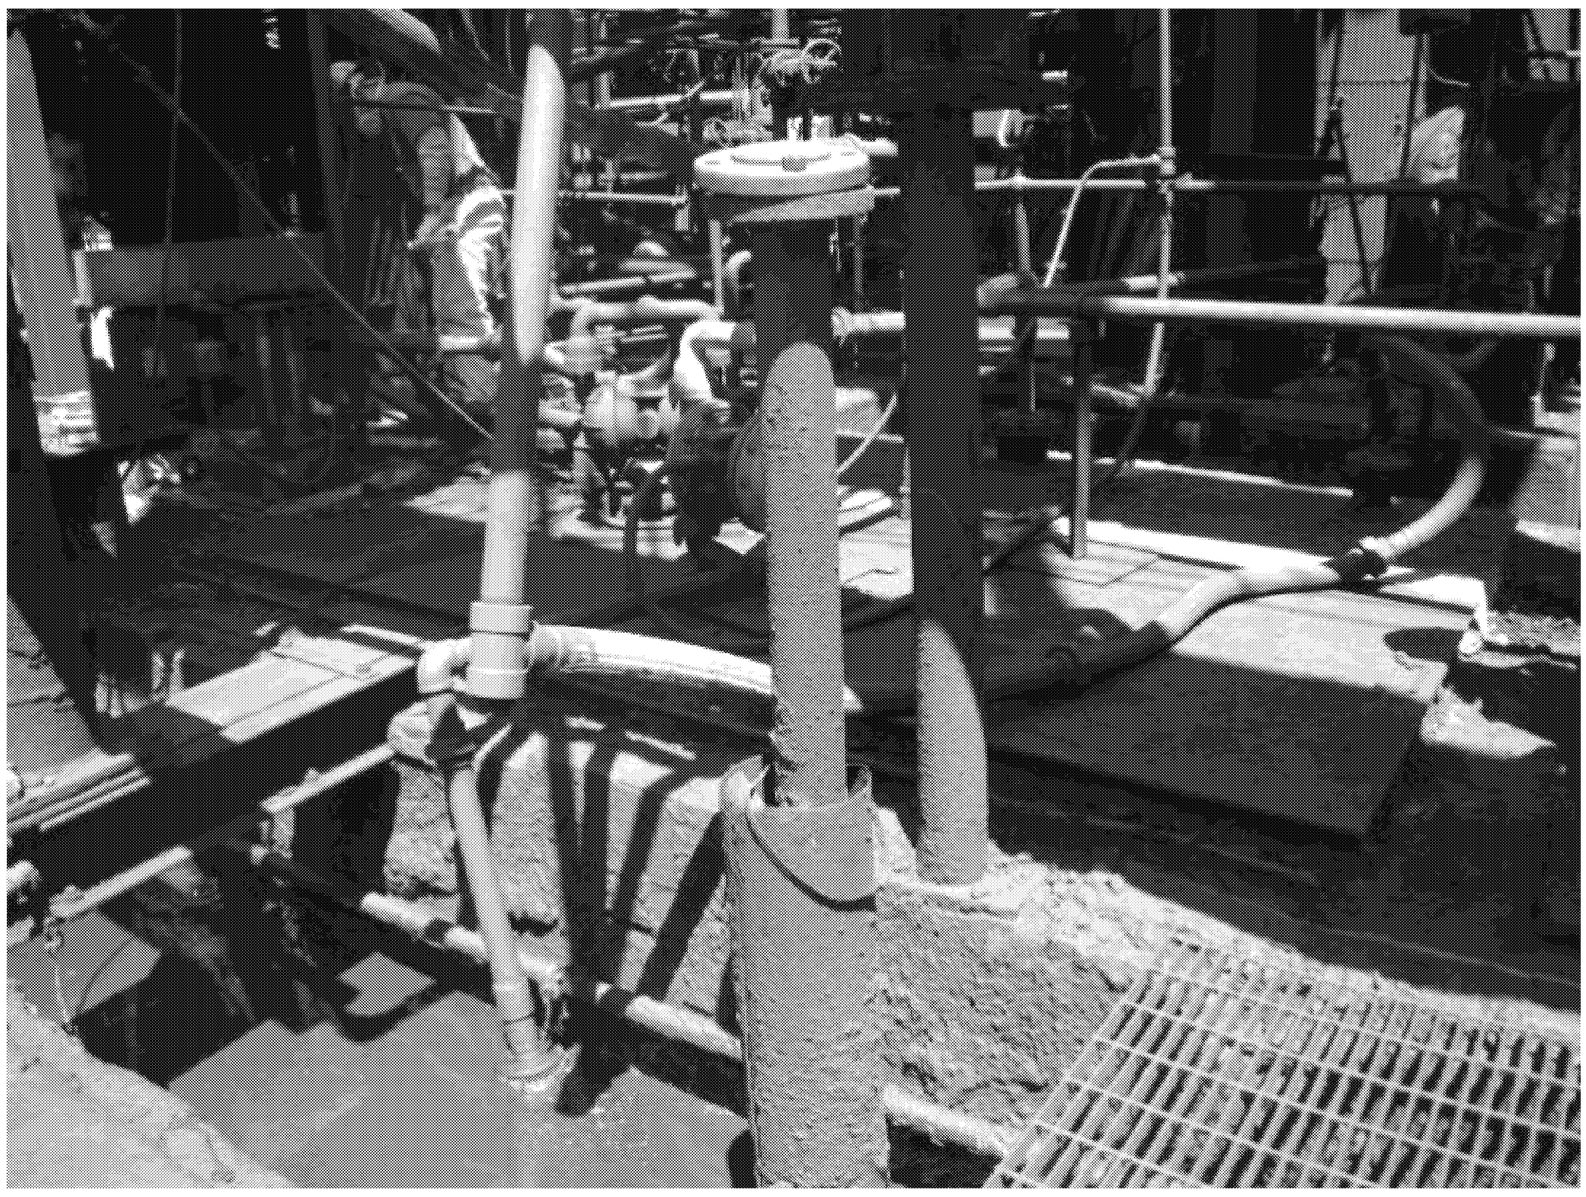
Photo Number: IMGP0051 Photographer: D. Au
Date/Time: 5/6/2011 11:54:36 AM
Description: Overview of sump and piping near Wilputte decanter

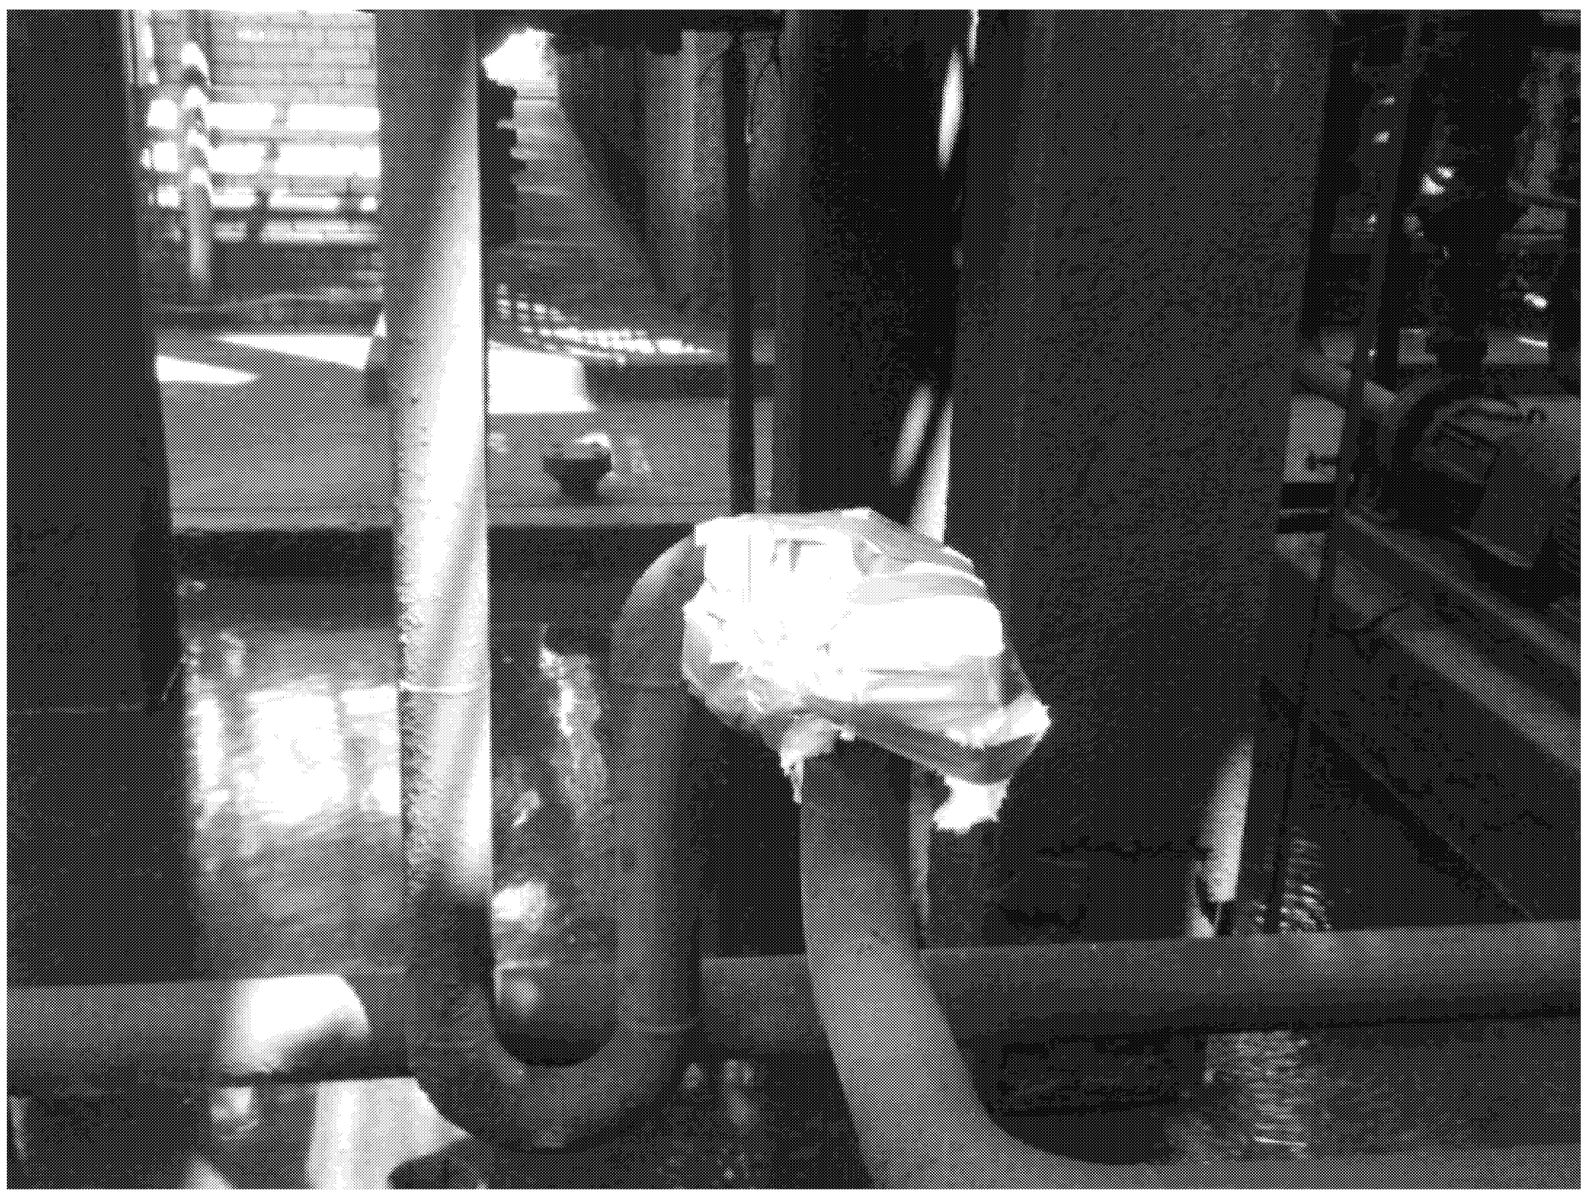
Photo Number: IMGP0053 Photographer: D. Au
Date/Time: 5/6/2011 1:55:27 PM
Description: Leaking seal on south side of dirty water sump

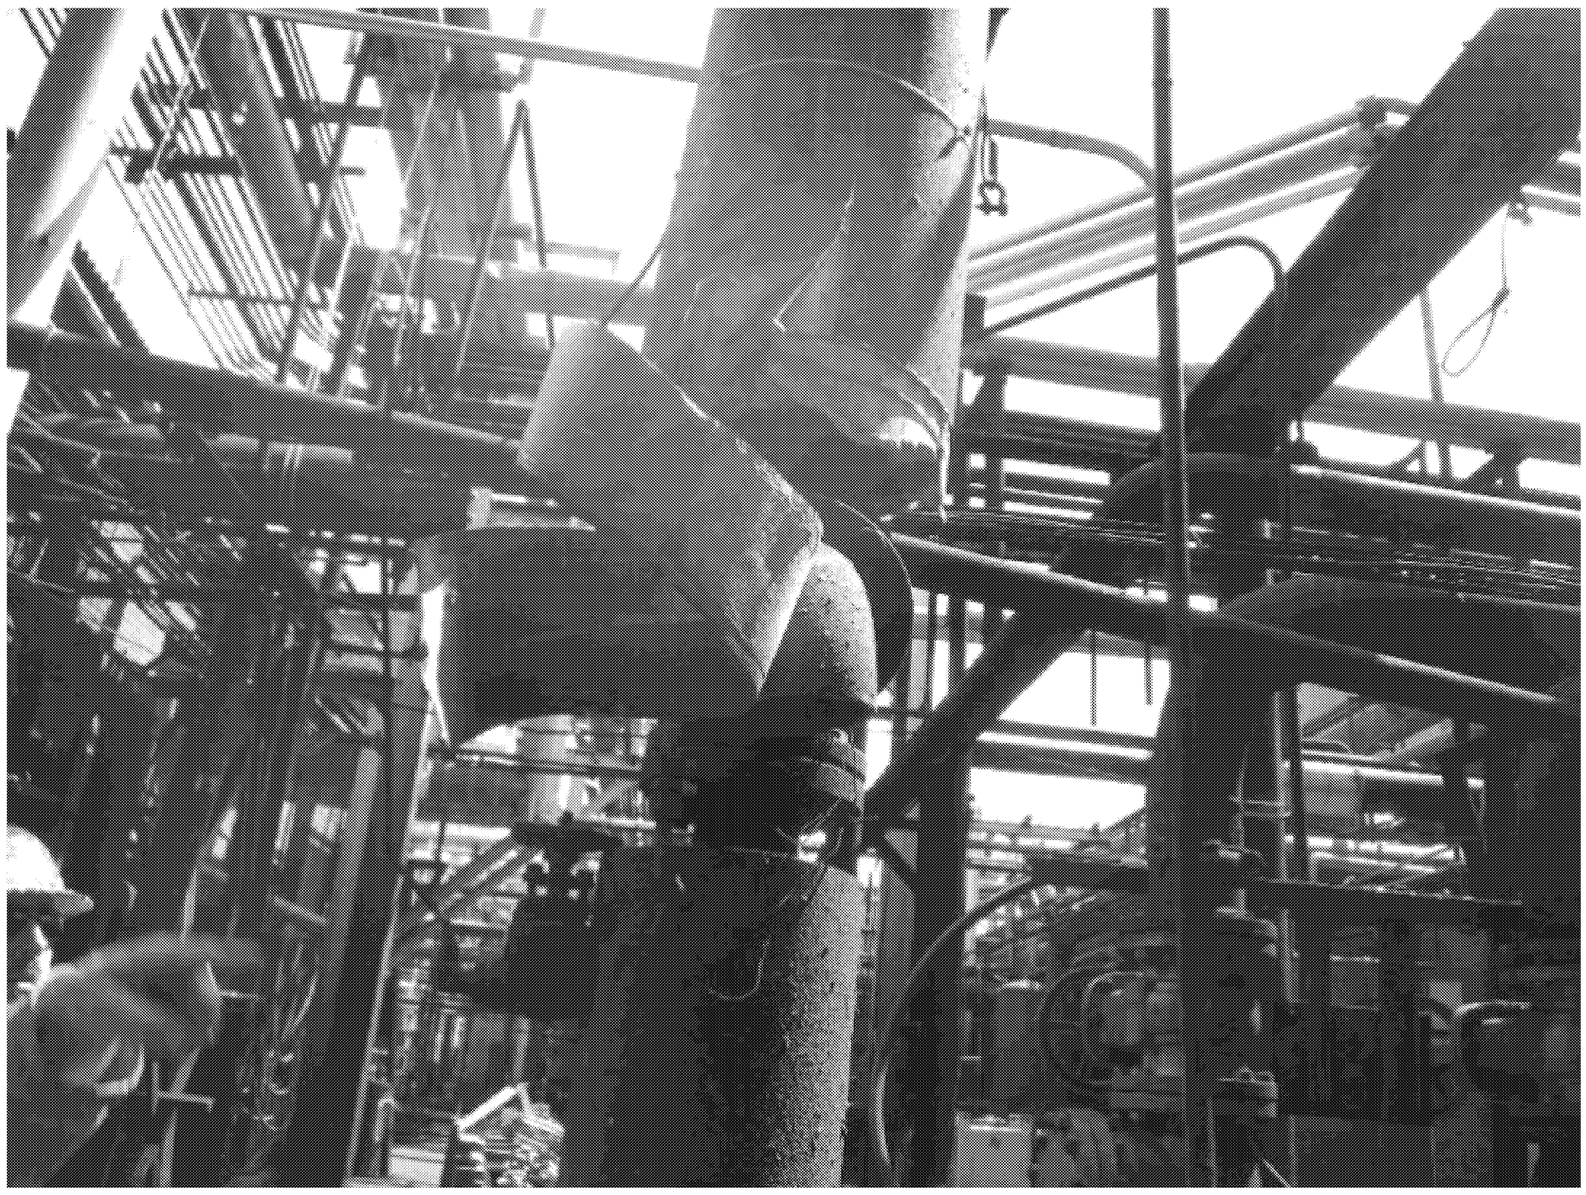
Photo Number: IMGP0054 Photographer: D. Au
Date/Time: 5/6/2011 2:25:56 PM
Description: BTX tank decanter water overflow pipe and funnel sealed with duct tape and insulation

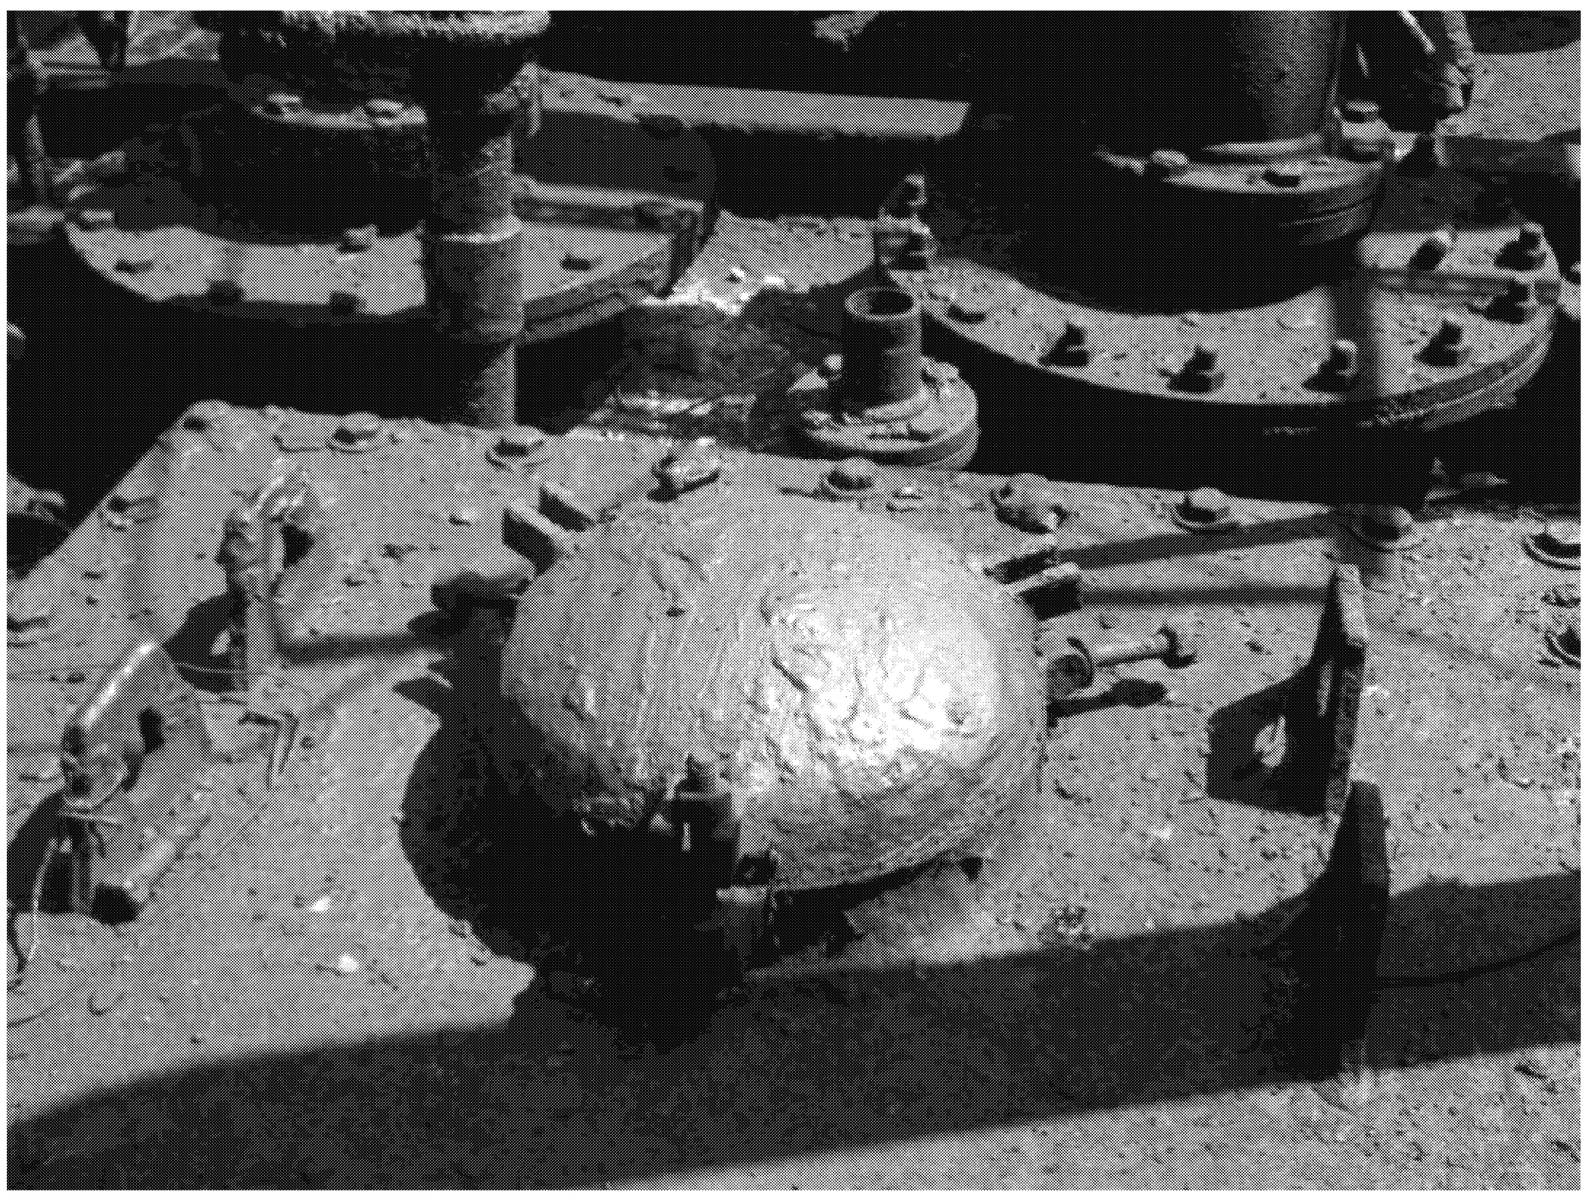
Photo Number: IMGP0055 Photographer: D. Au
Date/Time: 5/6/2011 2:48:58 PM
Description: Open vent off primary cooler sump

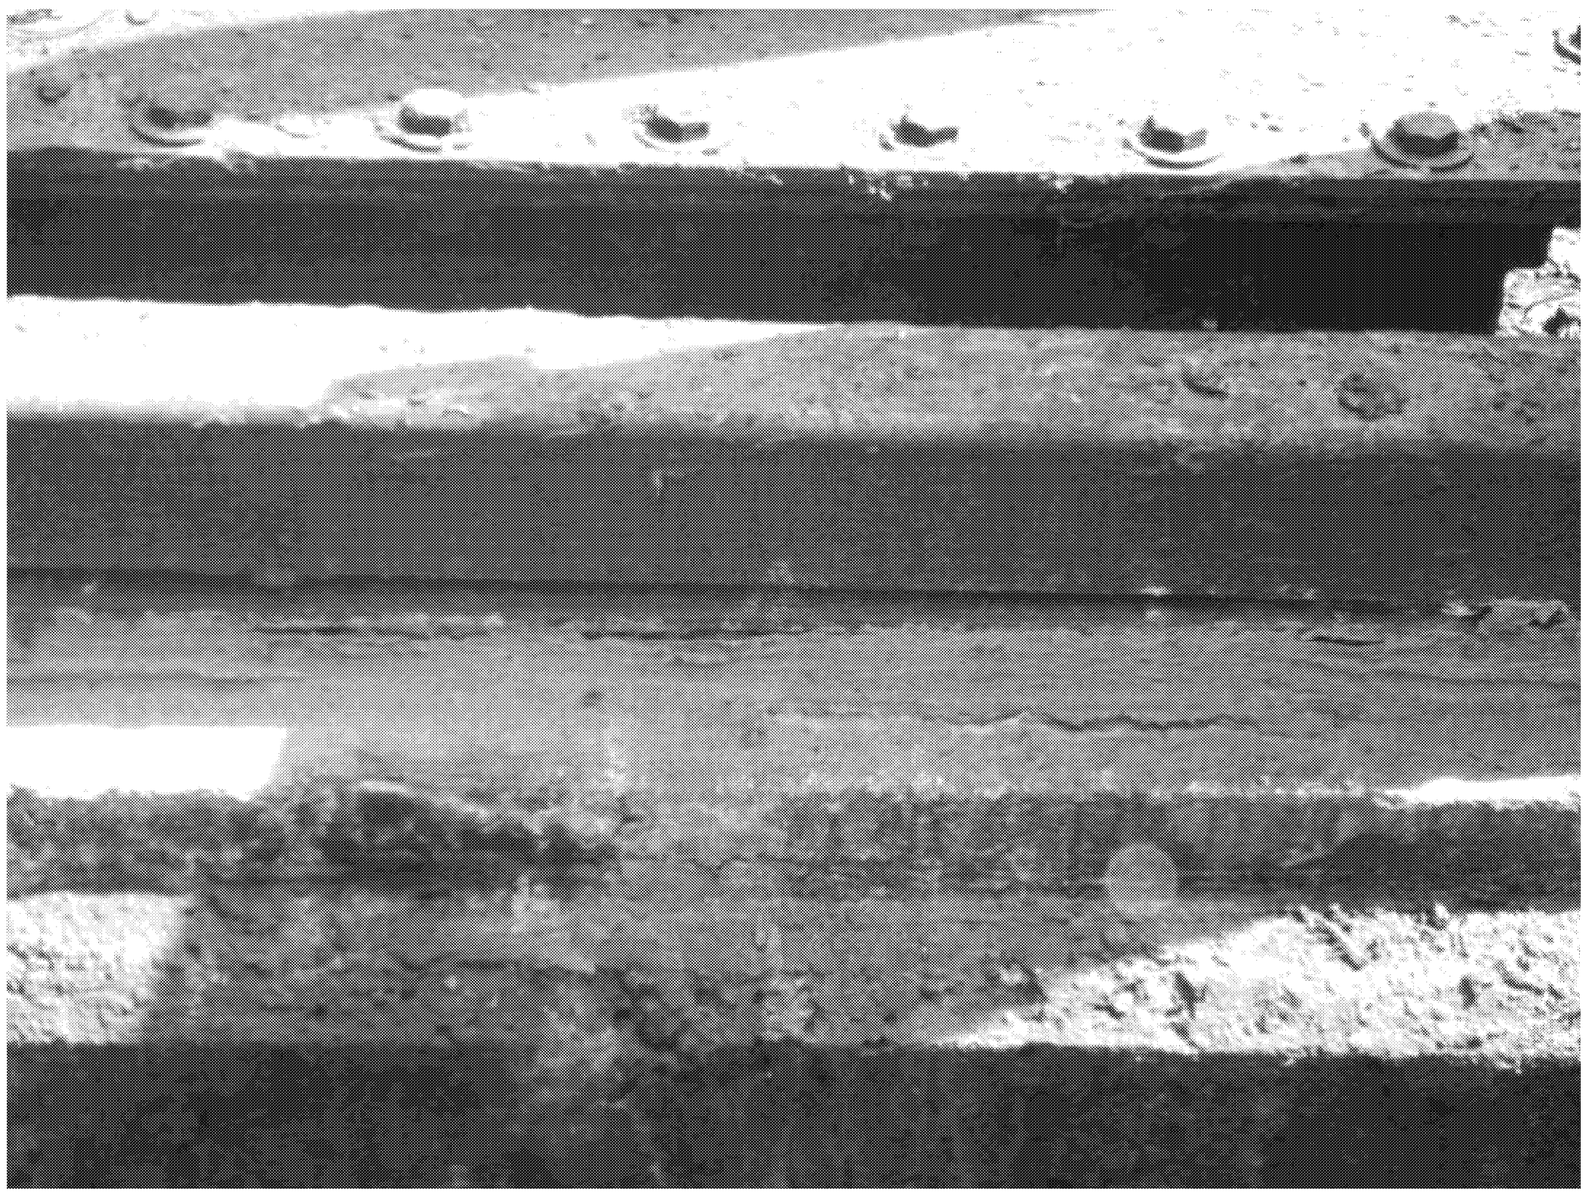
Photo Number: IMGP0056 Photographer: D. Au
Date/Time: 5/6/2011 2:53:56 PM
Description: Leaking rounded hatch cover on primary cooler sump

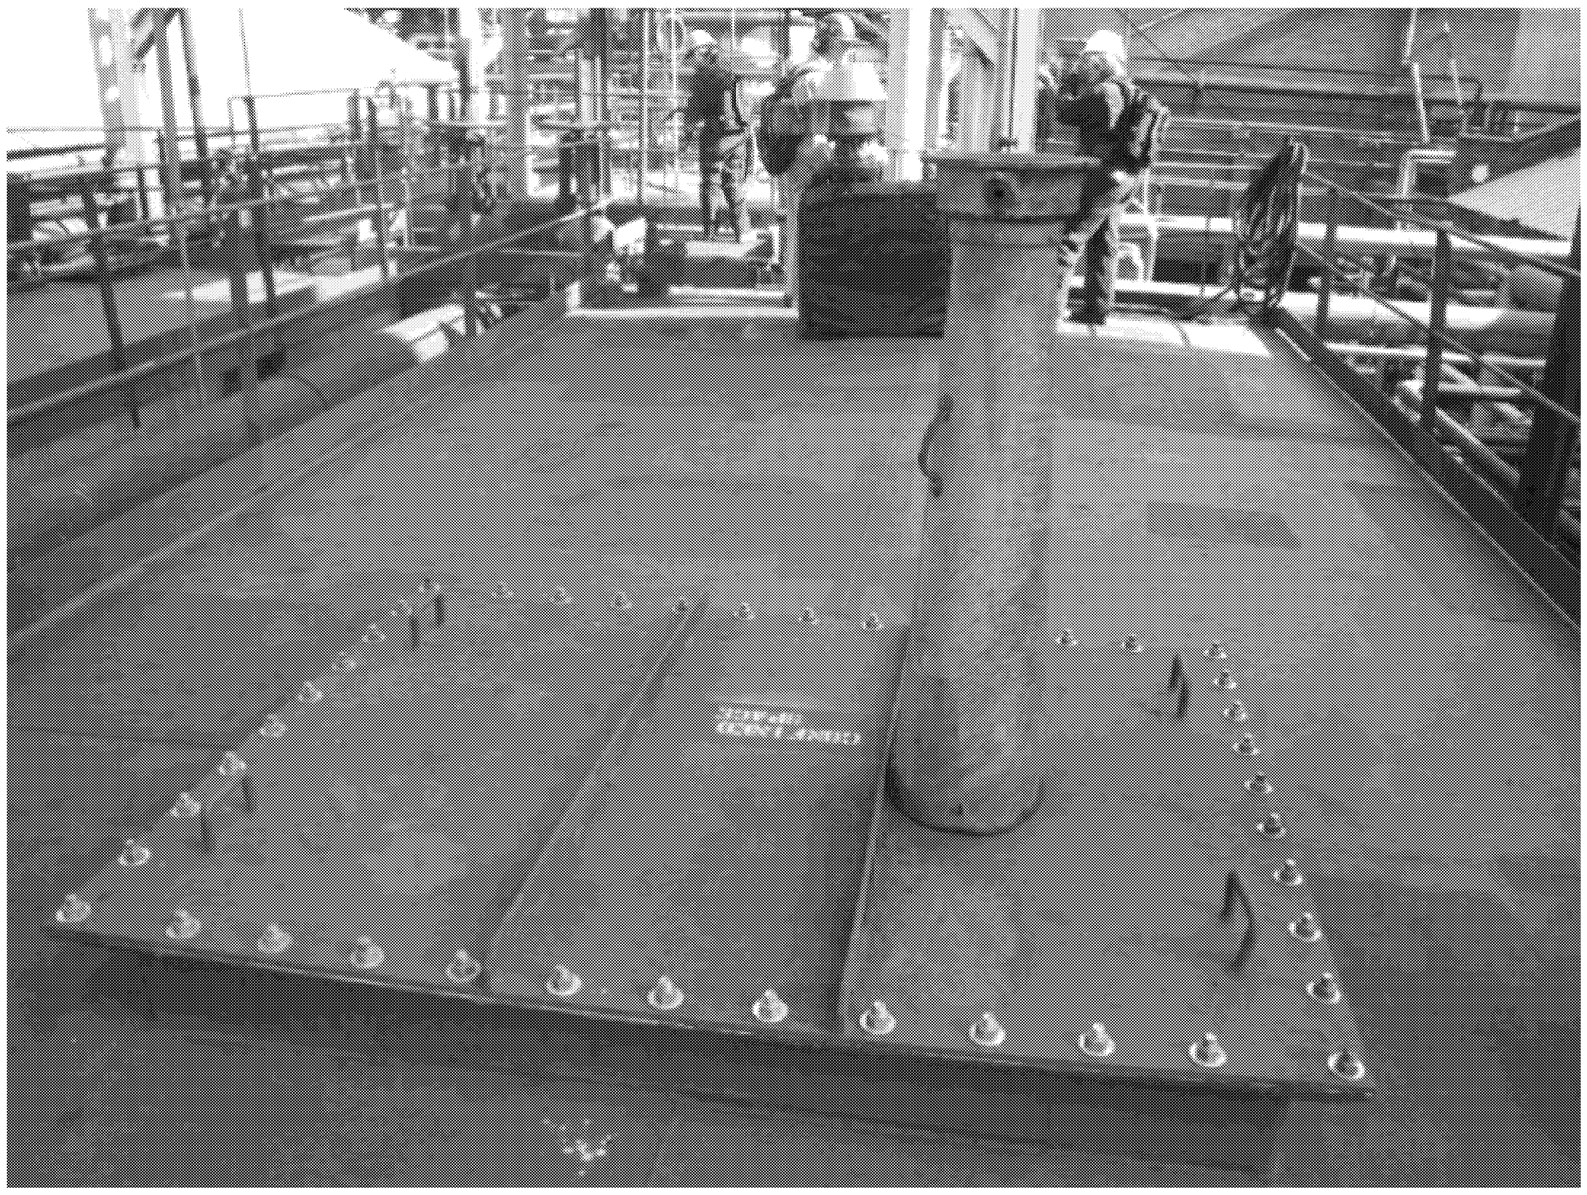
Photo Number: IMGP0060 Photographer: D. Au
Date/Time: 5/6/2011 3:56:39 PM
Description: Missing plug near valves 1967 and 1966

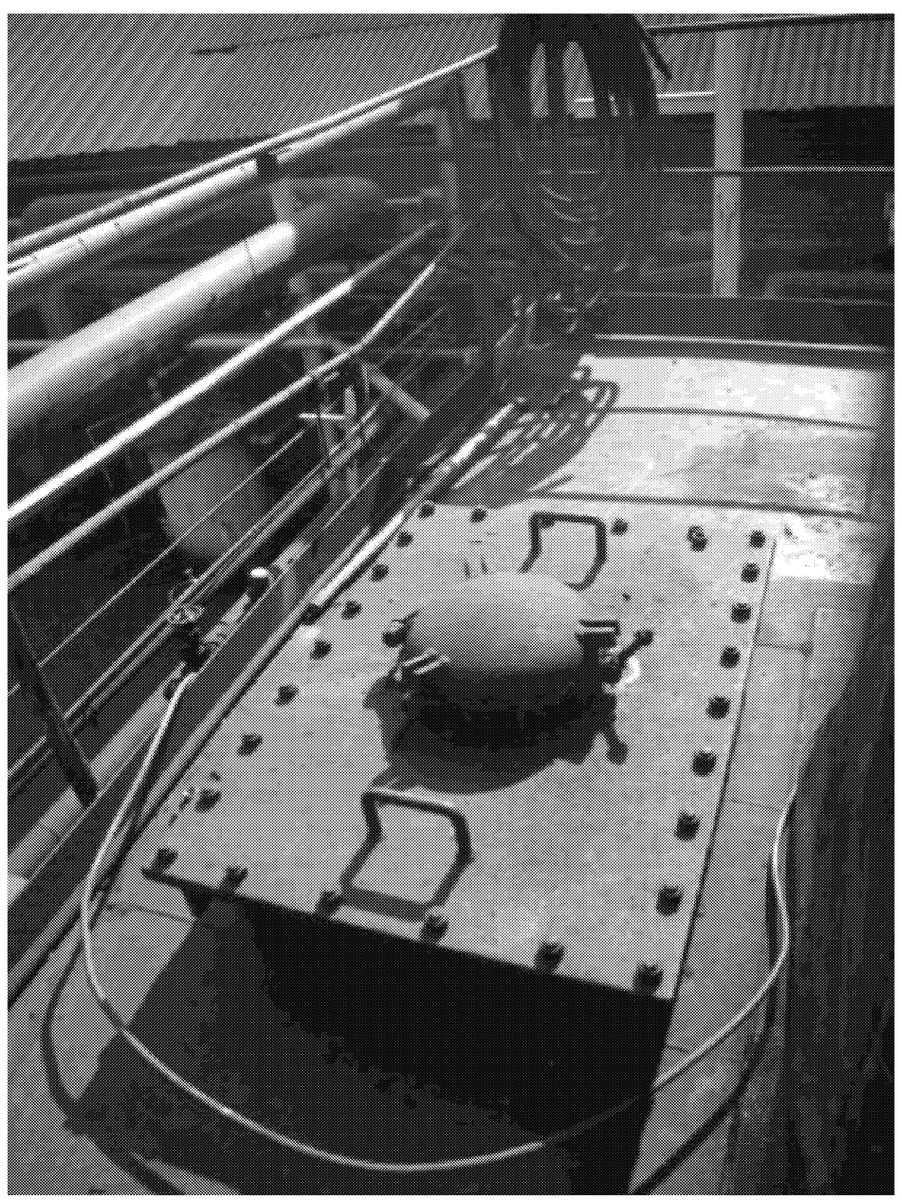
Photo Number: IMGP0061 Photographer: D. Au
Date/Time: 5/9/2011 8:58:40 AM
Description: East tar decanter large rectangular gasketed hatch (on top)

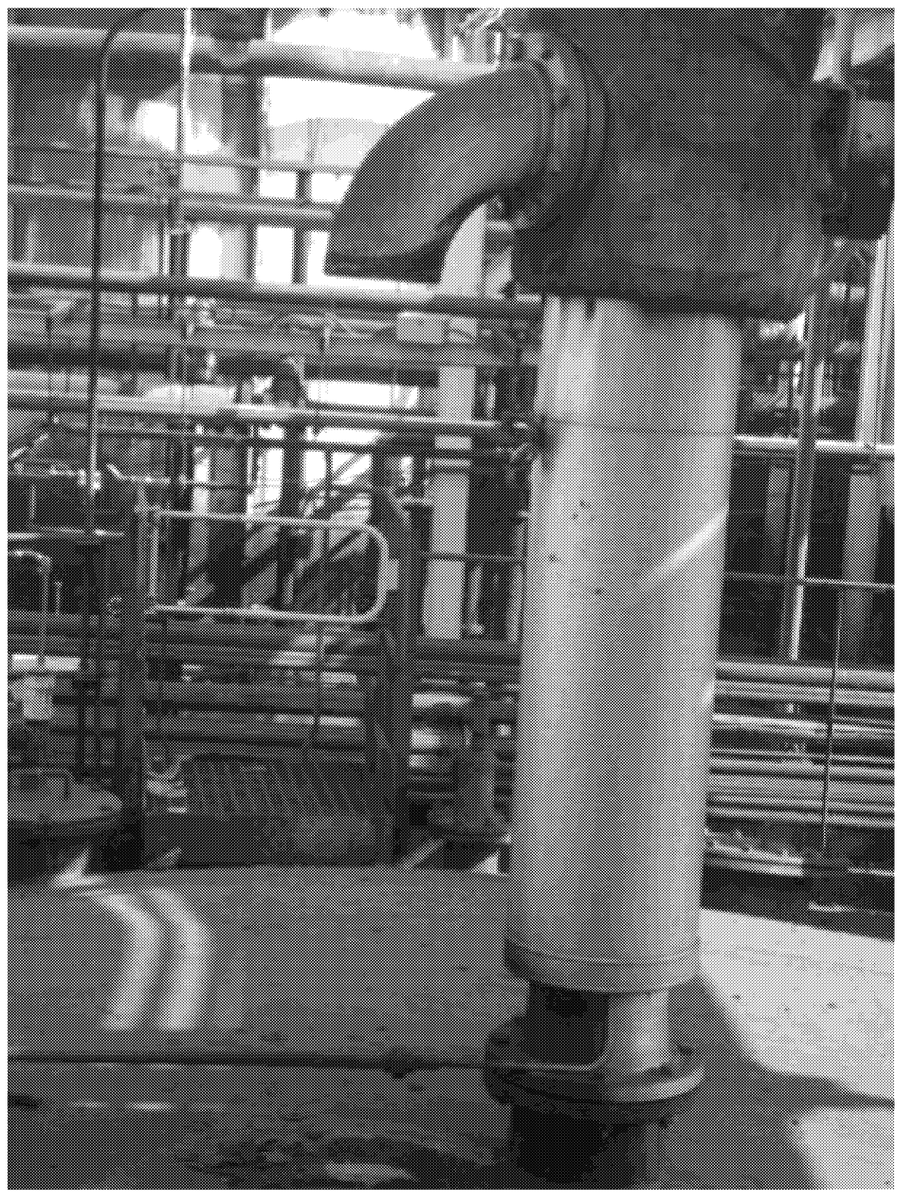
Photo Number: IMGP0062 Photographer: D. Au
Date/Time: 5/9/2011 9:00:29 AM
Description: Small round hatch on top of east tar decanter

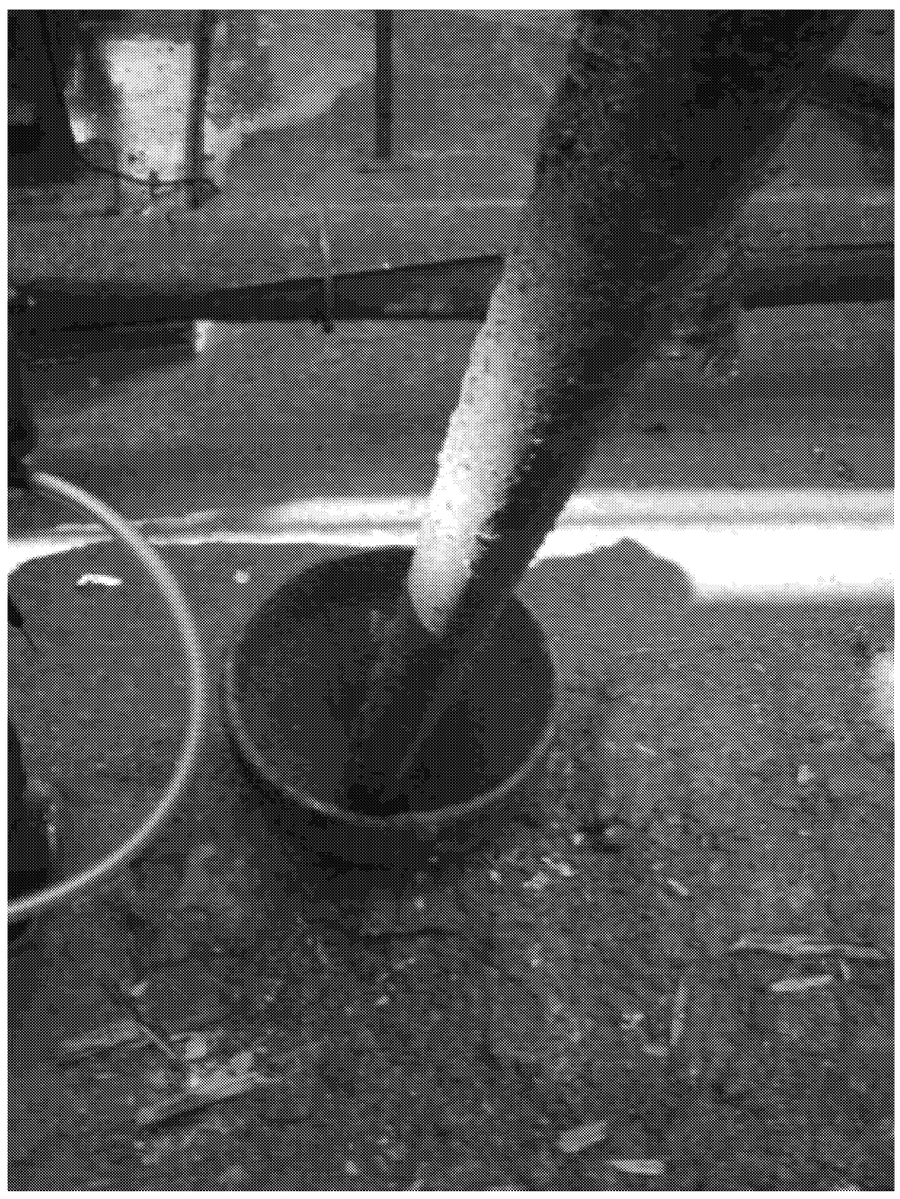
Photo Number: IMGP0067 Photographer: D. Au
Date/Time: 5/9/2011 9:33:14 AM
Description: Missing plug in tar storage area near pumps

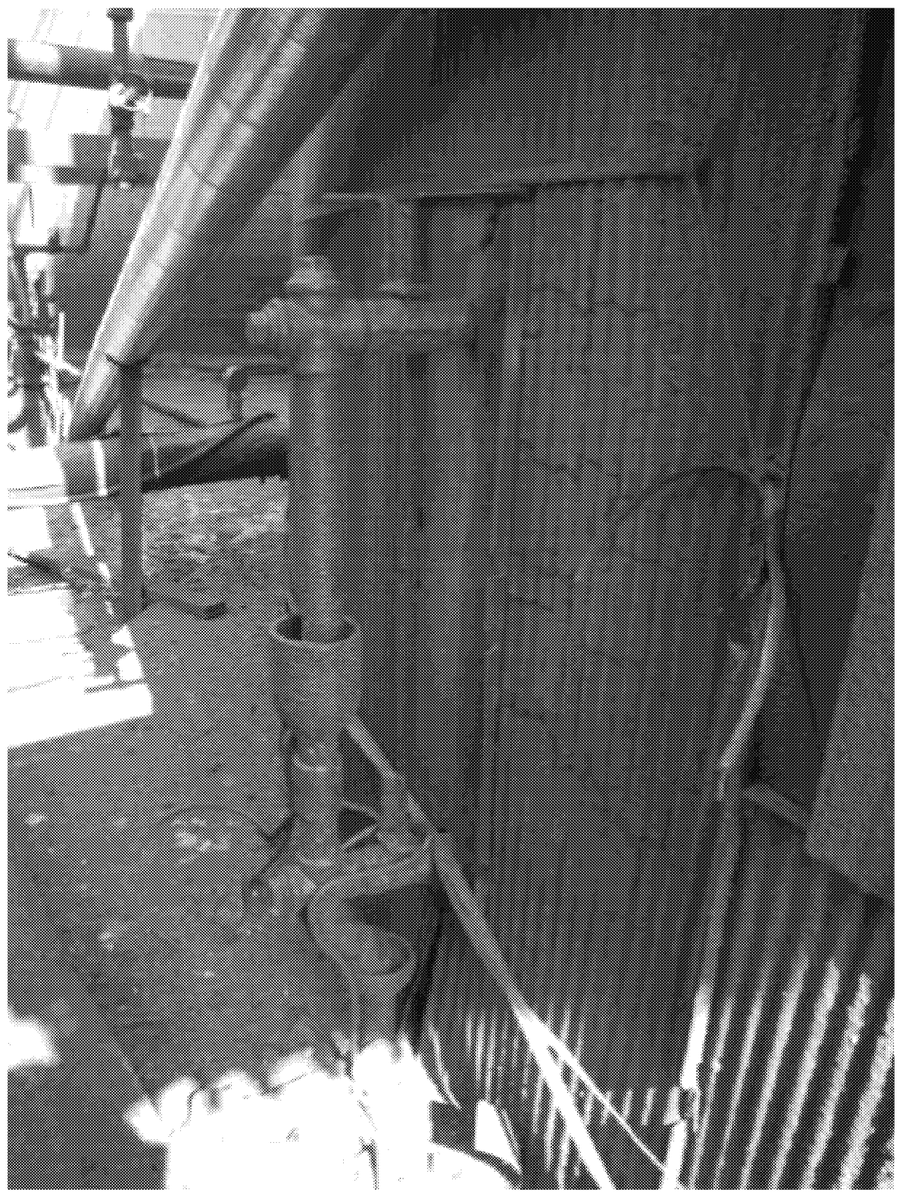
Photo Number: IMGP0068 Photographer: D. Au
Date/Time: 5/9/2011 9:38:23 AM
Description: Drain pot in tar storage area that goes to open ditch

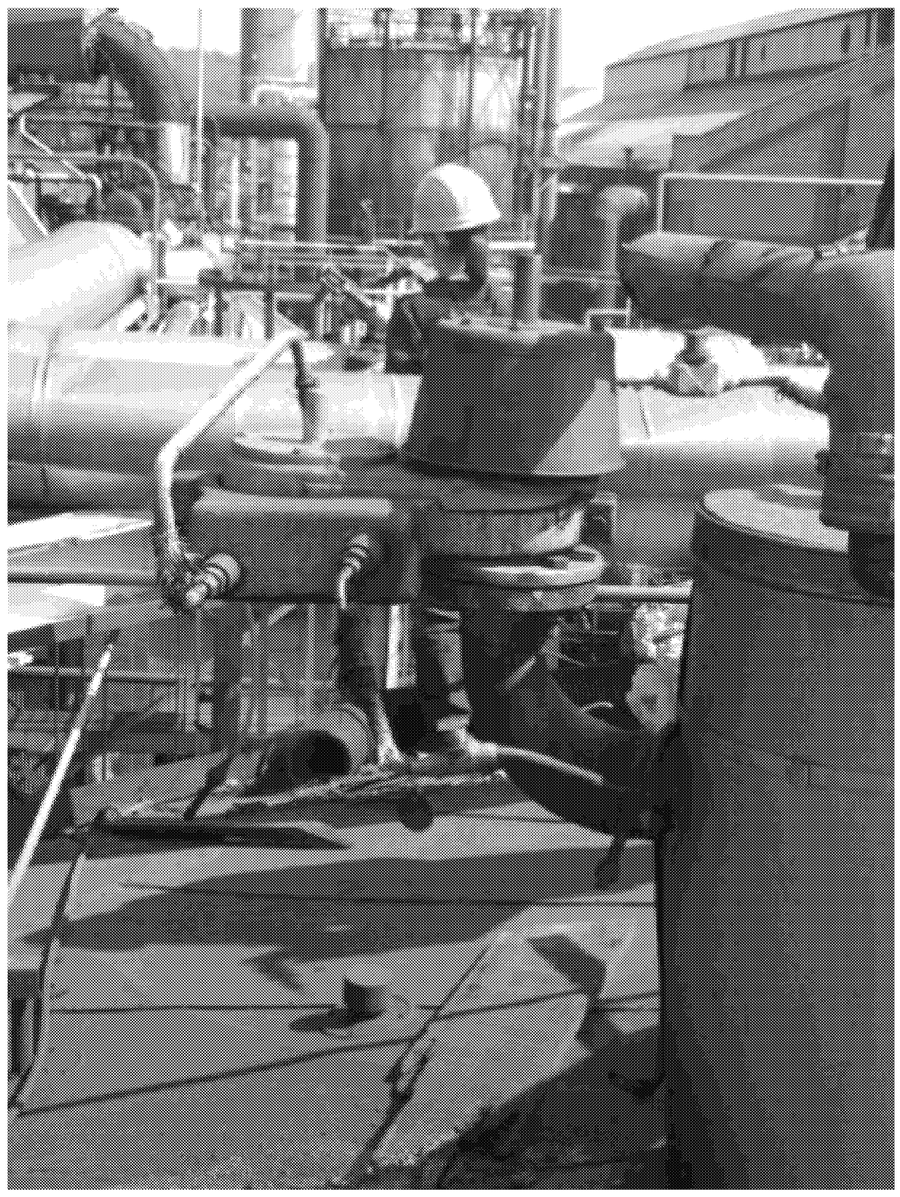
Photo Number: IMGP0070 Photographer: D. Au
Date/Time: 5/9/2011 9:53:26 AM
Description: Leaking valve 1923

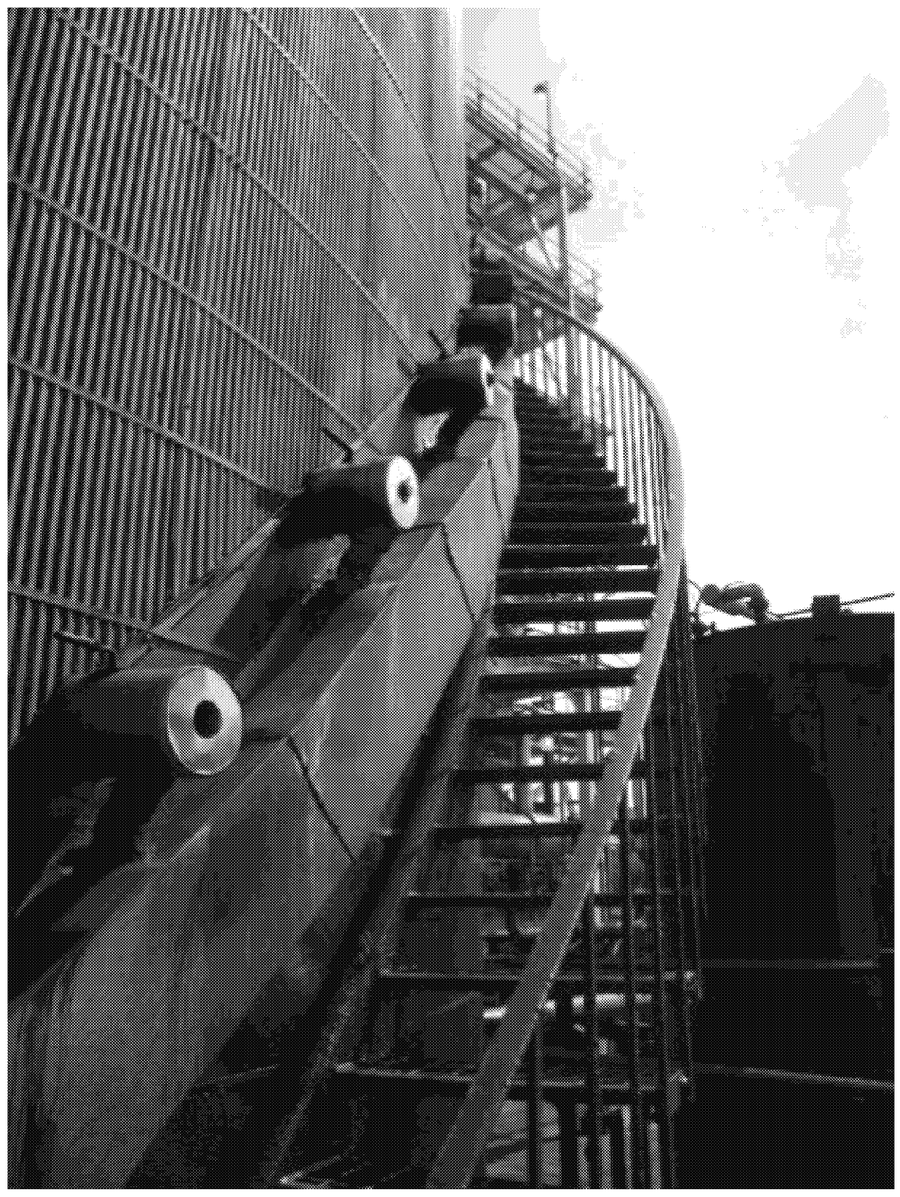
Photo Number: IMGP0071 Photographer: D. Au
Date/Time: 5/9/2011 9:55:38 AM
Description: Leaking flange near 1945 PVRV

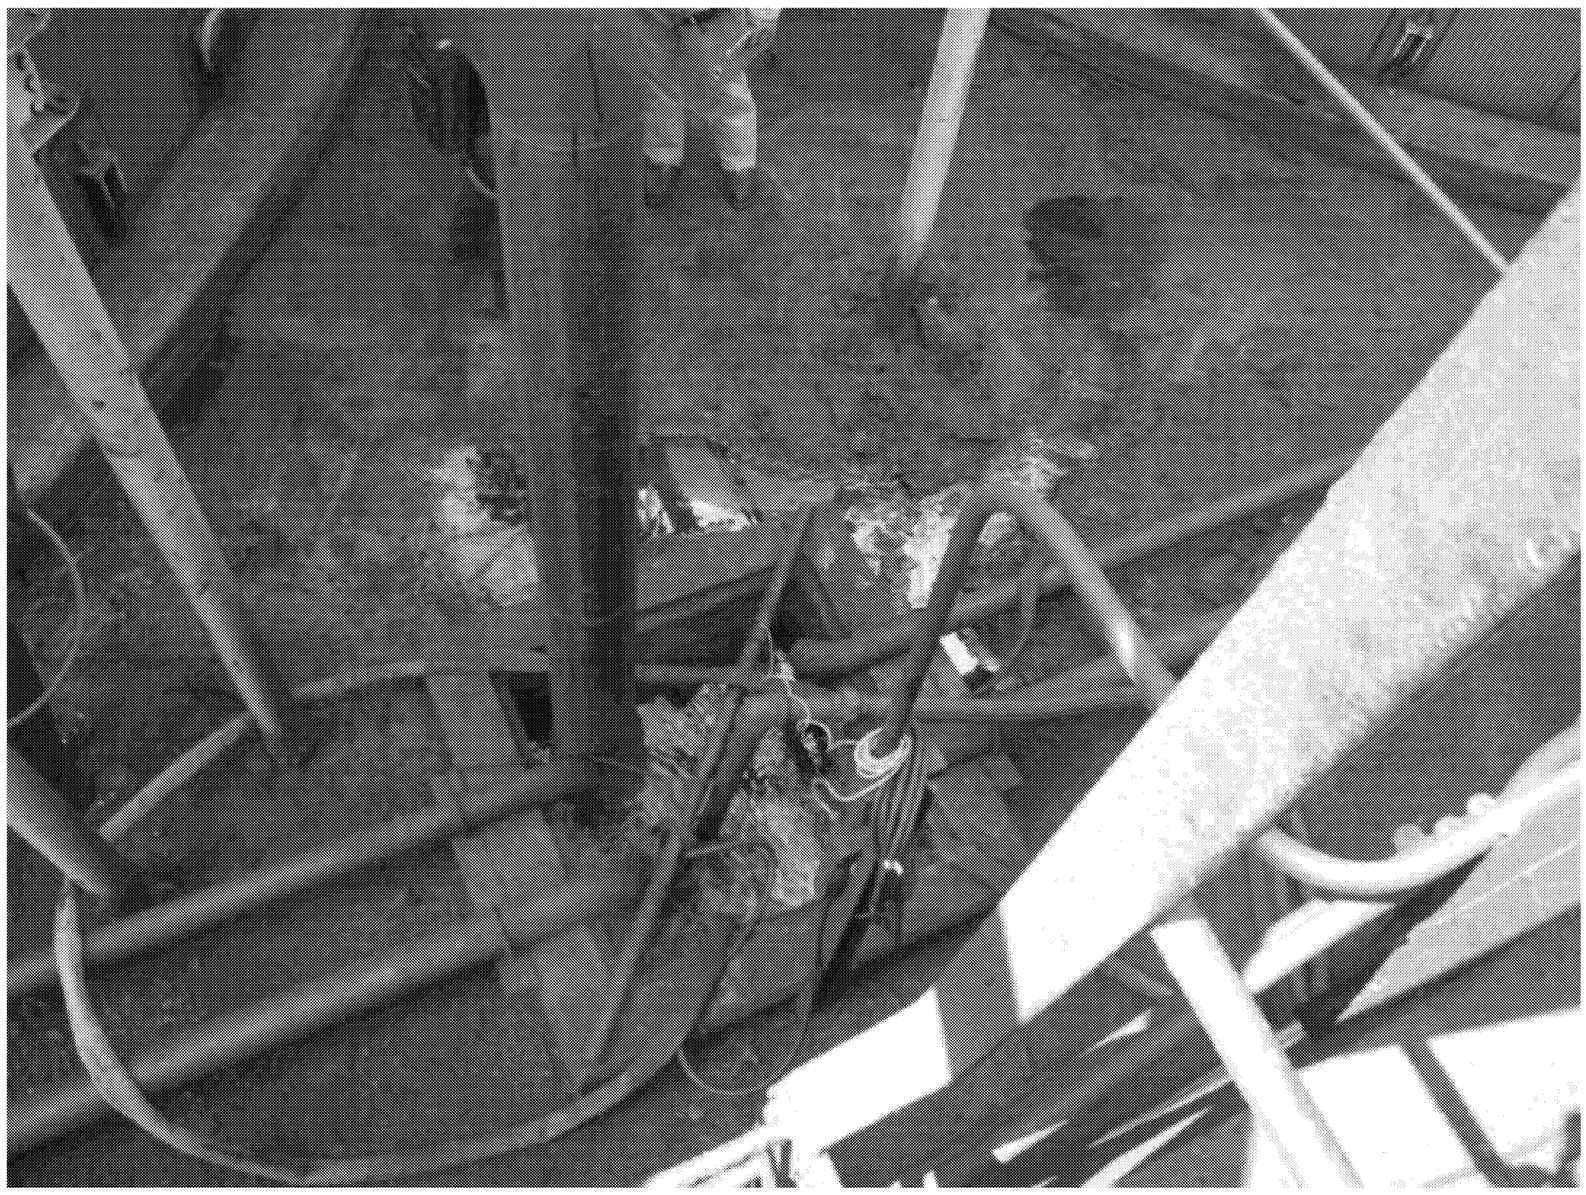
Photo Number: IMGP0072 Photographer: D. Au
Date/Time: 5/9/2011 10:11:11 AM
Description: Old tar level sample ports on tar storage tank
