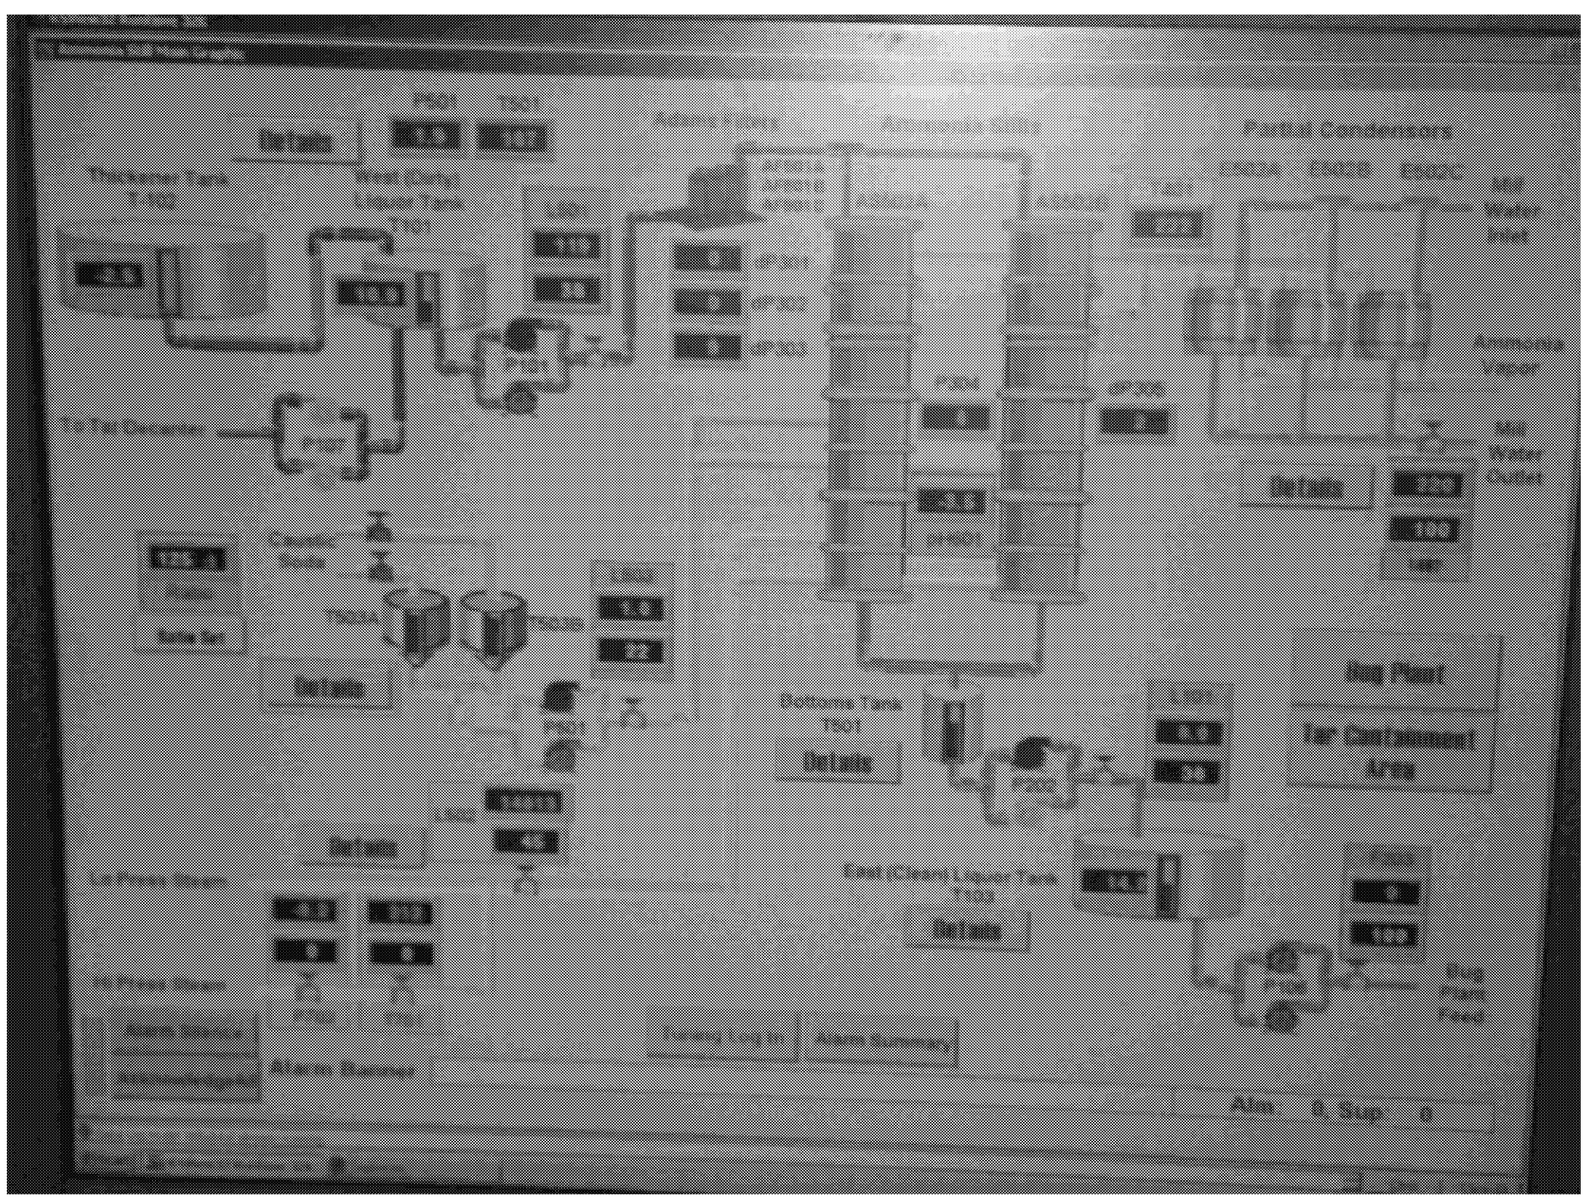
Photo Number: IMGP0103 Photographer: K. Pordesimo
Date/Time: 5/10/2011 10:23:11 AM
Description: Screen shot - tar containment area

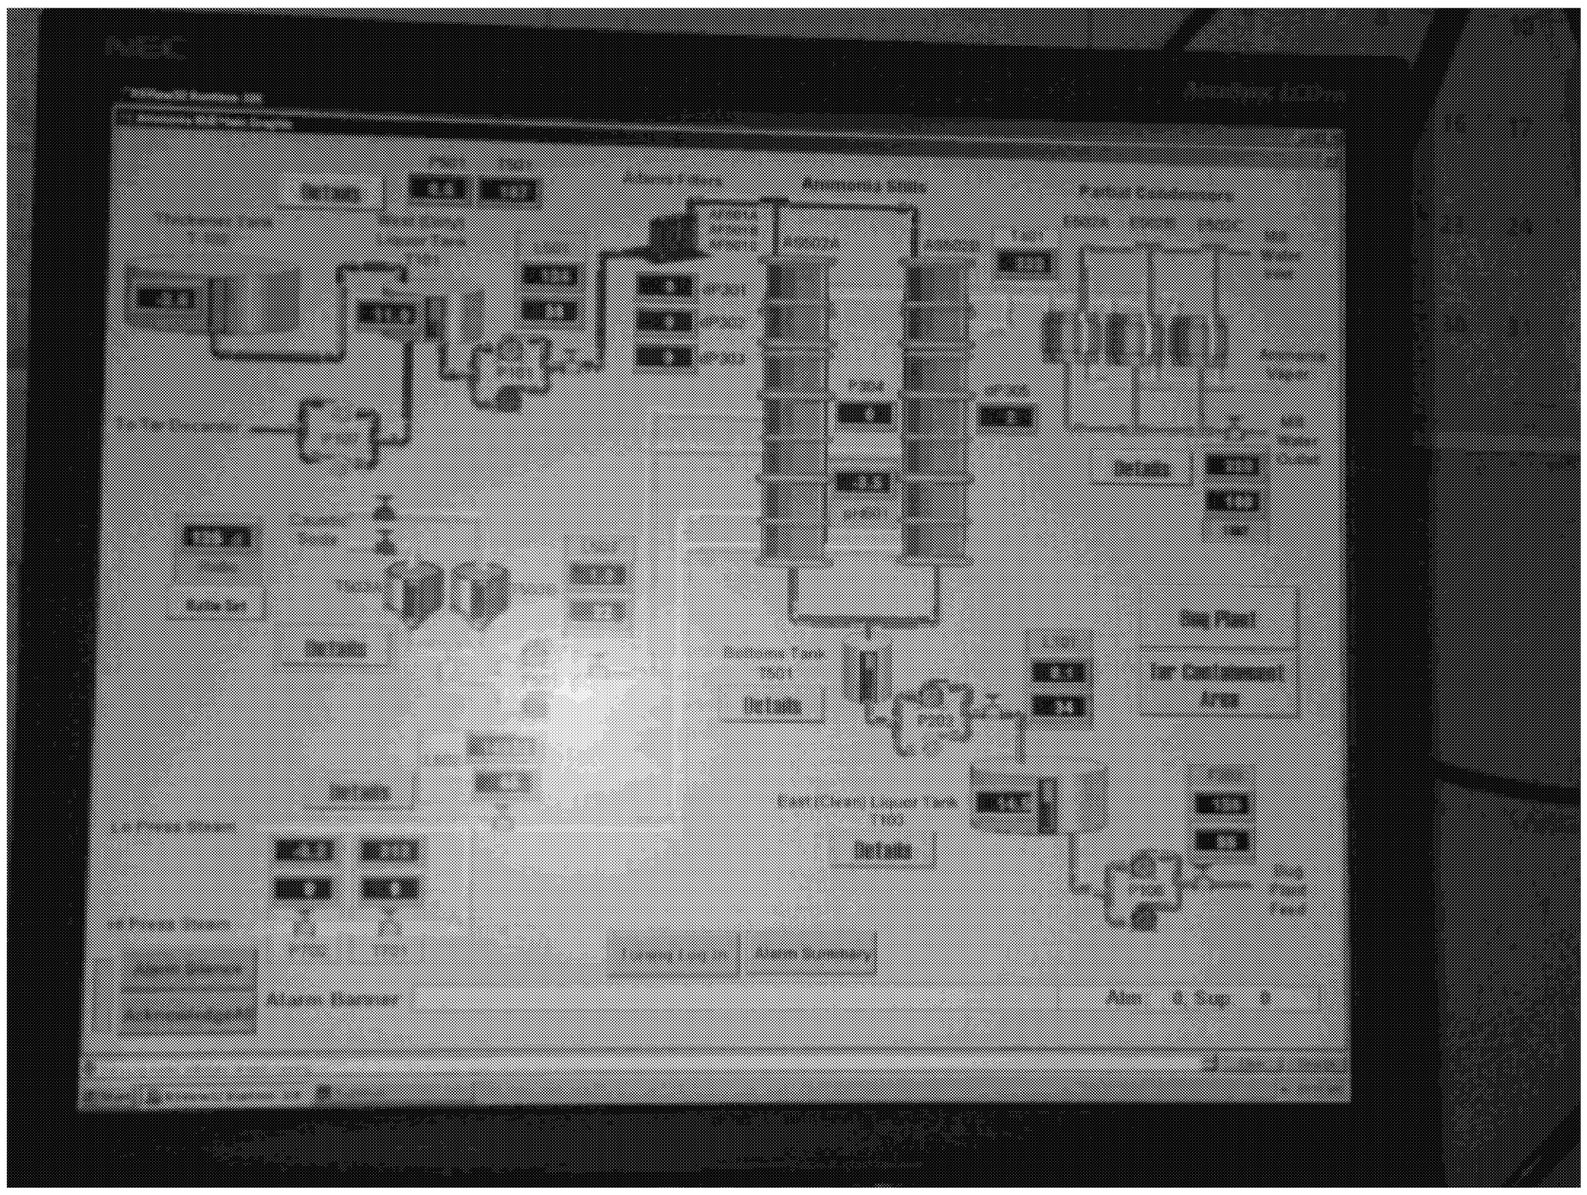
Photo Number: IMGP0104 Photographer: K. Pordesimo
Date/Time: 5/10/2011 10:24:29 AM
Description: Screen shot - ammonia pump and still area

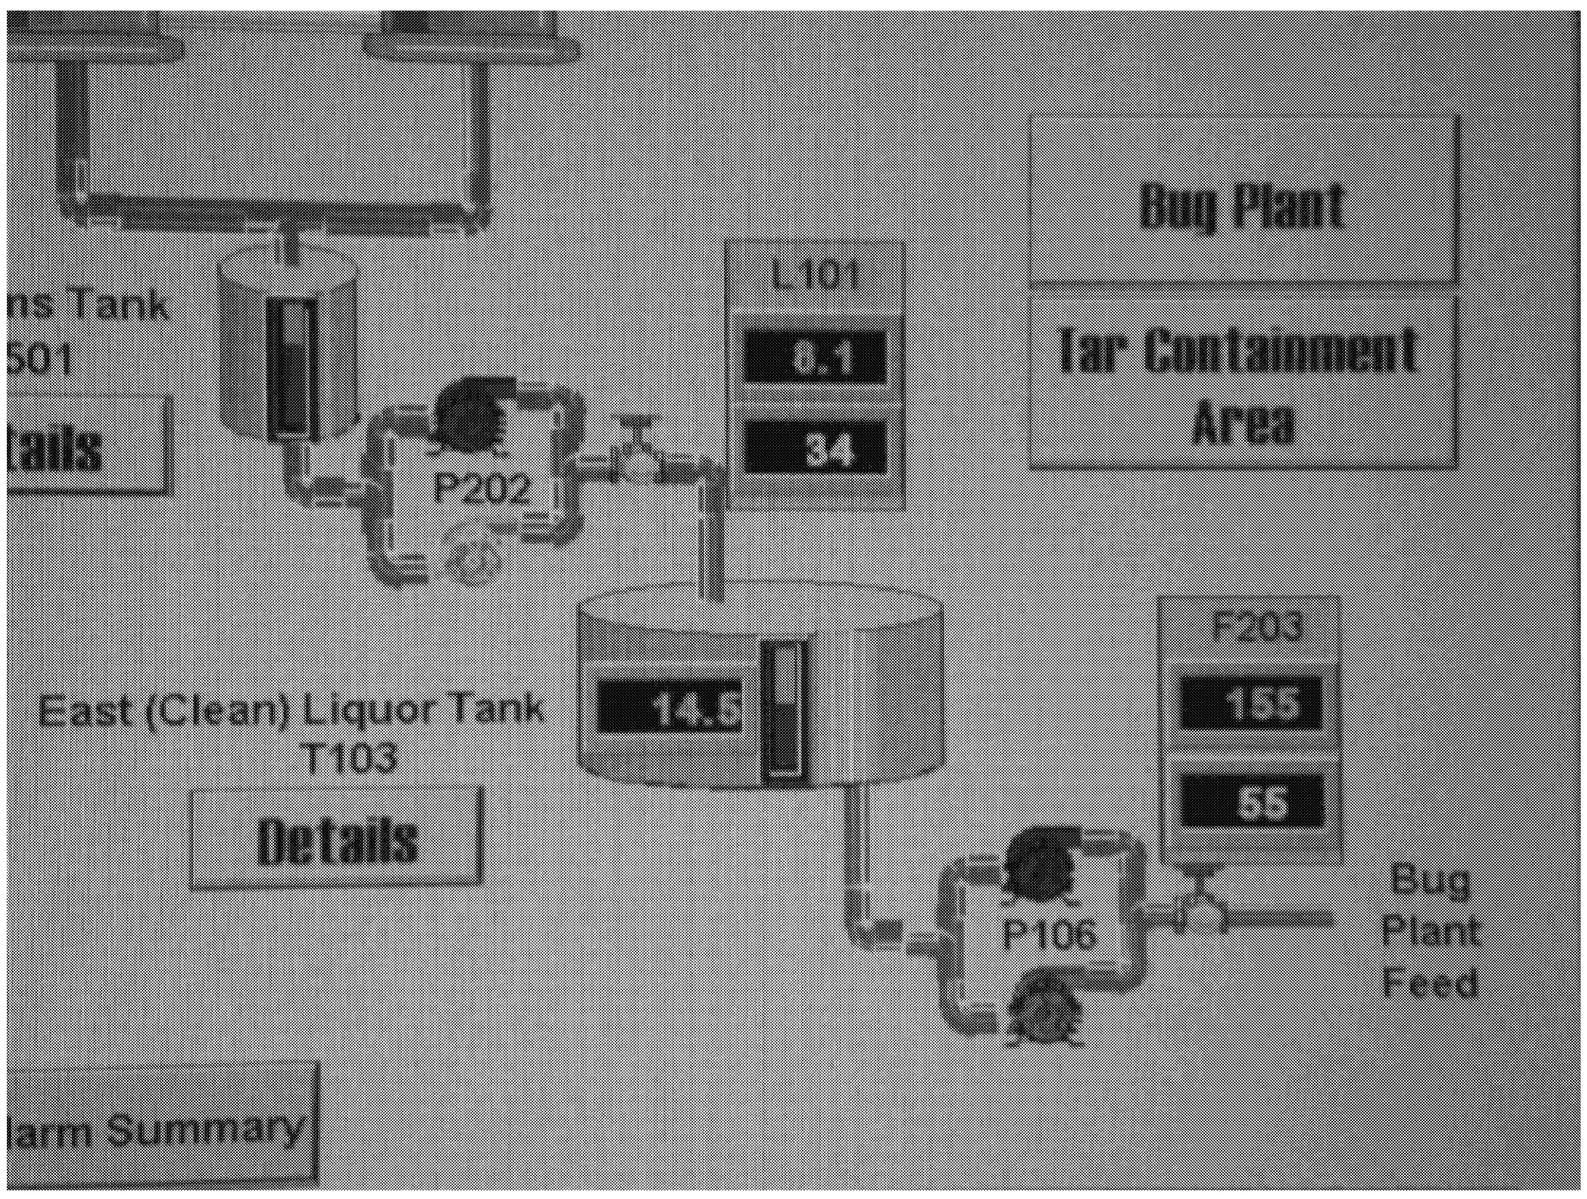
Photo Number: IMGP0105 Photographer: K. Pordesimo
Date/Time: 5/10/2011 10:52:34 AM
Description: Screen shot - ammonia pump and still graphic
