Field Report for Airborne Data Collected In Support of US EPA Region VI International Terminal Corporation Fire 18 March 2019

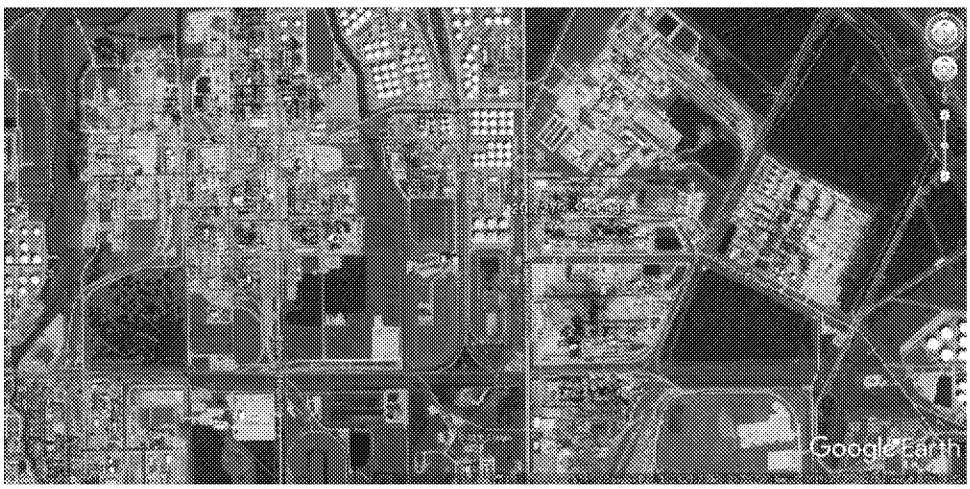
Figure 1: International Terminal Corporation, Deer Park, TX

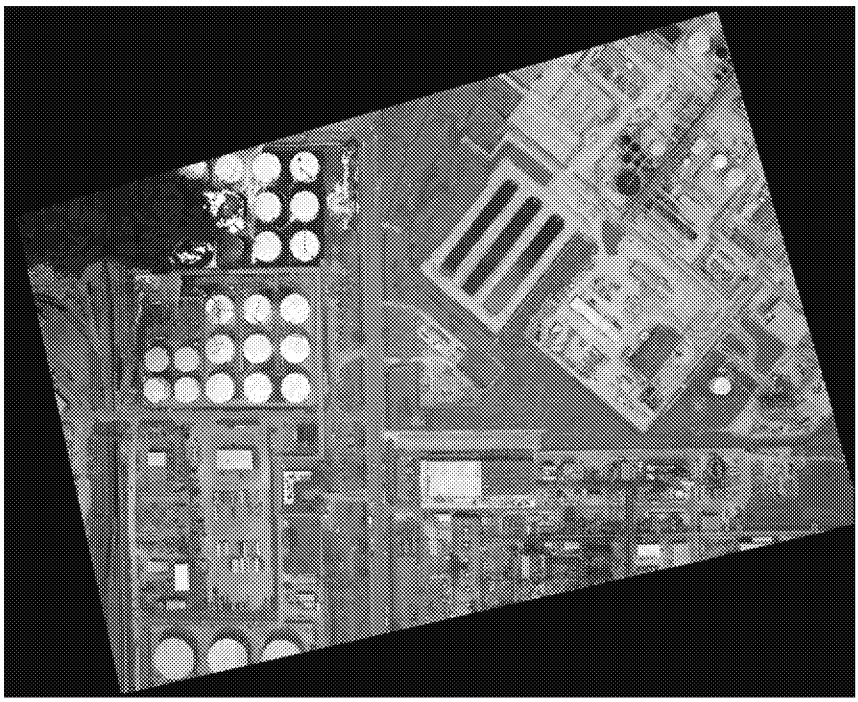
A full set of high resolution aerial digital photography were collected as part of the flight. Figure 6 shows a representative image collected as part of each pass. As discussed in the IRLS Figure 7 shows a representative oblique collected from the copilot station. This image clearly shows the presence of fire in the center tank with additional fire surrounding the tank. The fire is generating a large amount of smoke which is rising nearly vertical. The low light conditions of the image are a result of the plume shading the area as the aircraft passed over the site.

Figure 6: Aerial Image of the International Terminal Corporation Fire, Flt 2
