Field Report for Airborne Data Collected In Support of US EPA Region VI International Terminal Corporation Fire 18 March 2019

Background

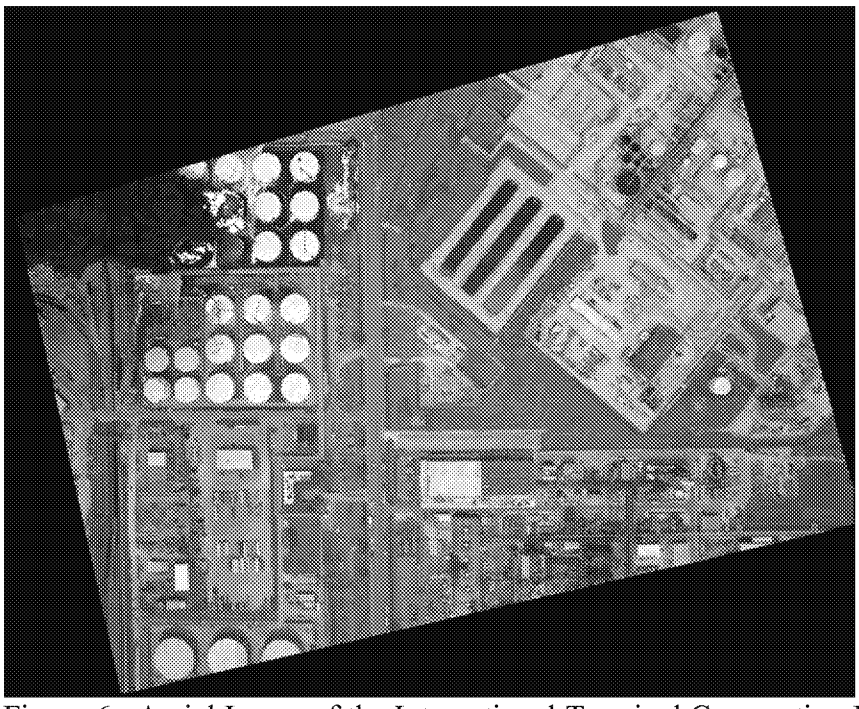
A full set of high resolution aerial digital photography were collected as part of the flight. Figure 6 shows a representative image collected as part of each pass. As discussed in the IRLS Figure 7 shows a representative oblique collected from the copilot station. This image clearly shows the presence of fire in the center tank with additional fire surrounding the tank. The fire is generating a large amount of smoke which is rising nearly vertical. The low light conditions of the image are actually a result of the plume shading the area as the aircraft passed over the site.

Figure 6: Aerial Image of the International Terminal Corporation Fire, Flt 2
