Field Report for Airborne Data Collected In Support of US EPA Region VI Intercontinental Terminals Company LLC Fire 19 March 2019

Data Results Flight 3, 19 March 2019

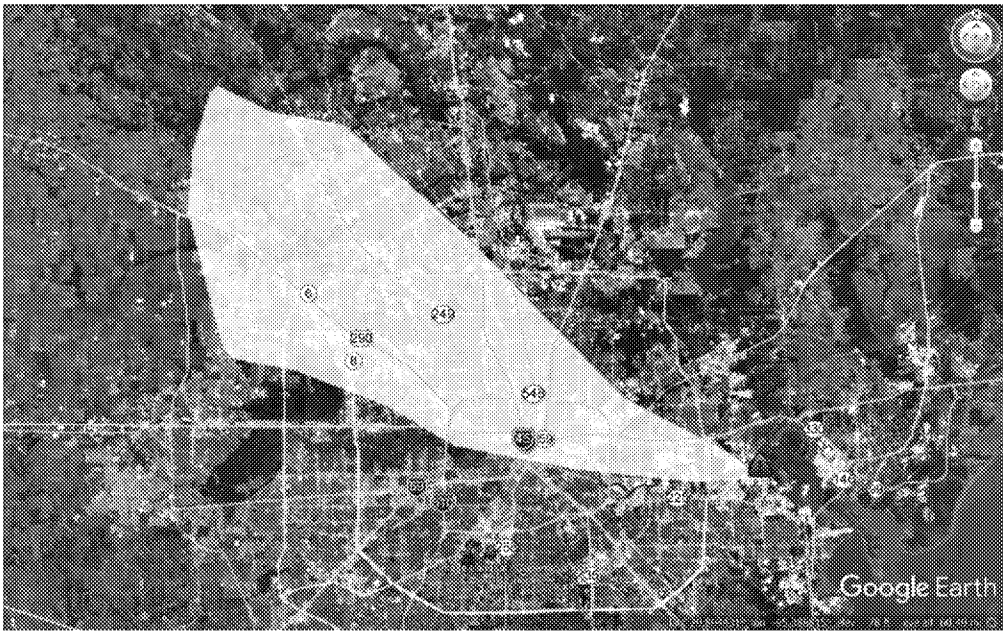
Figure 3: ITC Fire, Plume Outline 19 March 2019

As requested by Region 6, ASPECT estimated the perimeter location, floor and ceiling altitudes of the plume based on distance downwind from the fire. Figure 3 shows a generalized outline of the plume based on this measurement. Table 2 provides a summary of the plume geometry including centerline position, plume floor and ceiling altitudes and estimated cross plume distance in relationship to downwind distance.

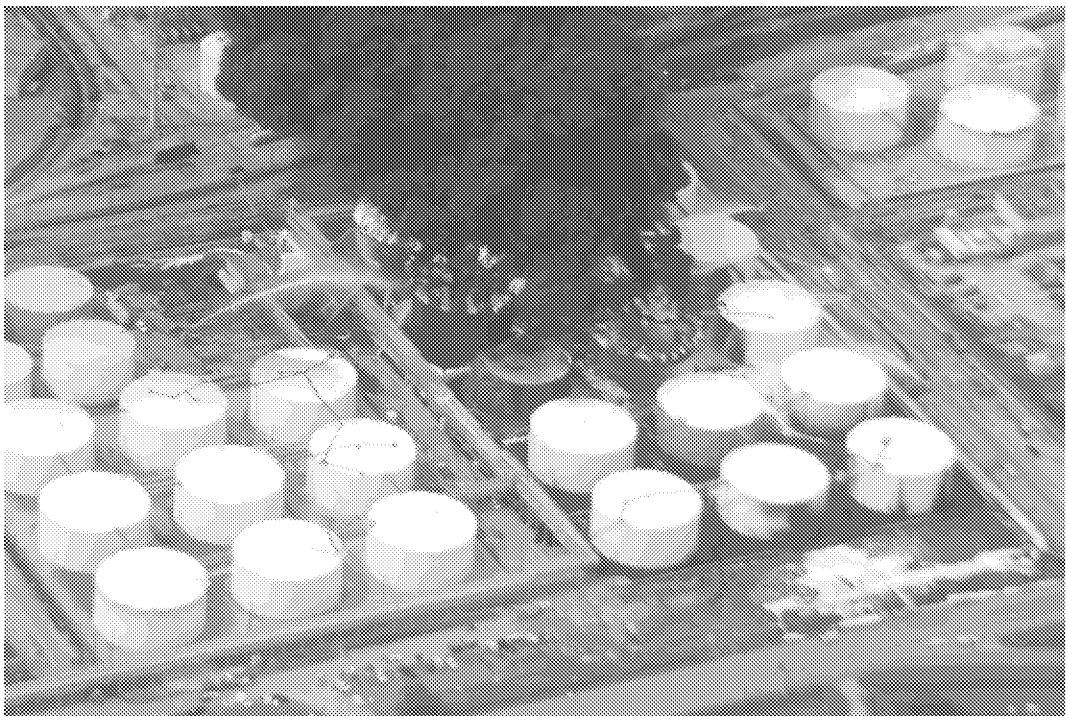
Figure 7: Aerial Image of the ITC Fire, Flight 3

A full set of high resolution aerial digital photography were collected as part of the flight. Figure 7 shows a representative overhead image collected as part of each pass. Figure 8 illustrates a typical oblique image. Both images confirm the finding that the fire is much more involved than on prior days with most of the tanks in the tank farm on fire.
