Field Report for Airborne Data Collected In Support of US EPA Region VI International Terminal Corporation Fire 17 March 2019

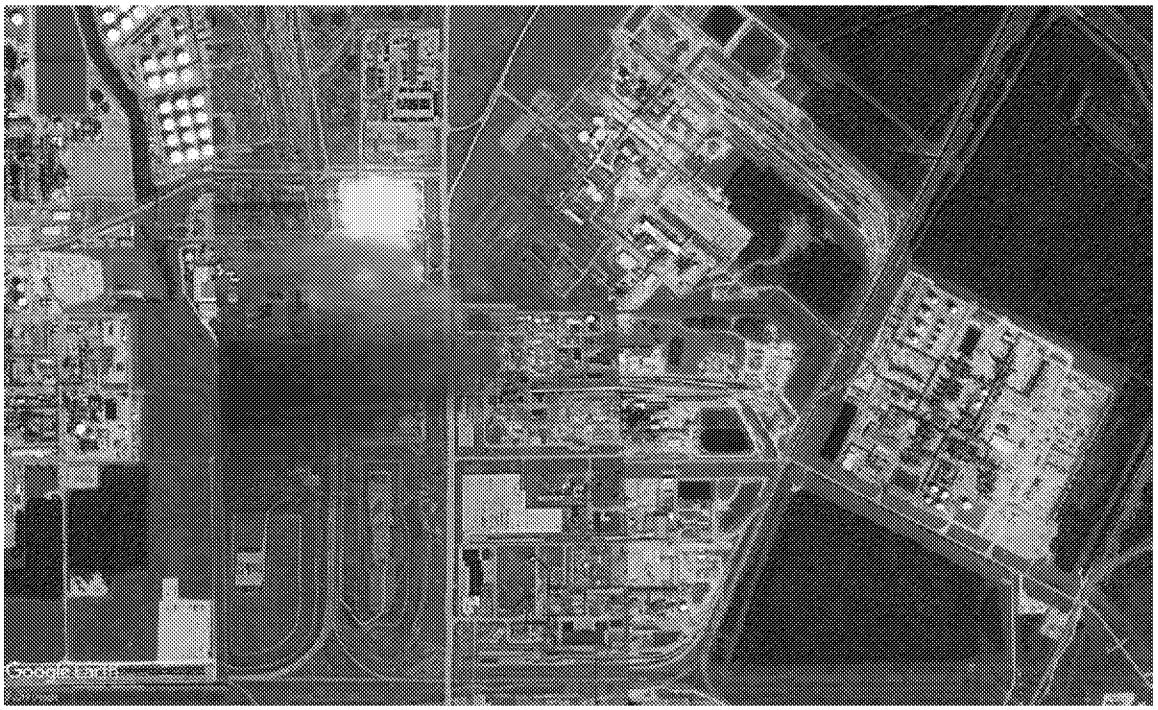
band infrared image obtained from data collected for Run 4. The white area within the image overlay is the thermal plume of the fire. Immediately south of the fire, a region of elevated temperature can be seen. This is most likely air being heated by the fire. Approximately 300 meters further south an area of obscuration of the surface (ground) thermal signature is present. This is likely the impact of volume and geometry of the plume block transmission due to the particulate load of the fire. It should be noted that no evidence of a chemical plume being generated by the fire was observed. A similar image generated on run 5 clearly shows an elevated temperature plume being generated by the fire (Figure 5).

Figure 4: – 3 band IR image, Run 4, International Terminal Corporation Fire

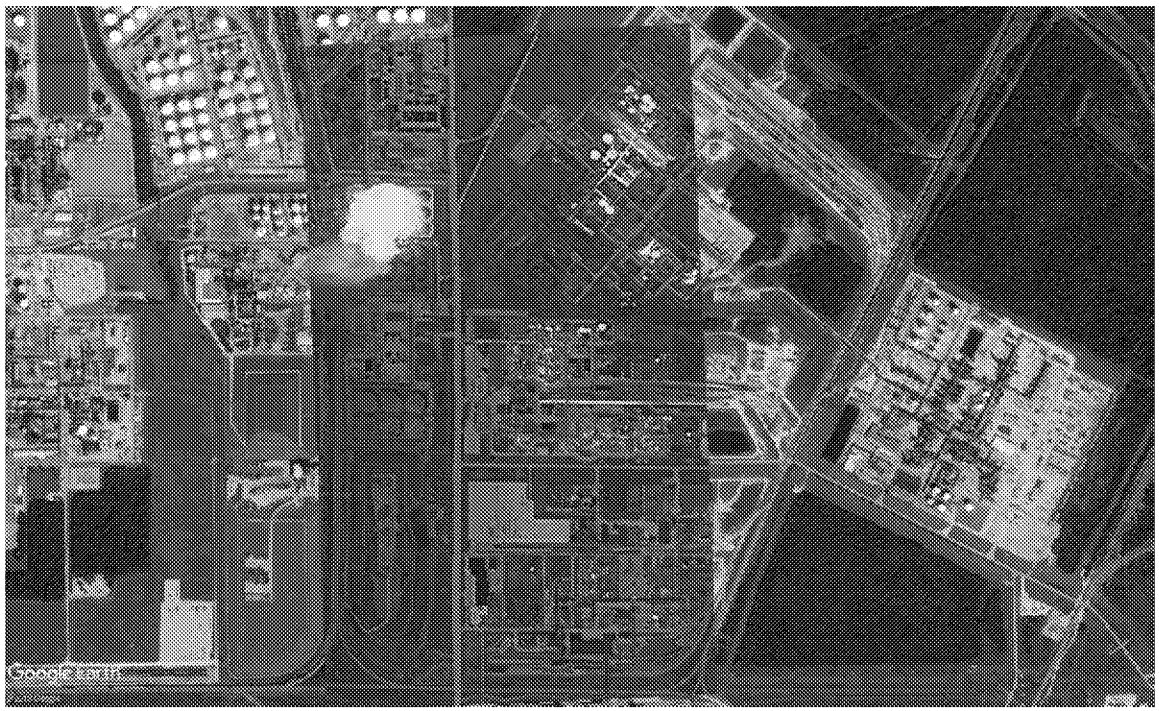
Figure 5: 3 band IR image, Run 5, International Terminal Corporation Fire

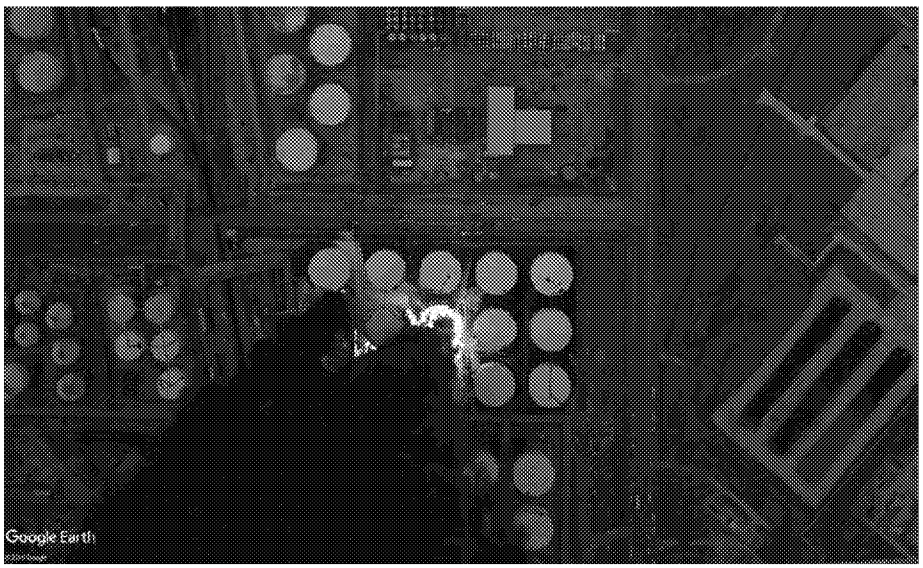
A full set of high resolution aerial digital photography were collected as part of the flight. Figure 7 shows a representative image collected as part of each pass. This image clearly shows the presence of fire in the center tank with additional fire surrounding the tank. The fire is generating a large amount of smoke which is rising nearly vertical. The low light conditions of the image are actually a result of the plume shading the area as the aircraft passed over the site.

Figure 7: Aerial Image of the International Terminal Corporation Fire.
