Field Report for Airborne Data Collected In Support of US EPA Region VI Intercontinental Terminals Corporation LLC Fire 19 March 2019

Data Results Flight 3, 19 March 2019

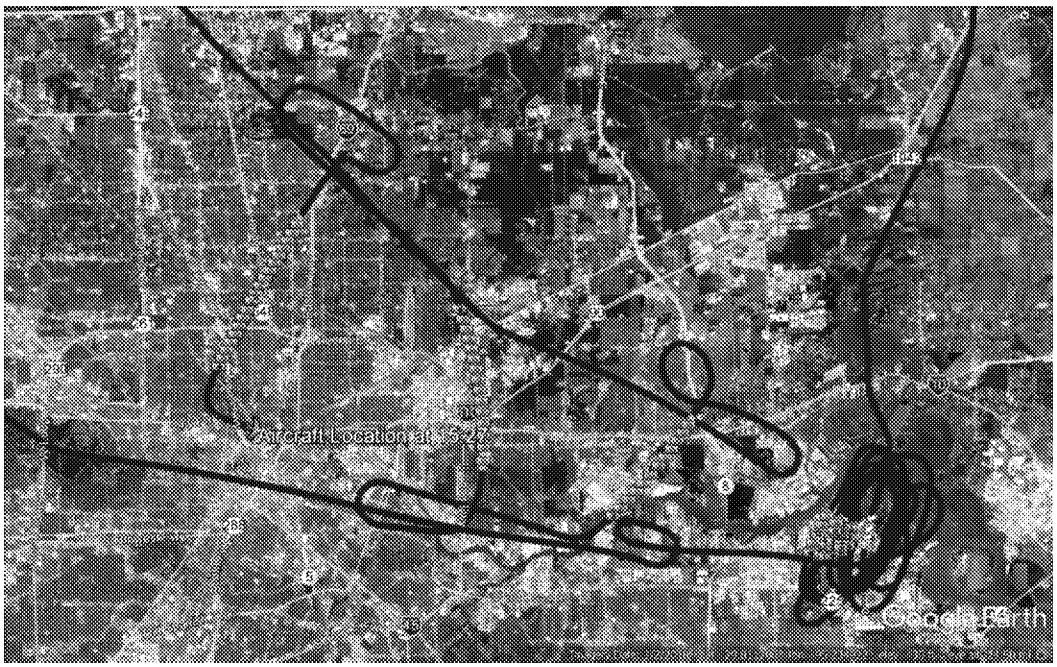
Figure 4B: Flight lines in the extended downwind area of the fire.

The order to launch the aircraft was given at 0700 local on 19 March 2019 and the aircraft was airborne at 0718. The initial data collection run over the site was at 0855 (local) The aircraft made a total of 12 data collection passes; flight information is summarized in Appendix A and Figure 4A and 4B.

Notes for Figure 4A and 4B: The blue lines represent the ASPECT flight path, green lines represent when the Infrared Line Scanner was actively collecting data, and the camera icons represent when a photo was taken.
