Field Report for Airborne Data Collected In Support of US EPA Region VI International Terminal Corporation Fire 18 March 2019

Flight 2.

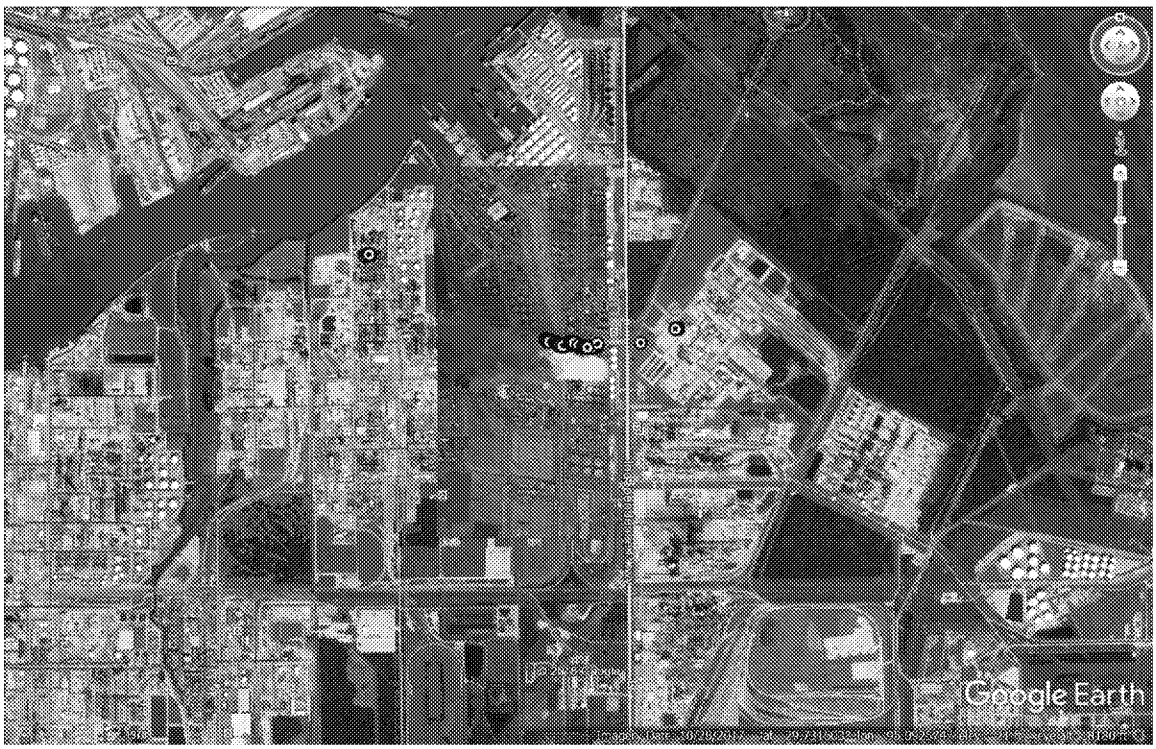
Figure 5: Chemical detections as denoted by dots on the image.

Spectral examination of the fire showed more detections than on the afternoon/evening of 17 March 2019. Figure 5 shows the where individual compounds were detected in relationship to the fire. Most of the compounds detected were made on the northern side of the fire. Compound detections east of the fire are most likely native compounds present in the urban air.

Table 3 list the compounds detected and the maximum concentration estimated from the FTIR data. These detections are very low with the highest being just above 1 ppm. It should be noted that based on the plume structure and height, it is probable that most/all of the detected compounds near and/or generated by the fire are several hundred meters in altitude.
