Field Report for Airborne Data Collected In Support of US EPA Region VI International Terminal Corporation Fire 18 March 2019

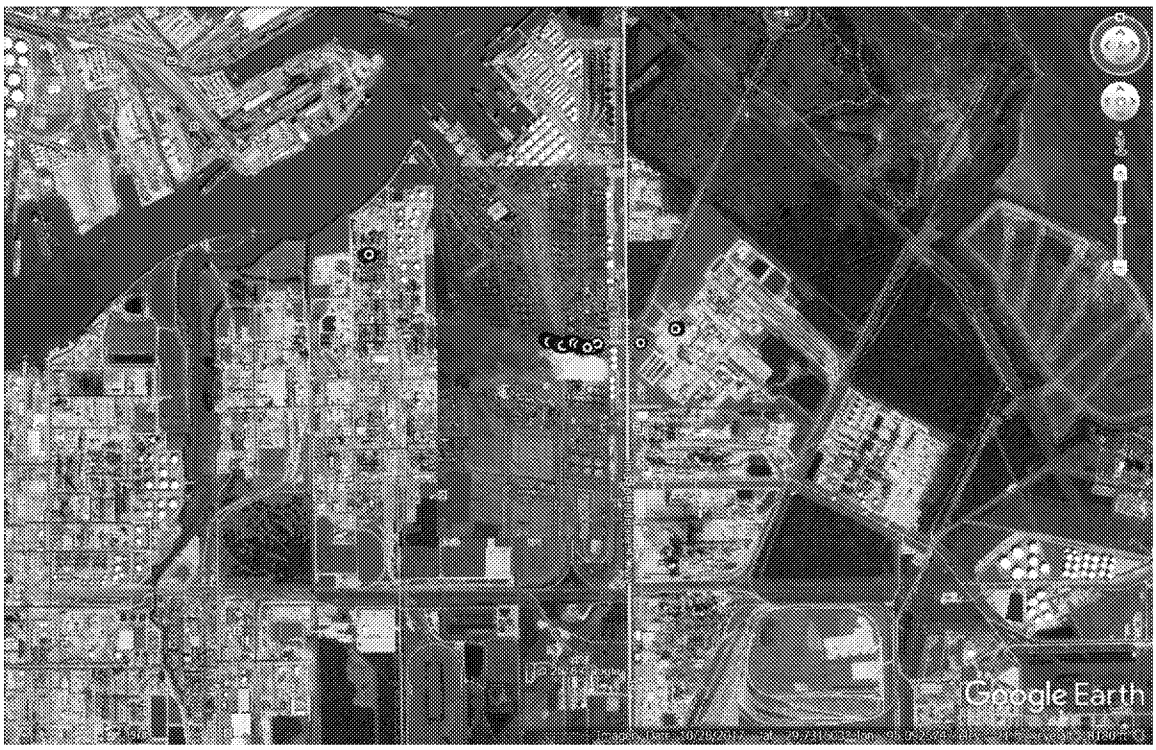
Figure 5: Chemical detections as denoted by dots on the image.

Spectral examination of the fire showed more detections than on the afternoon/evening of 17 March 2019. Figure 5 shows the where individual compounds were detected in relationship to the fire. Most of the compounds detected were made on the northern side of the fire. Compound detections east of the fire are most likely native compounds present in the urban air.

Table 3 list the compounds detected and the maximum concentration estimated from the FTIR data. These detections are very low with the highest being just above 1 ppm. It should be noted that based on the plume structure and height, it is probable that most/all of the detected compounds near and/or generated by the fire are several hundred meters in altitude.

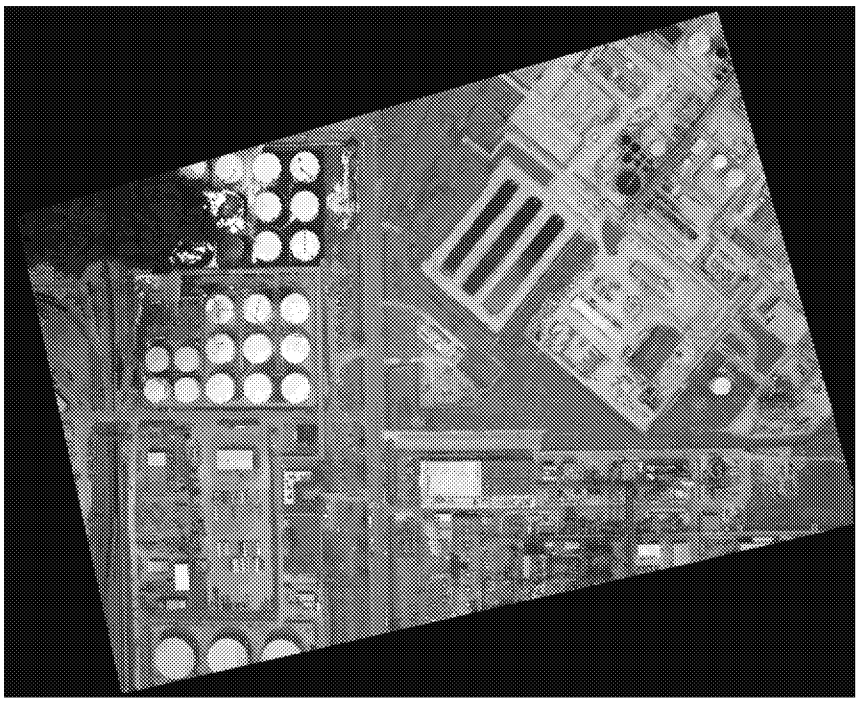
Figure 6: Aerial Image of the International Terminal Corporation Fire, Flt 2

A full set of high resolution aerial digital photography were collected as part of the flight. Figure 6 shows a representative image collected as part of each pass. As discussed in the IRLS Figure 7 shows a representative oblique collected from the copilot station. This image clearly shows the presence of fire in the center tank with additional fire surrounding the tank. The fire is generating a large amount of smoke which is rising nearly vertical. The low light conditions of the image are a result of the plume shading the area as the aircraft passed over the site.
