Field Report for Airborne Data Collected In Support of US EPA Region VI Intercontinental Terminals Company LLC Fire 20 March 2019

Data Results Flight 4, 20 March 2019

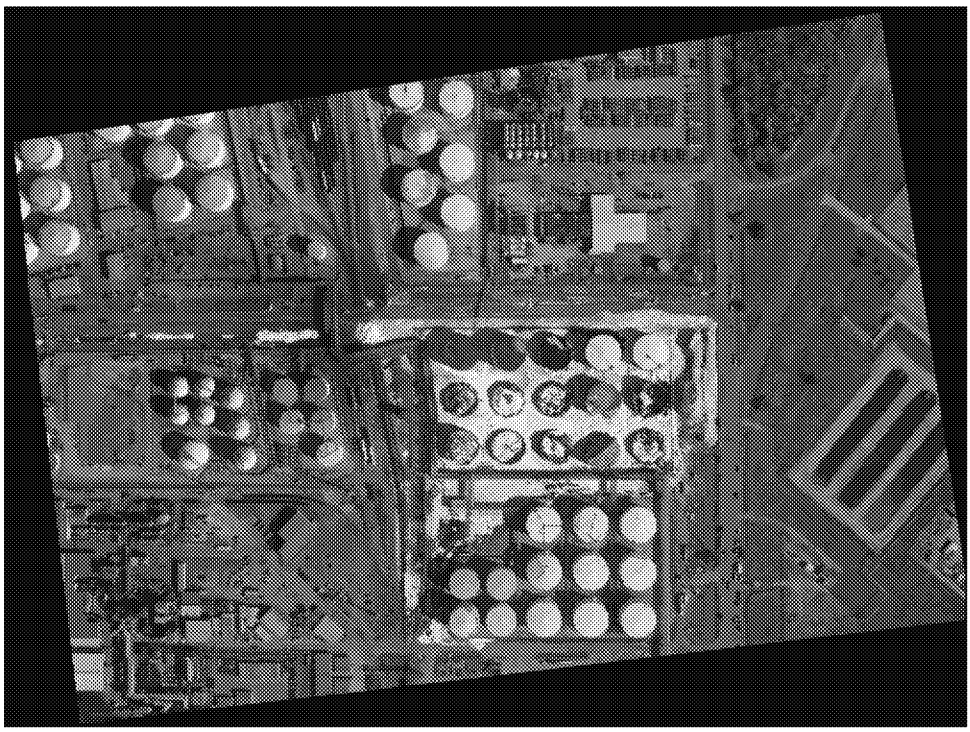
Figure 6: Aerial Image of the ITC Fire, Flight 4

A full set of high resolution aerial digital photography were collected as part of the flight. Figure 6 shows a representative overhead image collected as part of each pass. As evident in the image, the fires associated with the tank farm are absent. In addition, the secondary containment area of the tank farm appears to be filled with a white substance. Figure 7 illustrates a typical oblique image. Both images confirm the finding that the fire has been extinguished and that the secondary containment is filled with a white substance.
