Field Report for Airborne Data Collected In Support of US EPA Region VI International Terminals Corporation LLC Fire 19 March 2019

Data Results Flight 3, 19 March 2019

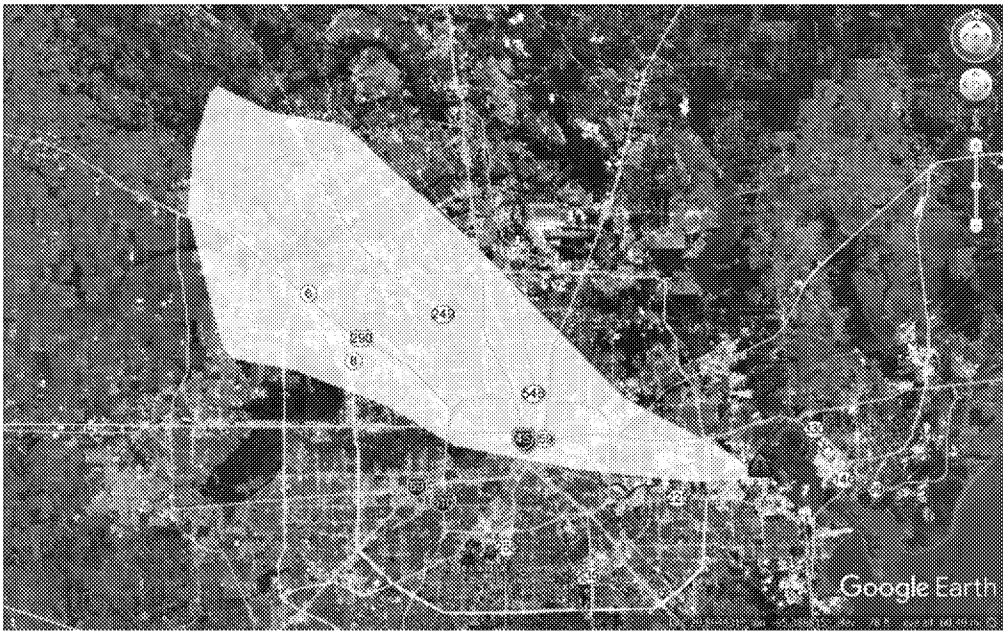
Figure 3: ITC Fire, Plume Outline 19 March 2019

As requested by Region 6, ASPECT estimated the perimeter location, floor and ceiling altitudes of the plume based on distance downwind from the fire. Figure 3 shows a generalized outline of the plume based on this measurement. Table 2 provides a summary of the plume geometry including centerline position, plume floor and ceiling altitudes and estimated cross plume distance in relationship to downwind distance.
