Field Report for Airborne Data Collected In Support of US EPA Region VI International Terminal Corporation Fire 17 March 2019

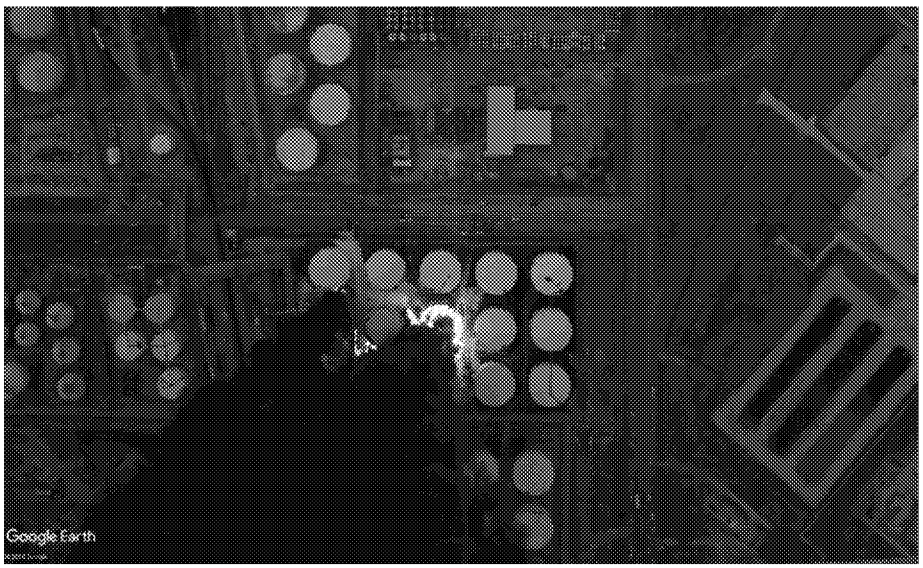
A full set of high resolution aerial digital photography were collected as part of the flight. Figure 7 shows a representative image collected as part of each pass. This image clearly shows the presence of fire in the center tank with additional fire surrounding the tank. The fire is generating a large amount of smoke which is rising nearly vertical. The low light conditions of the image are actually a result of the plume shading the area as the aircraft passed over the site.

Figure 7: Aerial Image of the International Terminal Corporation Fire.
