Field Report for Airborne Data Collected In Support of US EPA Region 6 Intercontinental Terminals Company LLC Fire 22 March 2019

Data Results Flight 6 7, 8 and 9 22 March 2019

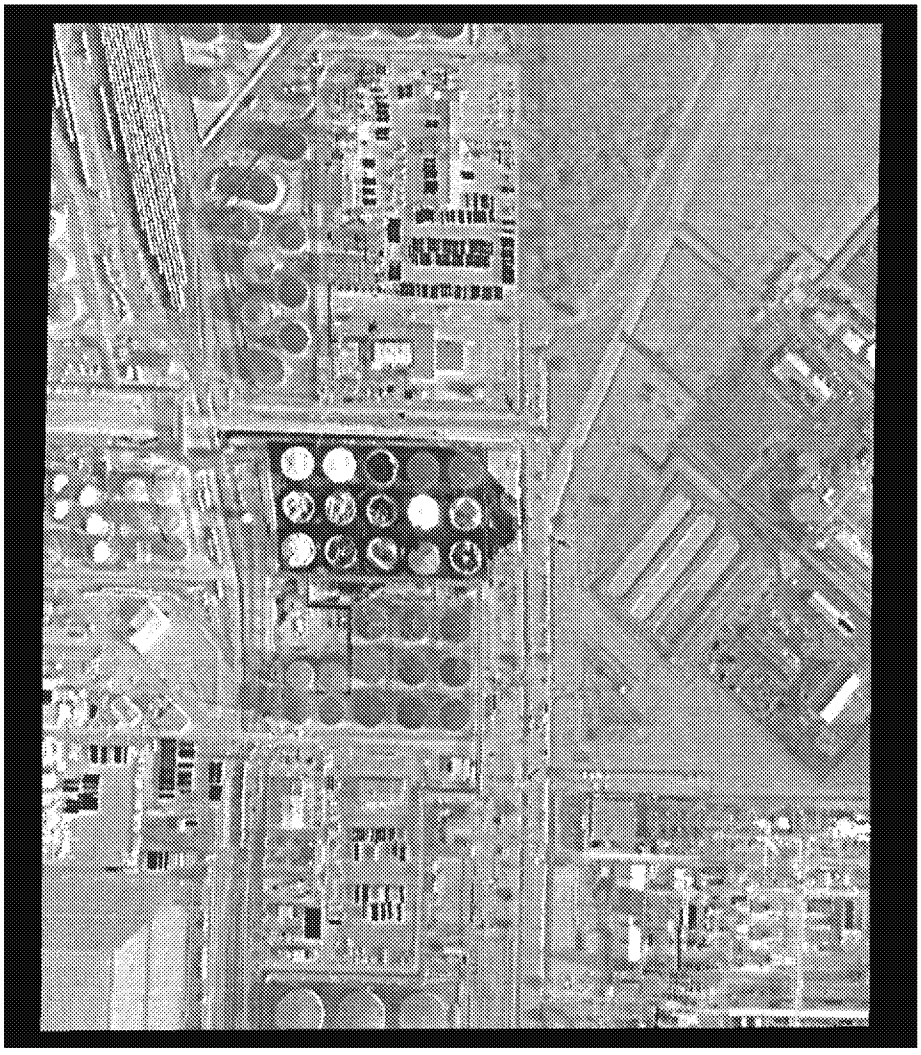
A total of 4 test and 17 data passes were made in the proximity of the impacted tank farm and also in extended areas surrounding the site and infrared line scanner images were generated for each pass. Figure 3 shows a typical 3-band infrared image obtained from data collected for Run 5. Examination of the IR image shows the tank farm with a black color within the secondary containment. This is actually white foam which is cooler than the surrounding oil and environment. A thermal analysis was conducted on a similar image with the results given in Figure 4 and tends to show that the tanks on the western end are actually the hottest with the NW tank consistently showing an elevated temperature remotely estimated to be about 70°C.

Figure 3: IR image of ITC data for 22 March 2019, Flight 7 Run 3

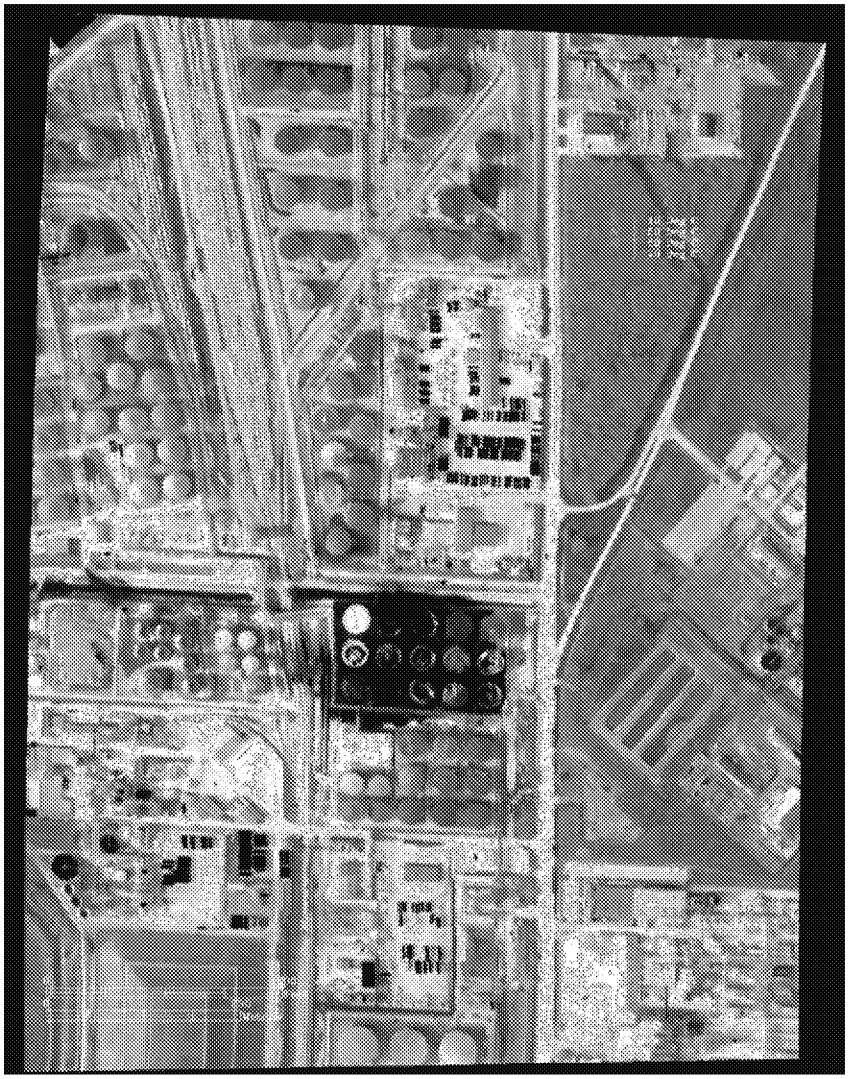
Figure 4: IR Thermal Analysis 22 March 2019, Flight 9, Run 3

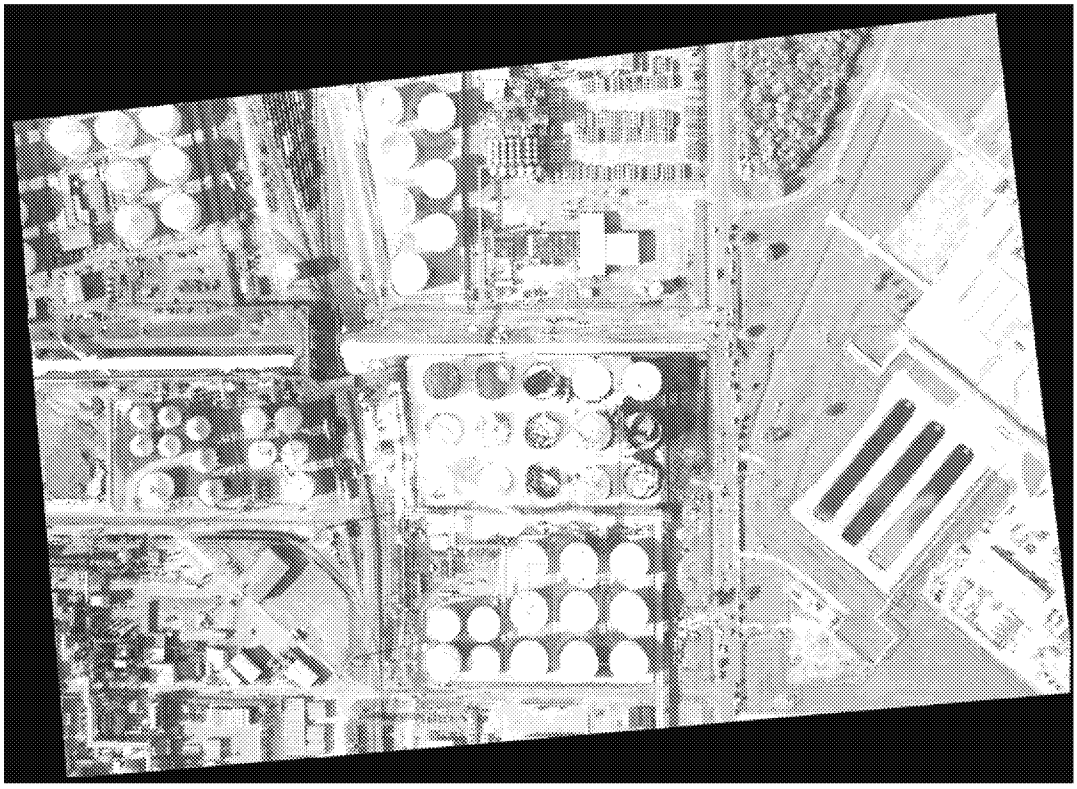
A full set of high resolution aerial digital photography was collected as part of the flight. Figure 8 shows a representative overhead image collected as part of each pass over the tank farm. Evident in this image is the white material in the drainage ditch located on the north side of the secondary containment. This does suggest that the containment structure may have been compromised. Figure 9 shows an oblique image of the tank farm and the fire that reignited. Note that the top of the image is toward the south. The location of the fire is generally consistent with IR thermal and night vision analysis described in the above section.

Figure 8: Aerial Image of the ITC Tank Farm, Flight 9
