AIR MONITORING MAP
KMCO INC EXPLOSION
16503 RAMSEY RD
CROSBY, HARRIS COUNTY, TEXAS

REPORTING PERIOD #01
4/2/2019 1200 - 4/2/2019 1500

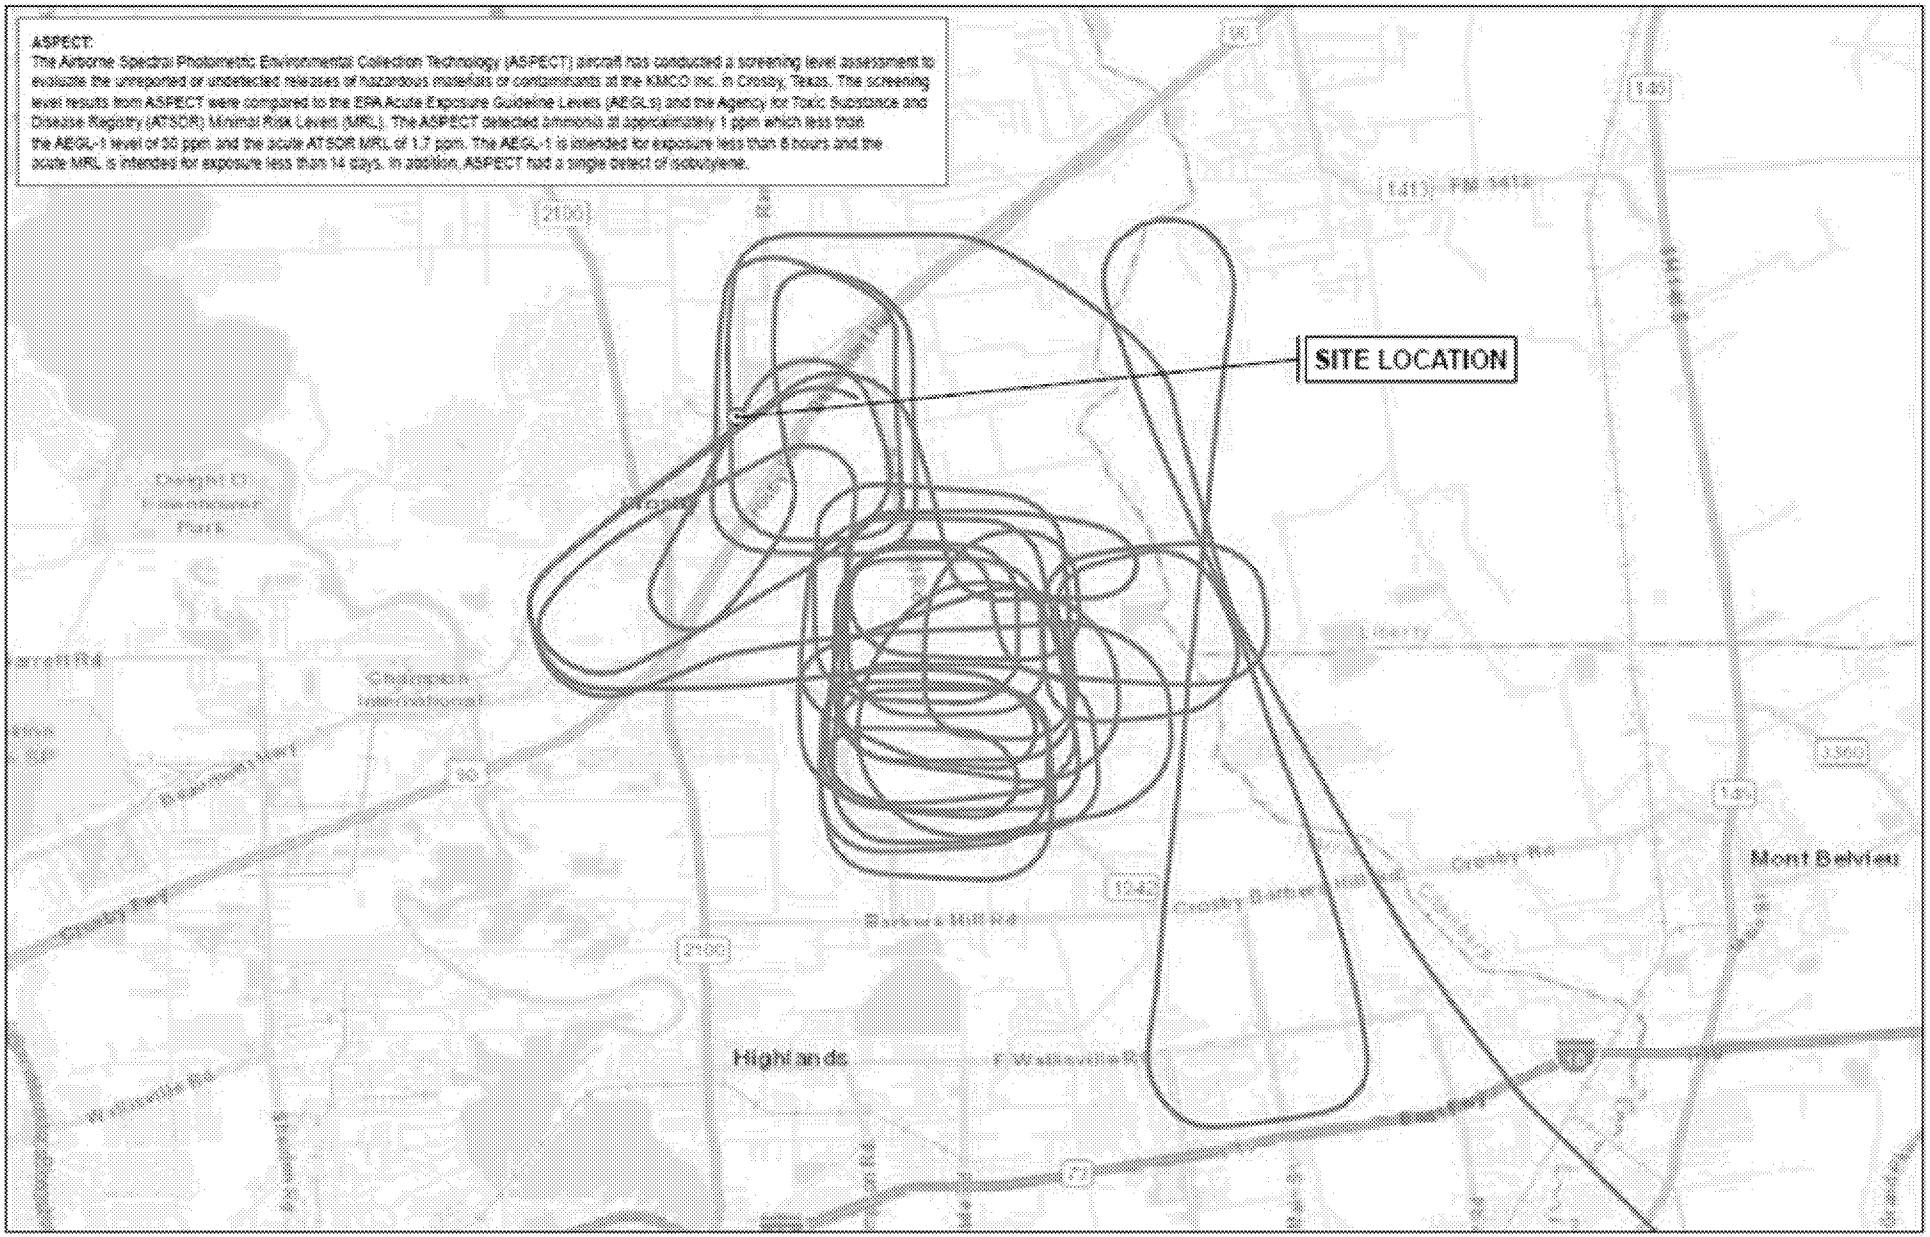
ASPECT:
The Airborne Spectral Photometric Environmental Collection Technology (ASPECT) aircraft has conducted a screening level assessment to evaluate the unreported or undetected releases of hazardous materials or contaminants at the KMCO Inc. in Crosby, Texas. The screening level results from ASPECT were compared to the EPA Acute Exposure Guideline Levels (AEGL's) and the Agency for Toxic Substance and Disease Registry (ATSDR) Minimal Risk Levels (MRL). The ASPECT detected ammonia at approximately 1 ppm which less than the AEGL-1 level of 30 ppm and the acute ATSDR MRL of 1.7 ppm. The AEGL-1 is intended for exposure less than 8 hours and the acute MRL is intended for exposure less than 14 days. In addition, ASPECT had a single detect of styrene.

- SITE LOCATION
- ASPECT DATA (No Readings Above Benchmarks)
