RESOLUTION CONSULTANTS

Subject: **Well Inventory Memorandum – Navy Owned Wells, NWIRP Bethpage**

Date: July 2015

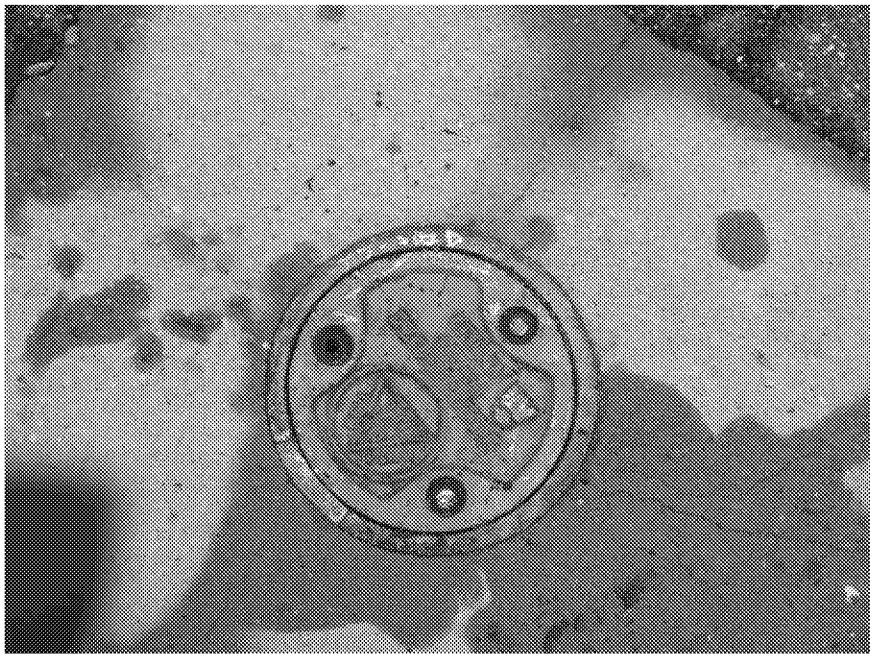
25.DSCN0172-BPS1-TT-MW307I

25	**TT-307I**	BPS1-TT-MW307I	200	188	198	5/22/2014	45.1	200	Fair	R	Pad cracked	1124915.179	213353.948	NWIRP - Southeast of south warehouse buildings
26	**TT-307D**	BPS1-TT-MW307D	286	276	286	5/22/2014	45.5	285.38	Fair	R	Pad cracked; needs bolts	1124926.585	213357.39	NWIRP - Southeast of south warehouse buildings
27	**TT-304D**	BPS1-TT-MW304D	191	180	190	5/20/2014	46.9	191	Good			1124994.61	213691.8	NWIRP - East of south warehouse buildings, stick ups cut off

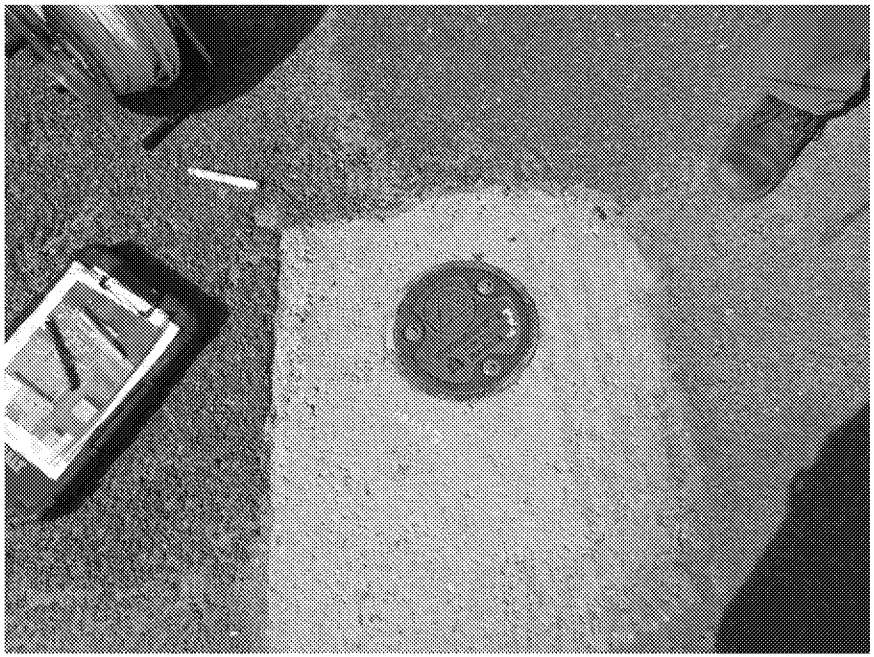
37.DSCN0124-BPS1-TT-MW303S

36	**TT-303I2**	BPS1-TT-MW303I2	156	146	156	5/20/2014	45.5	151	Good			1124562.054	213779.054	NWIRP - Between south warehouse buildings on northeast corner
37	**TT-303S**	BPS1-TT-MW303S	56	46	56	5/20/2014	45.3	51	Fair	R	Pad cracked	1124583.496	213778.188	NWIRP - Between south warehouse buildings on northeast corner
	MW-01	BPTTAOC22MW01	68	48	68	5/20/2014	51.93	57.15	Fair	R, S	OLM; needs bolts, locks, jplug	1123685.101	214049.1047	NWIRP - 39.4' from Al's trailer, 22.4' from fence
	MW-02	BPTTAOC22MW02	66	46	66	5/20/2014	52.6	52.6	Fair	R, S	needs bolts & locks	1123715.055	214058.1533	NWIRP - Site 2, beware OLM
38	**MW-03**	BPTTAOC22MW03	65.5	45.5	65.5	5/20/2014	59.1	66.4	Good	S		1123680.109	214136.7829	NWIRP - Site 2, northern side
39	**MW-04**	BPTTAOC22MW04	66	46	66	5/21/2014	51.57	68	Good	S		1123645.162	214018.5265	NWIRP - Site 2 on northwestern corner of office building
	MW-05	BPTTAOC22MW05	67	47	67	5/20/2014	NA	NA	decommissioned			1123702.574	214173.9136	NWIRP decommissioned
