Figure 12: Gamma Survey Overview Map

NIAGARA FALLS BOULEVARD RADIOLOGICAL SITE
NIAGARA FALLS, NEW YORK

U.S. ENVIRONMENTAL PROTECTION AGENCY
REMOVAL SUPPORT TEAM 3
CONTRACT # EP-S2-14-01

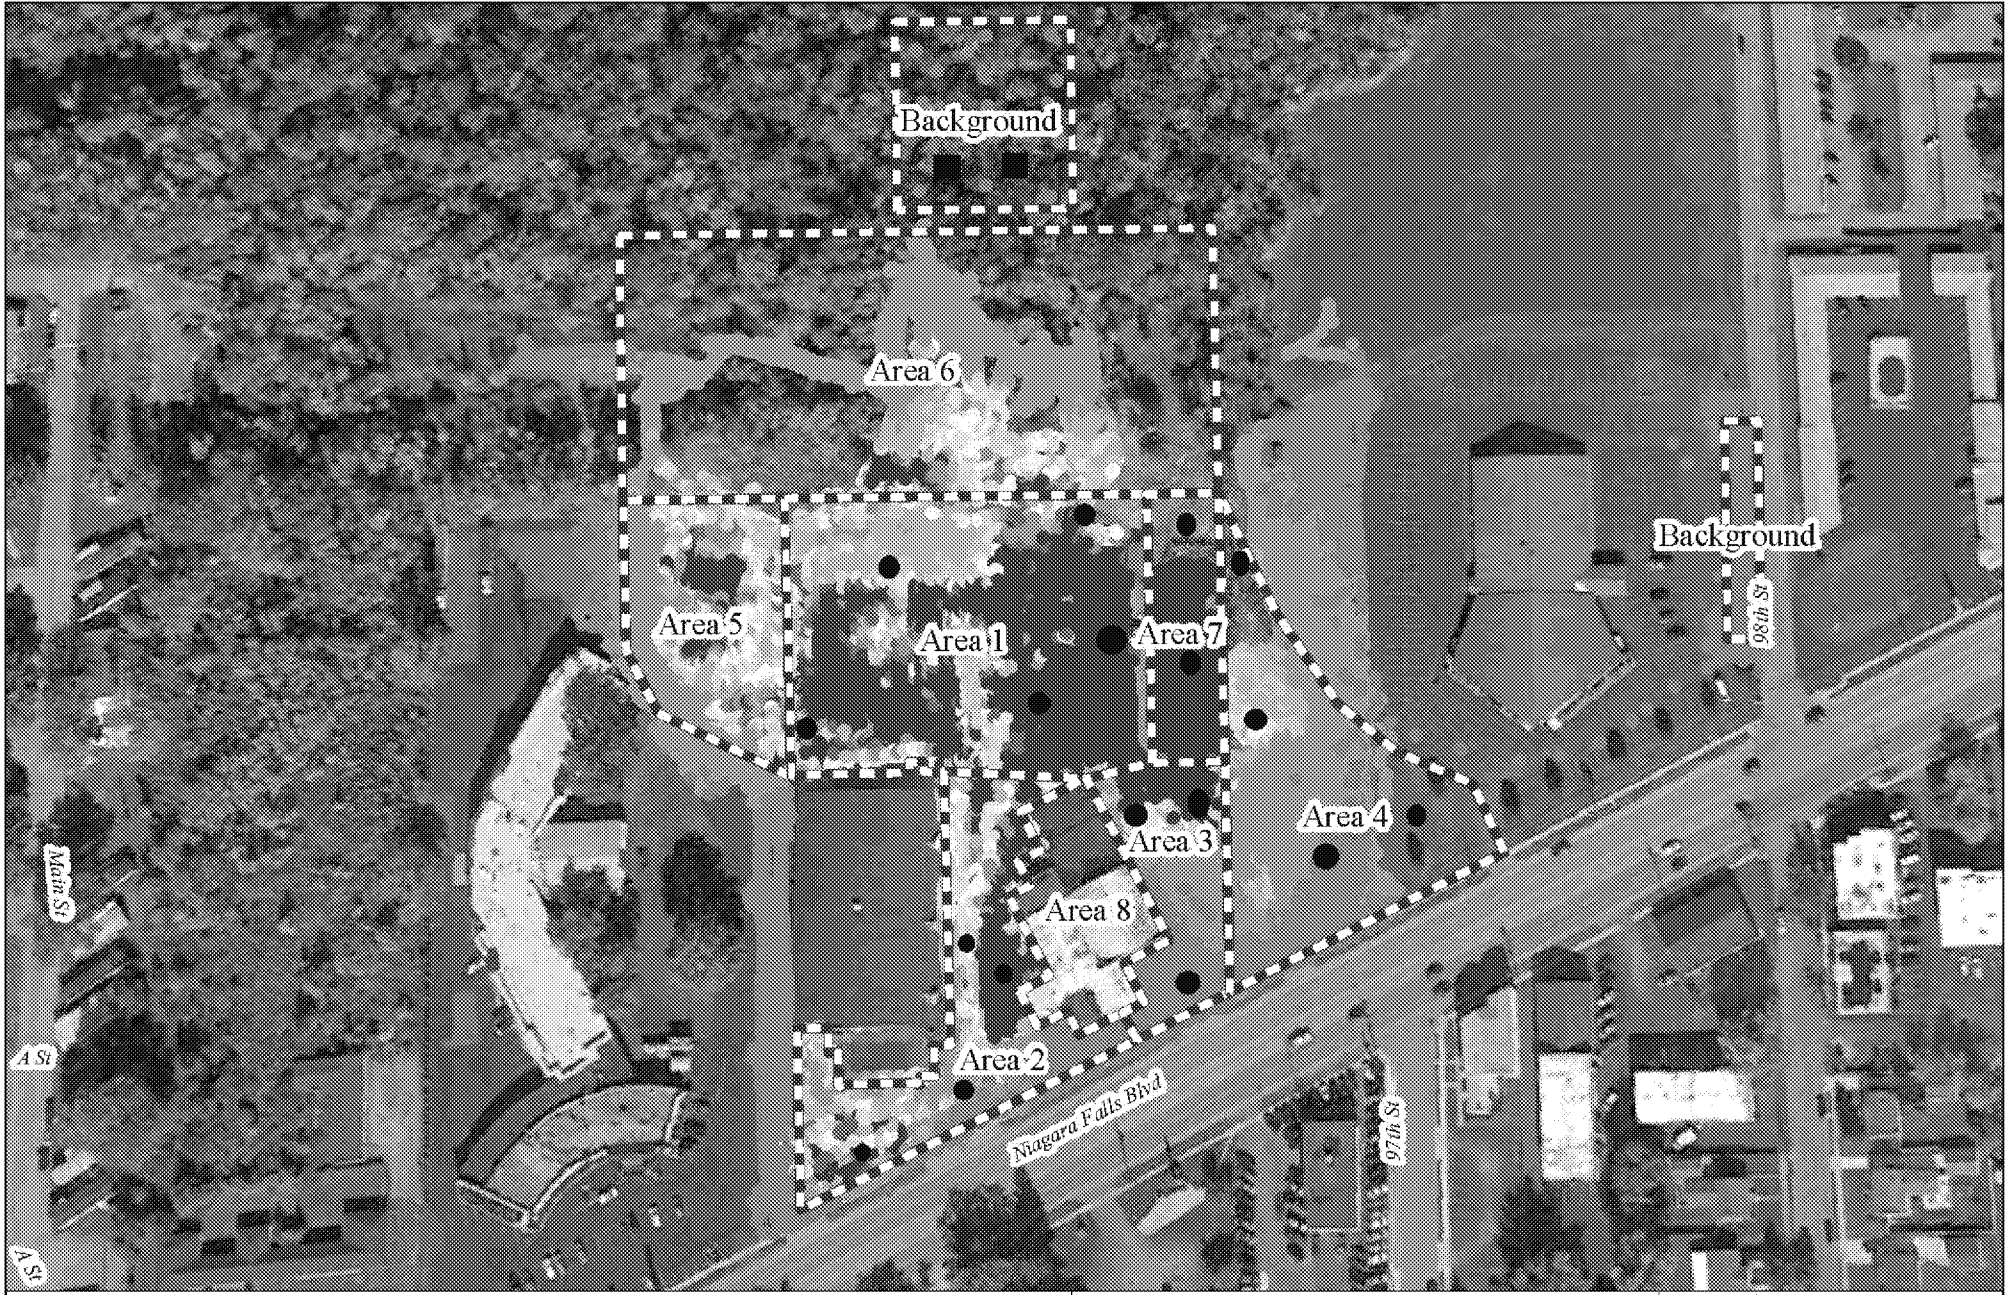
Notes:
Gamma survey conducted with Ludlum 3x3 Sodium Iodide Detector.
Gamma survey measurements presenting in micro-Roentgen per hour (µR/hr).
Background reading: 15 µR/hr.
