2017 ASPECT Preliminary Report
Arkema Plant Response
Crosby, TX

August 31, 2017
0600 hrs to 1900 hrs

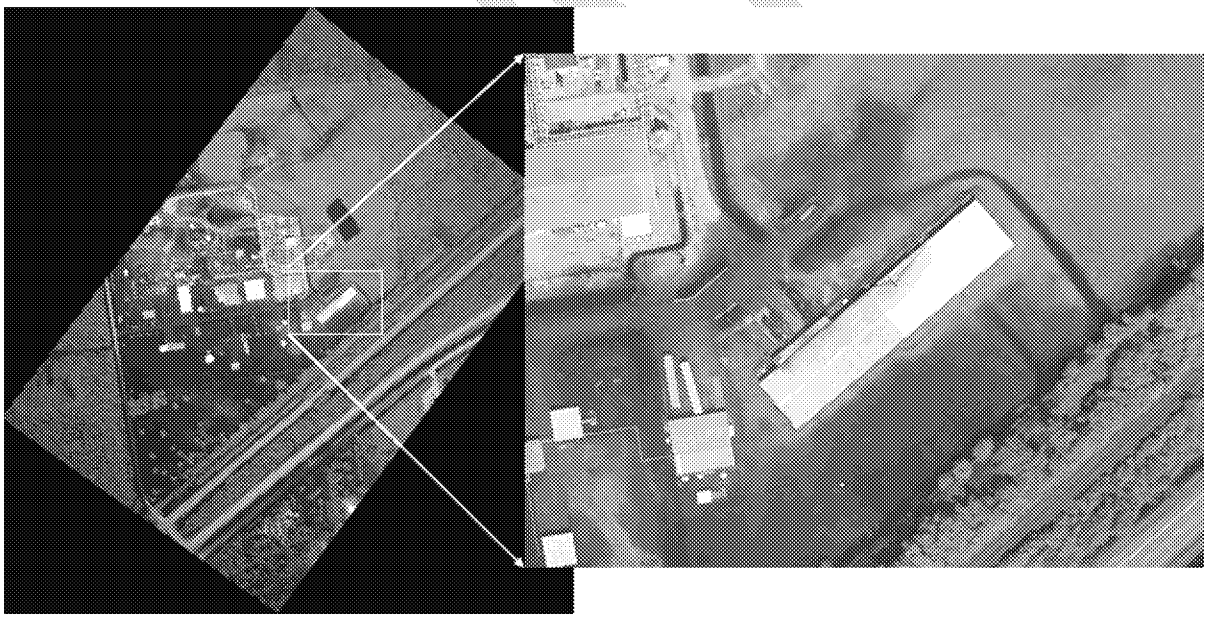
Figure 6: Low resolution aerial image retrieved from the aircraft during the afternoon sortie, approximately 1335 hrs. A copy of the entire image will be provided in an email. A portion of the photo was enlarged to show the affected building.

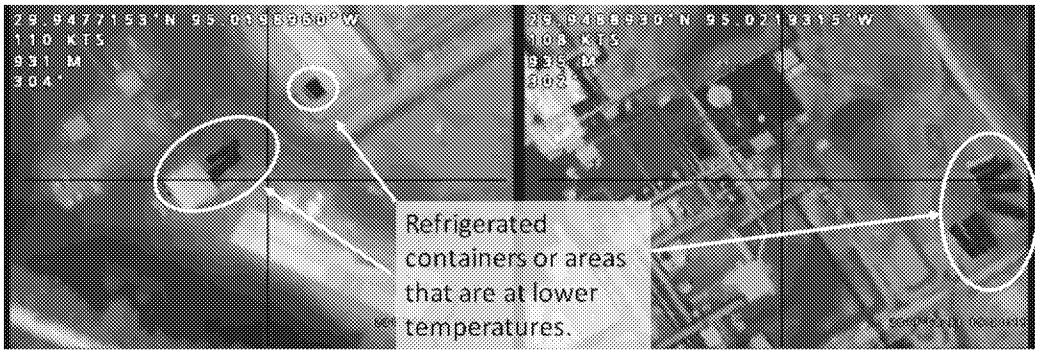
Figure 12 provides snap shots taken from an infrared video collected during the afternoon flight. Dark areas indicate lower temperatures. Eight tanks are identified in these images.

Figure 12: Infrared images obtained from an infrared video (1320 hrs CST) clearly showing heat signatures which identifies which containers are cooled (black colors) at the Arkema facility. Note the northernmost tank in the image to the right. It is painted blue which may affect its heat signature. These photos show eight tanks that are being refrigerated.
