2017 ASPECT Preliminary Report
Rapids Needs Assessment &
Arkema Plant Response, Crosby, TX

September 2, 2017
0700 hrs to 1730 hrs

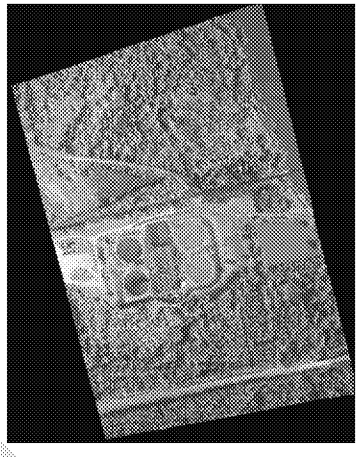
Figure 5: Example of a geo-corrected aerial photo over a water treatment facility. These are part of the rapid needs assessment mission.
